Inspection Report

Property Address:
7610 Trinity Pines Drive
Montgomery TX 77316

Home Data Inspection Services, PLLC

PROPERTY INSPECTION REPORT FORM

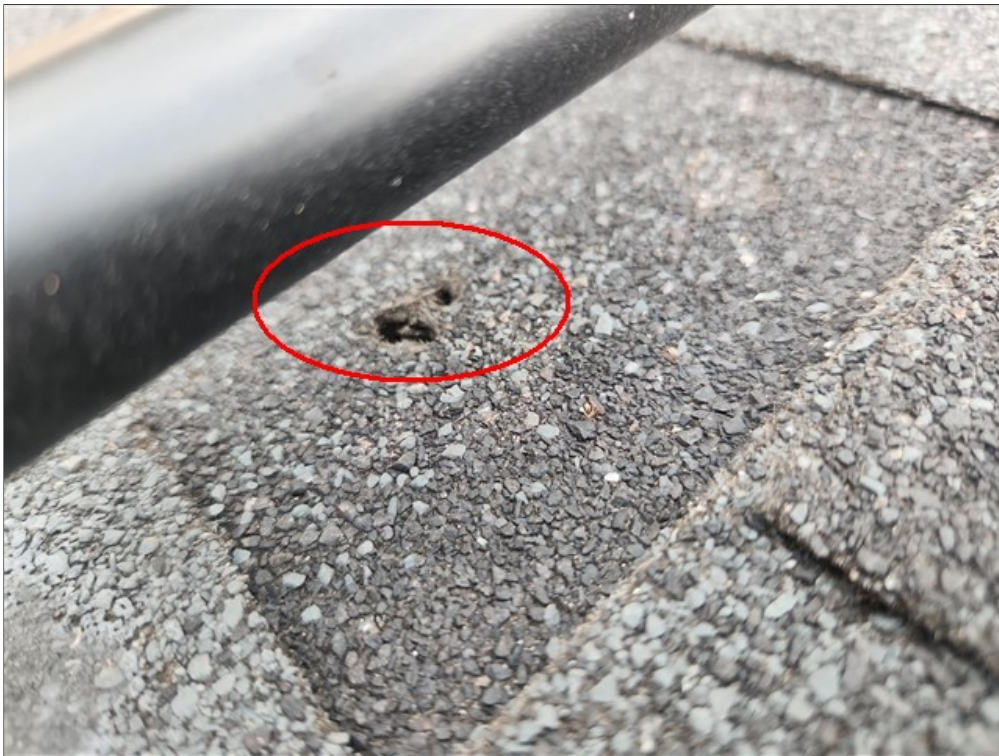
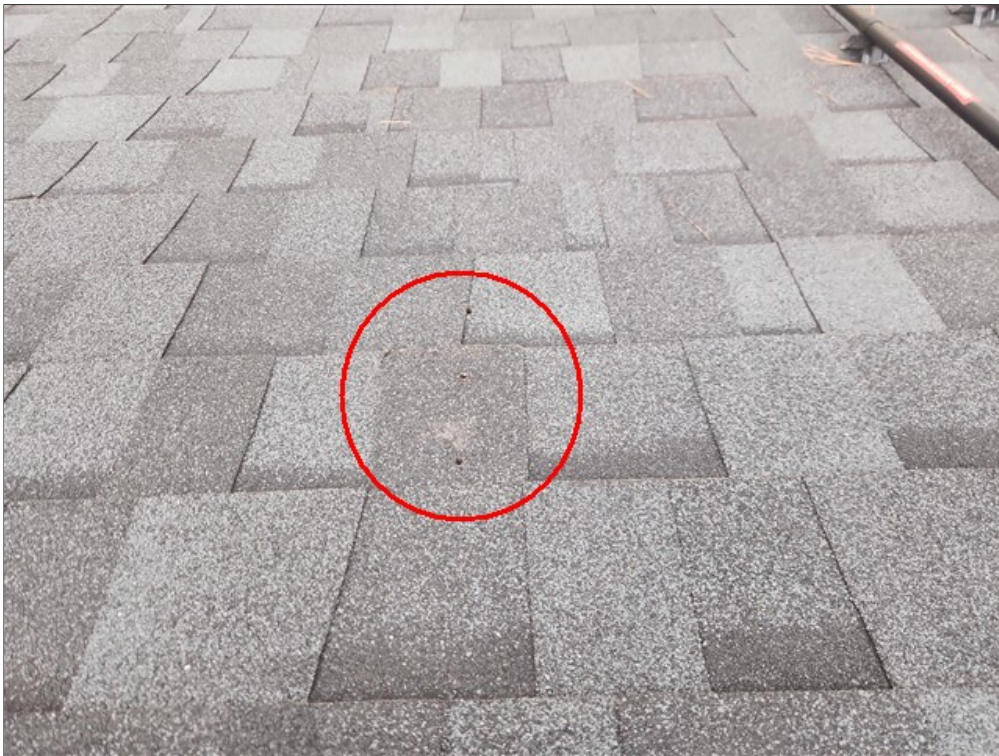
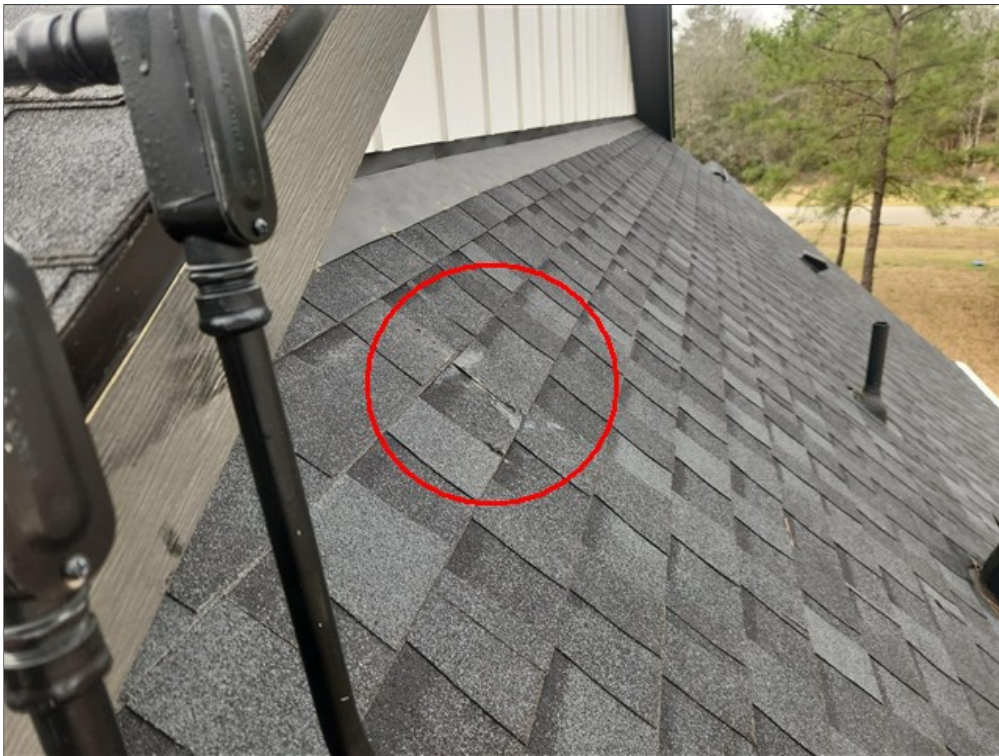
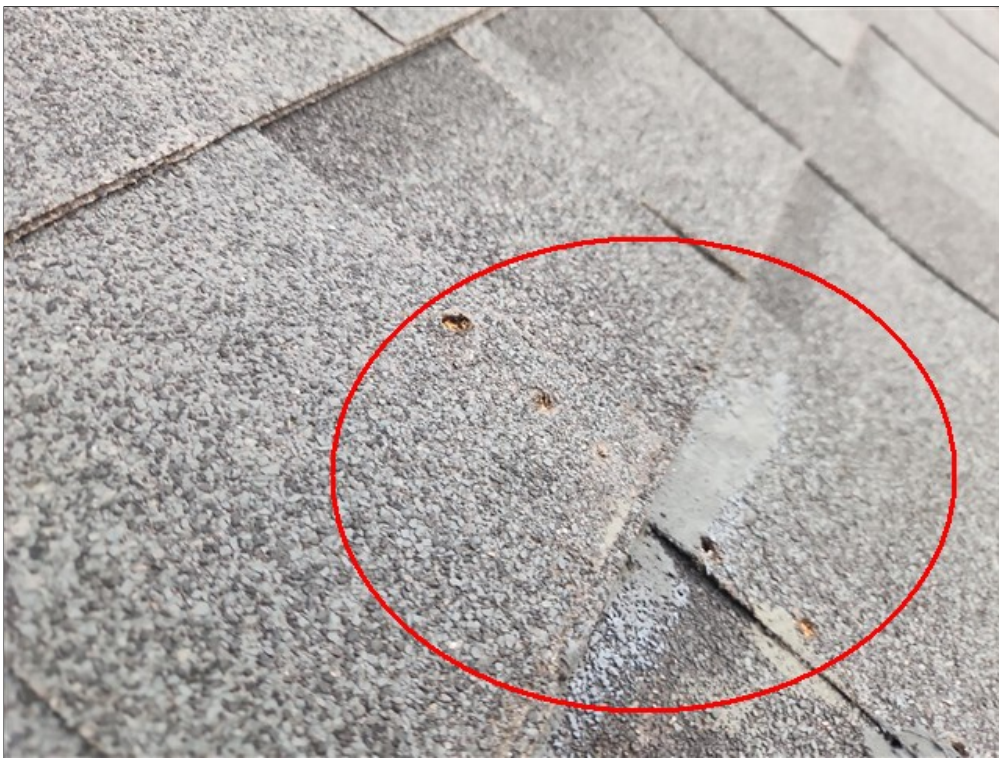
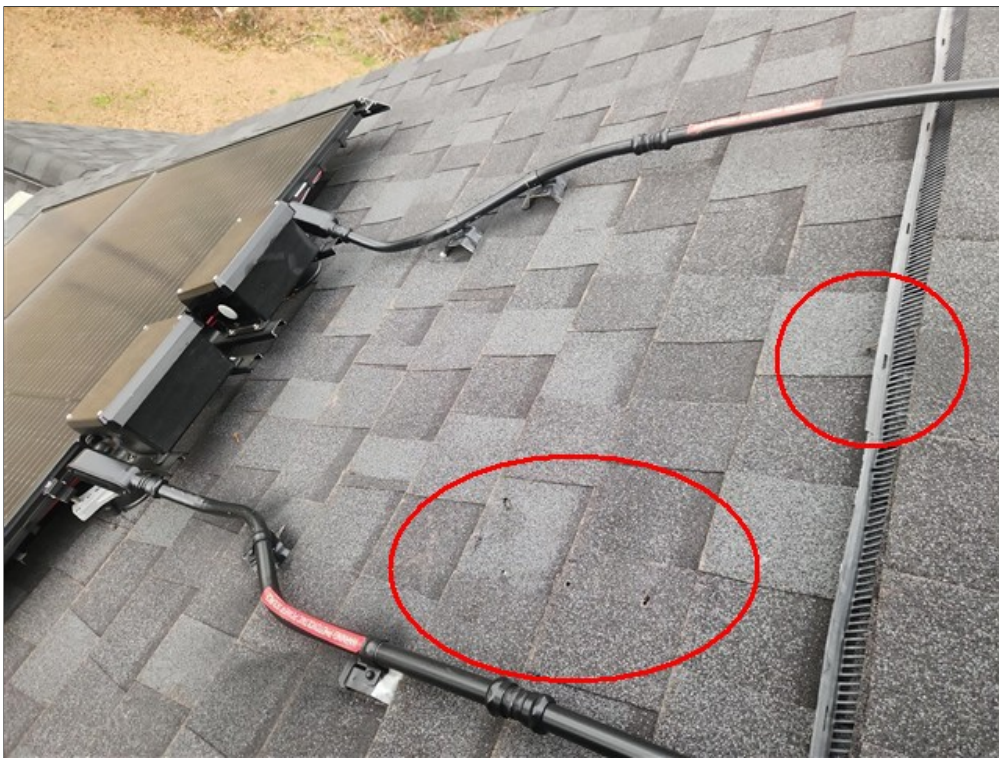
- Several shingles were observed to have holes through them. In most of these instances a metal (unpainted) flashing could be seen through the holes in the shingles but the inspector recommends either all of these damaged shingles have the holes sealed or be replaced.

C. Photos of damaged shingles (holes in shingles)

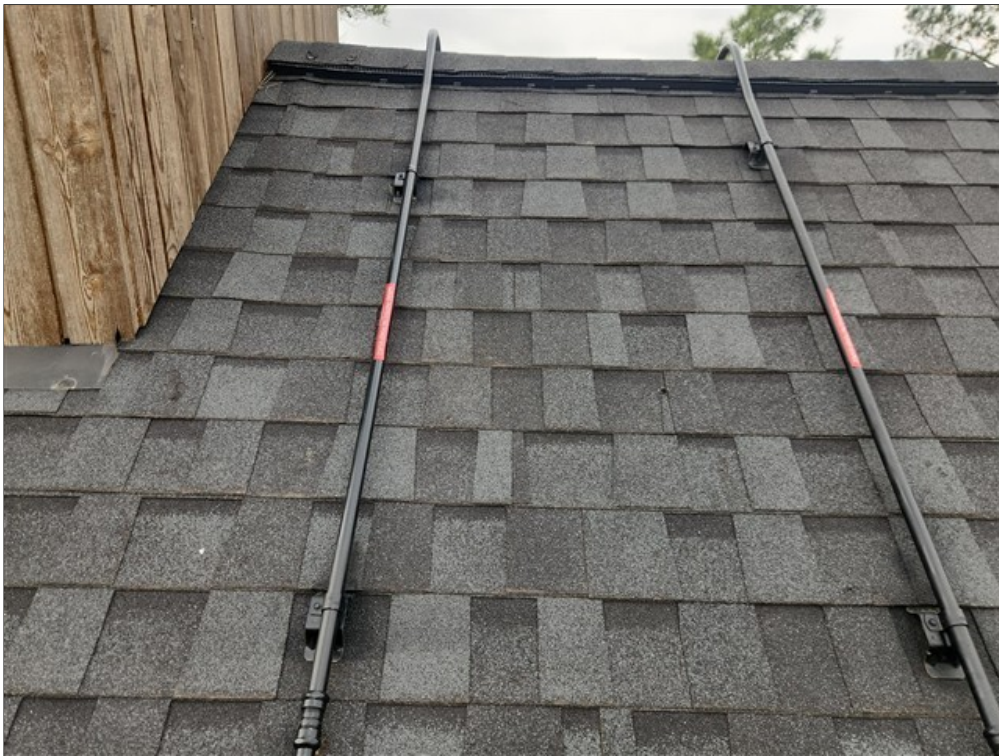
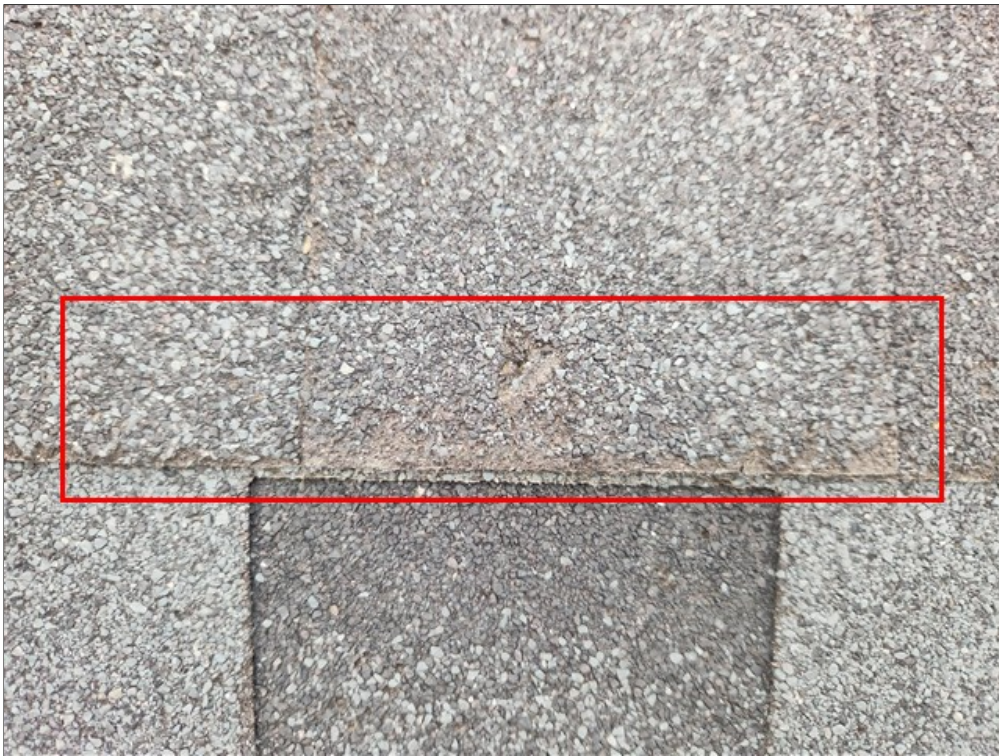
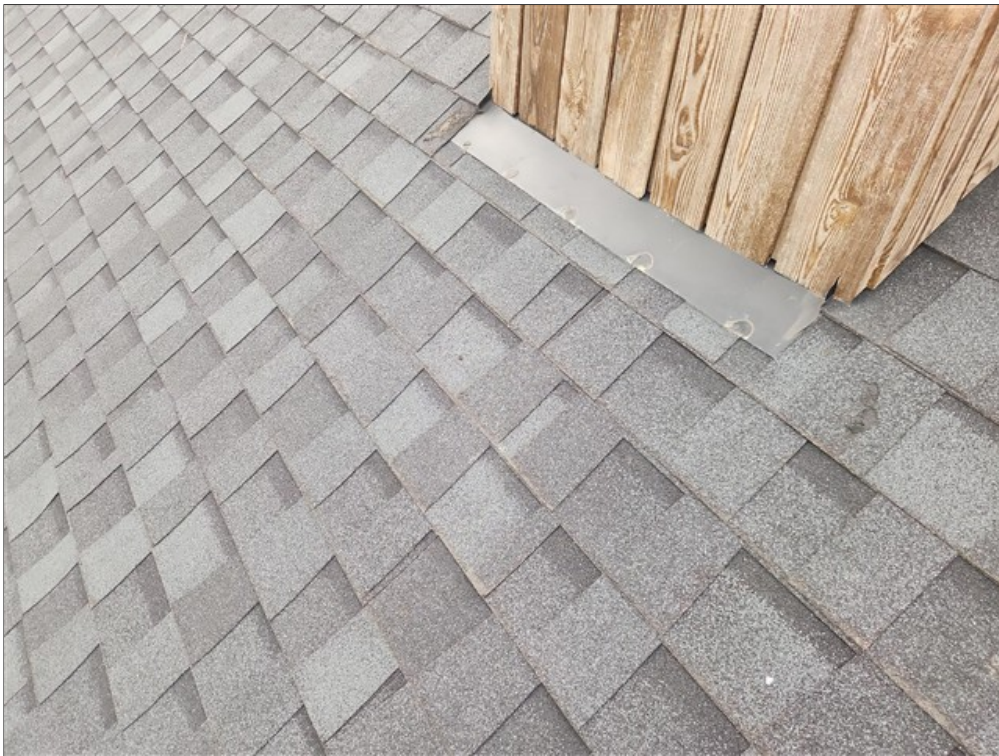
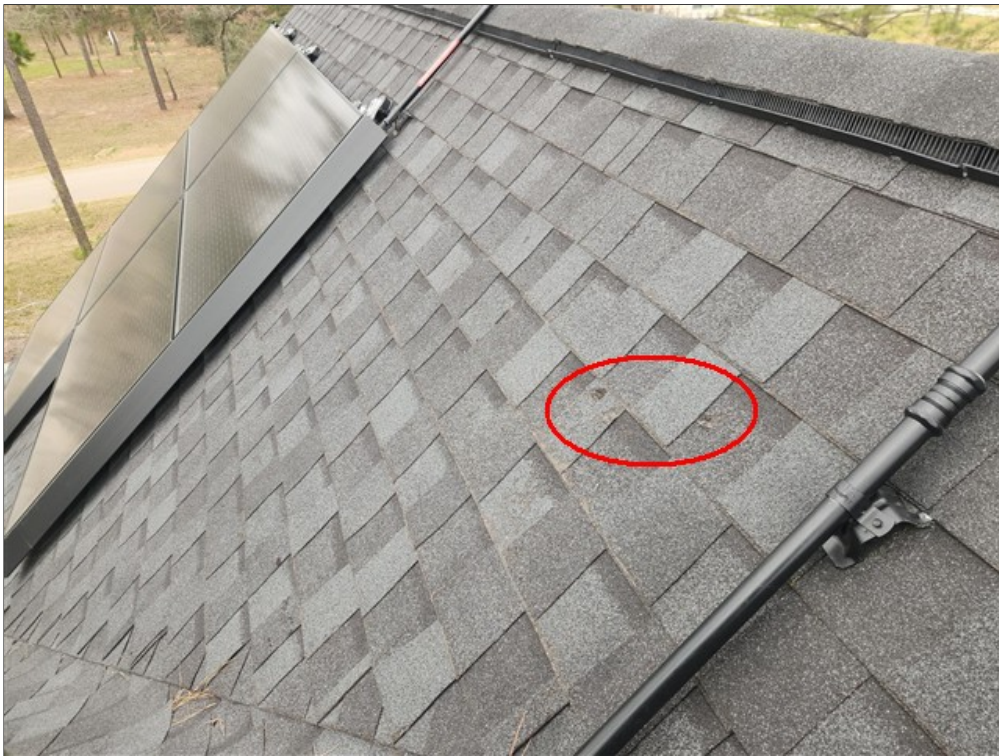
- Three areas equalling approximately 40 shingles were observed to be damaged in close proximity to where solar panels are installed. The damage was in the form of a notable amount of missing granules likely from foot traffic. Granules are the component of an asphalt shingle that protects the waterproofing material (asphalt) from the sun's UV light. Areas missing granules will age notably faster than shingles that are not missing their granules.

C. Areas where shingles are missing notable amount of their granules

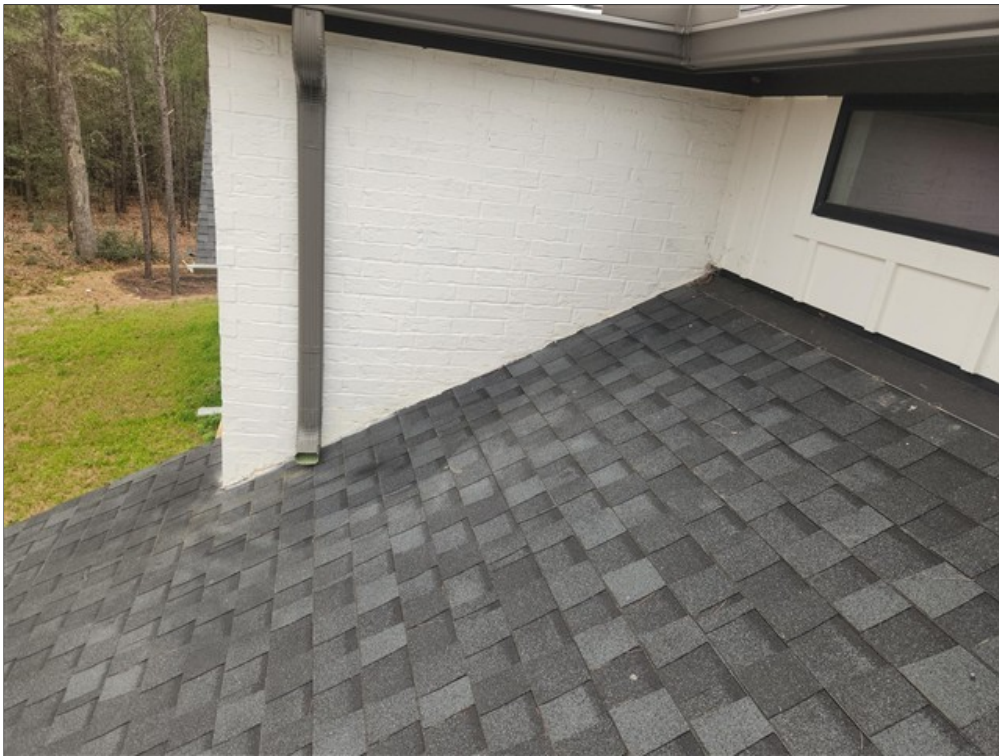
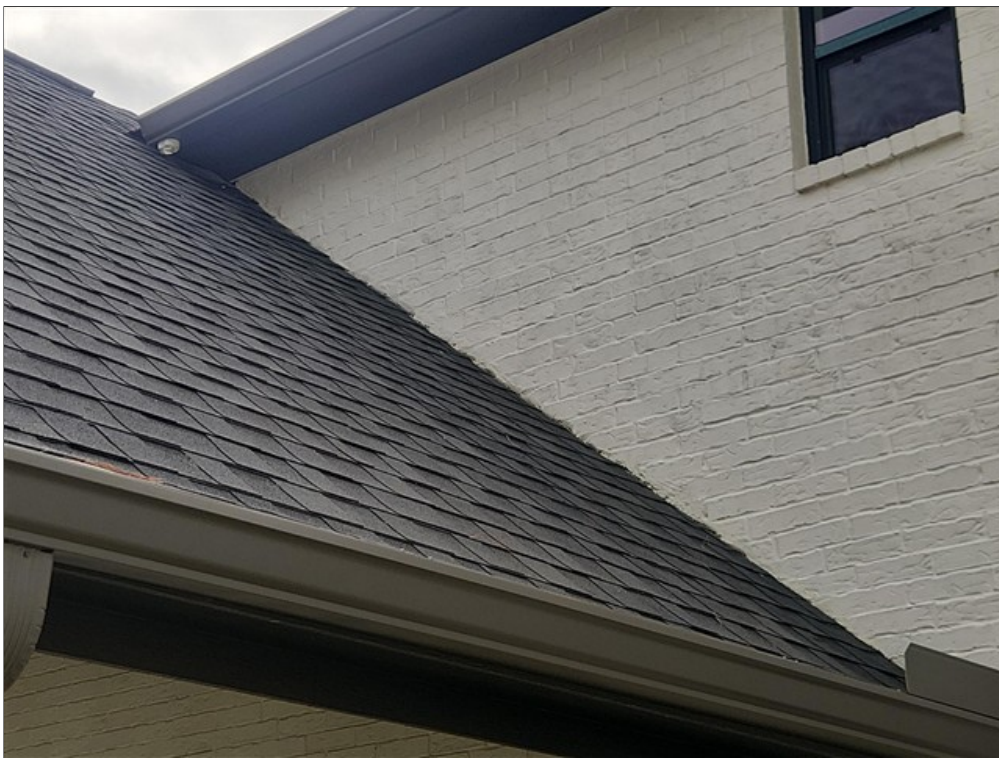
- The inspector was unable to confirm flashing was present at roof to brick wall transitions. The builder should be consulted regarding this condition and confirm flashing is present at these locations.

C. Photos of roof to brick wall transitions where flashing was not visible

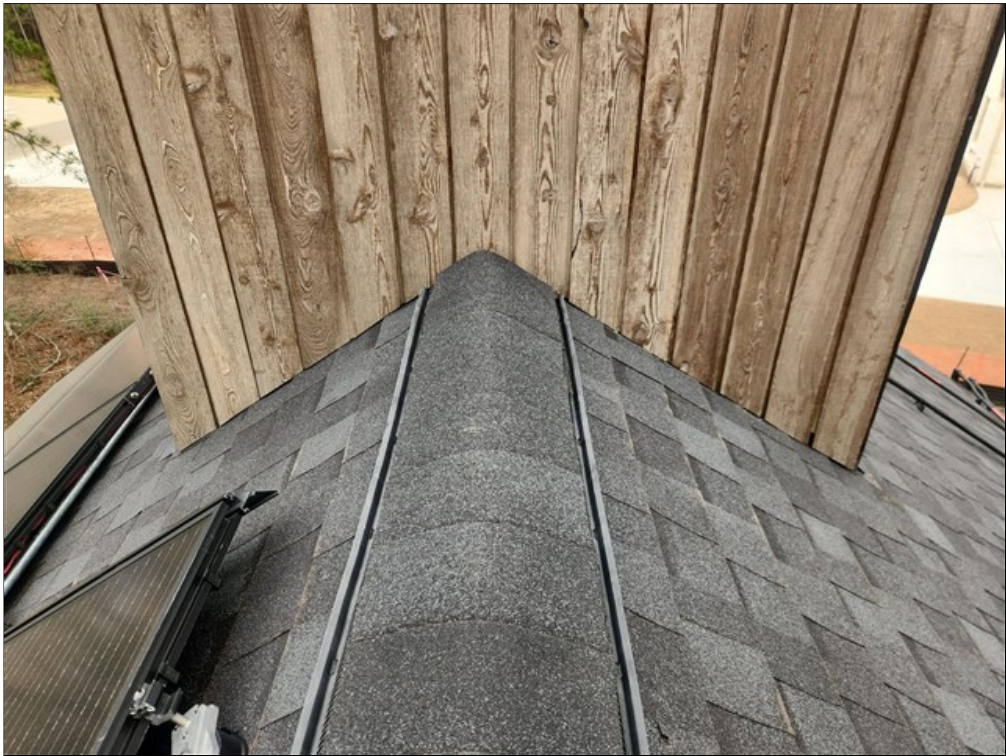
- The clearance of the wood siding and/or trim at some of the roof to wall transitions was observed to be insufficient. This condition leaves the siding and/or trim vulnerable to rot.

C. Photos showing wood siding has inadequate clearance from shingles in several locations

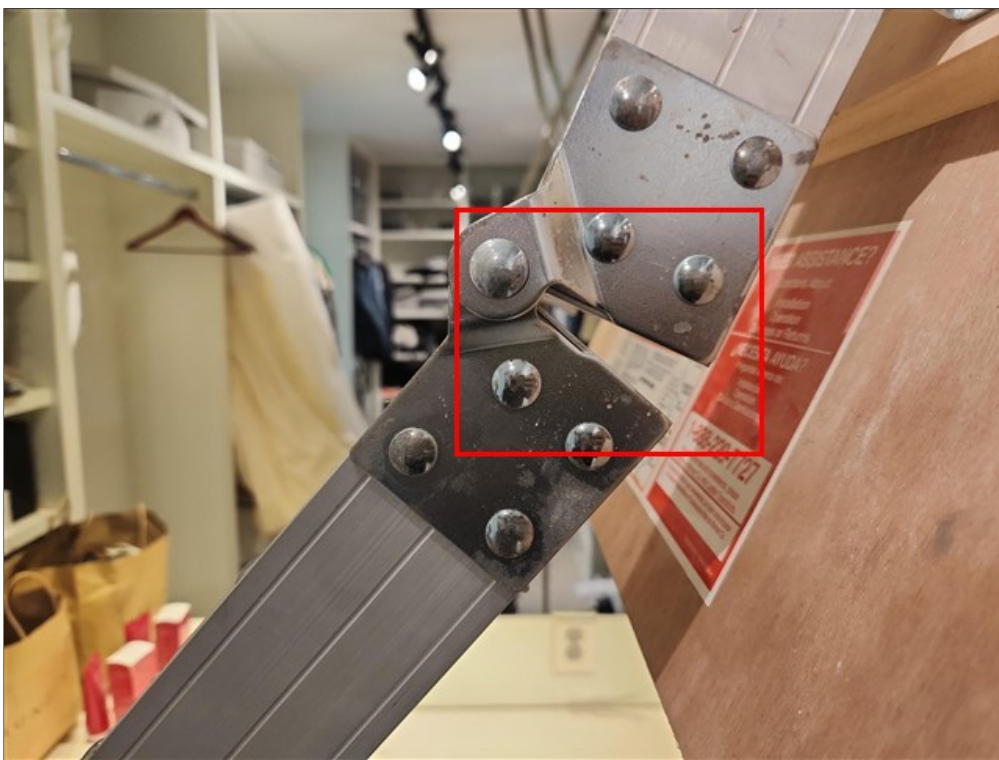
- Attic pull down ladder in master bedroom closet is improperly installed/improper length which is causing the ladder to not fully extend as required by the manufacturer .

D. Attic pull down ladder in master closet is improperly installed/improper length

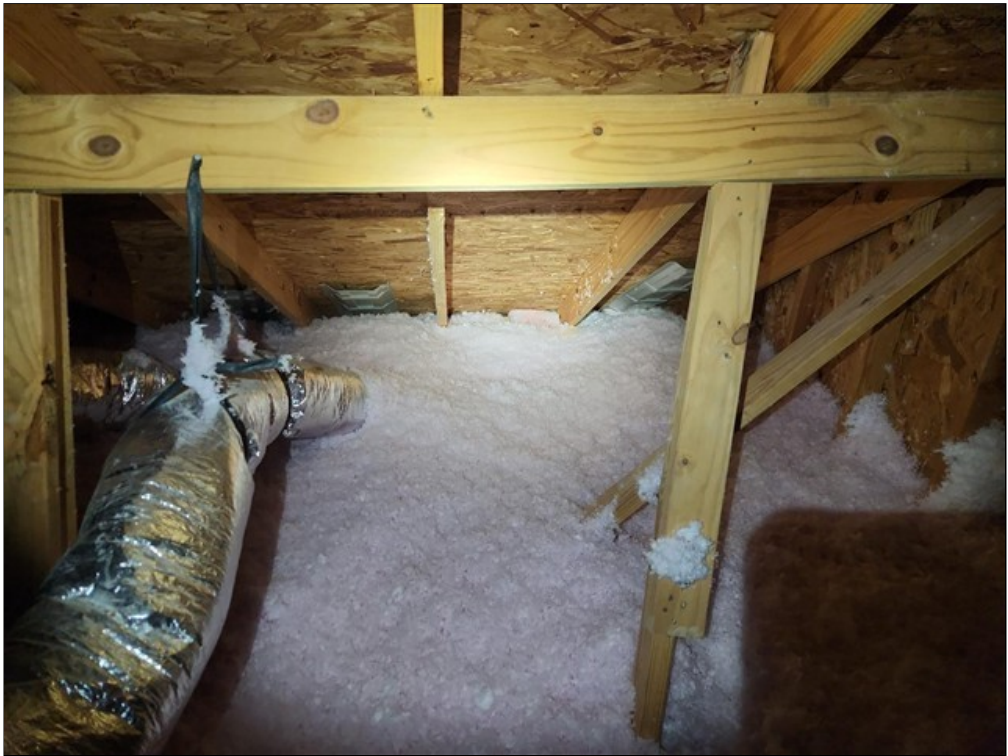
- Baffles were observed to be missing in some areas of the attic.

D. Baffles missing in attic

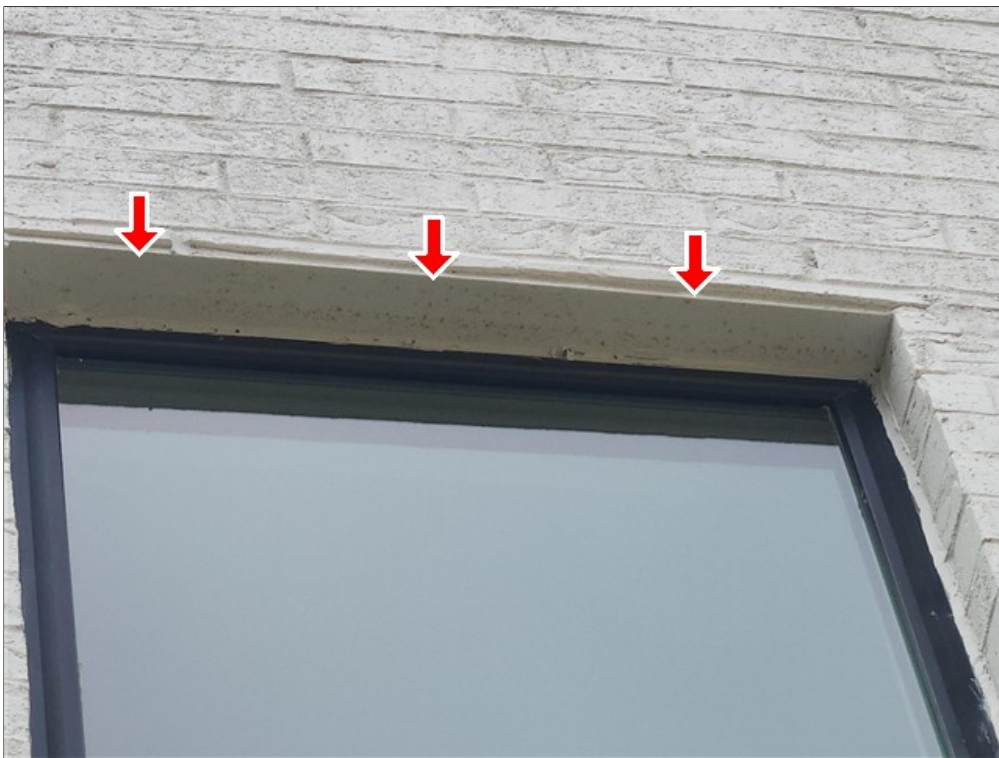
- Steel lintels above several windows were observed to be rusting at the time of the inspection.

E. Photos showing steel lintels above windows rusting

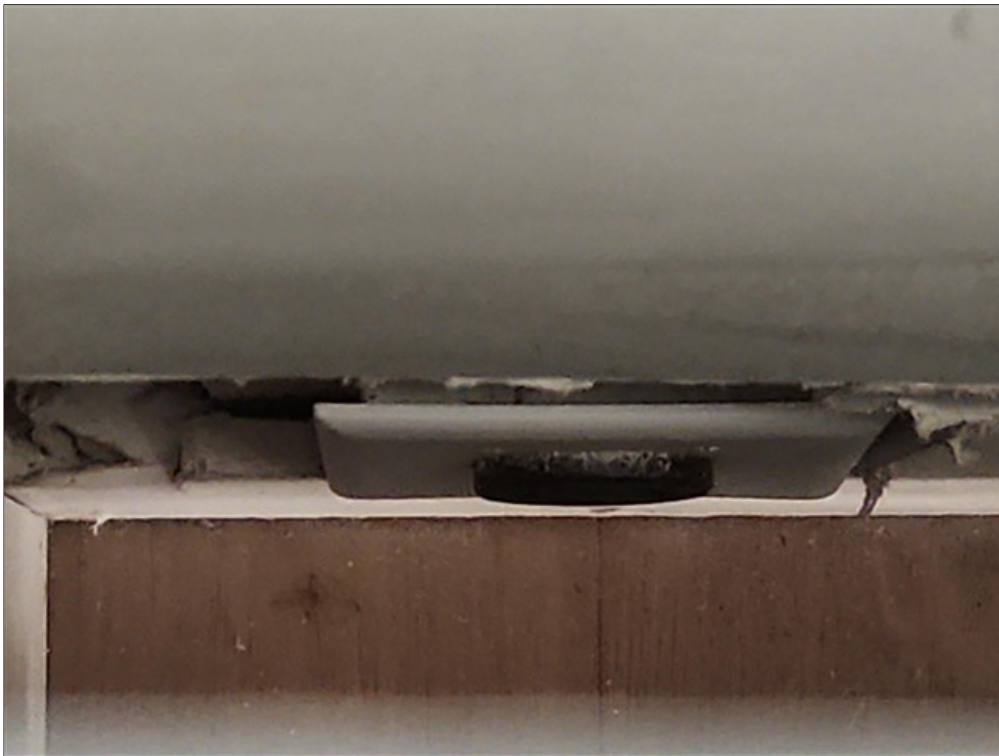
- An excessively large hole was observed in the wall around the receptacle behind the range.

E. Excessively large hole in wall around receptacle behind range

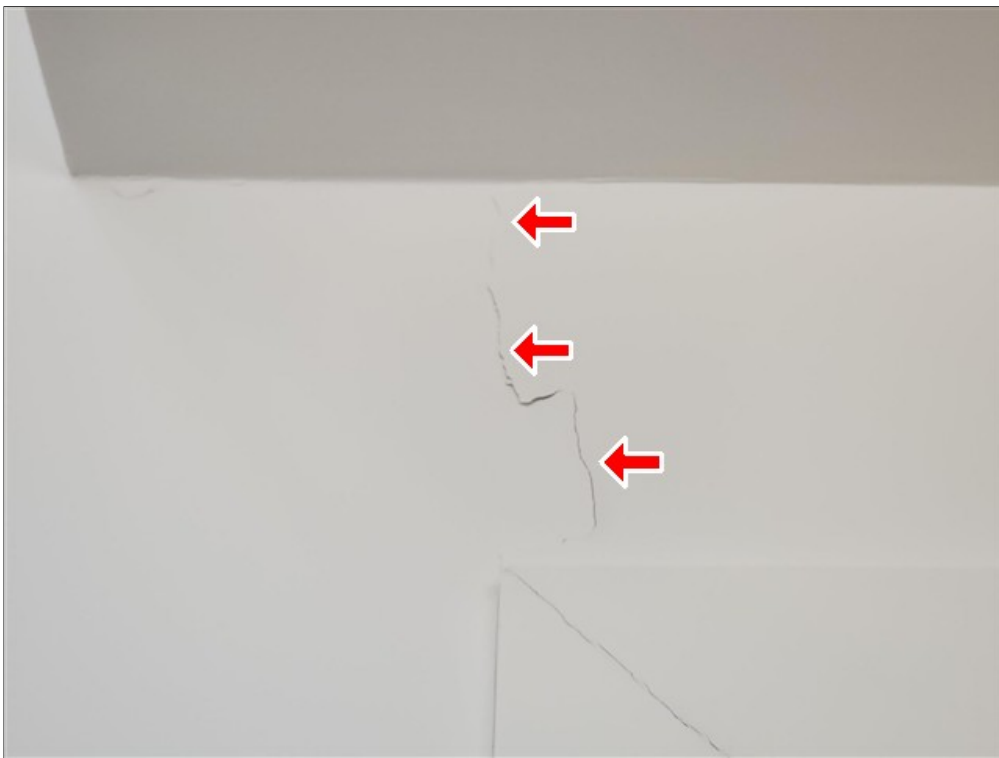
- (4)
- A drywall crack was observed in the wall above the powder room door.

E. Drywall crack in wall above powder room door

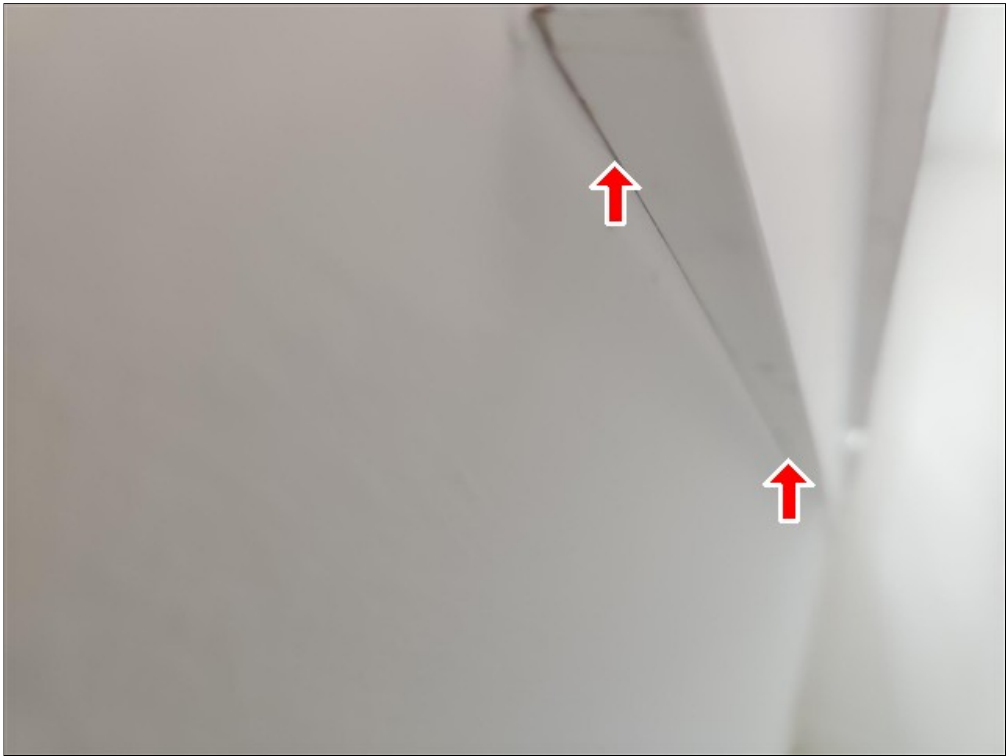
- Caulking was observed to be missing from the underside of window stool trim throughout home.

E. Example of caulking improvements needed at underside of window stool trim throughout the home

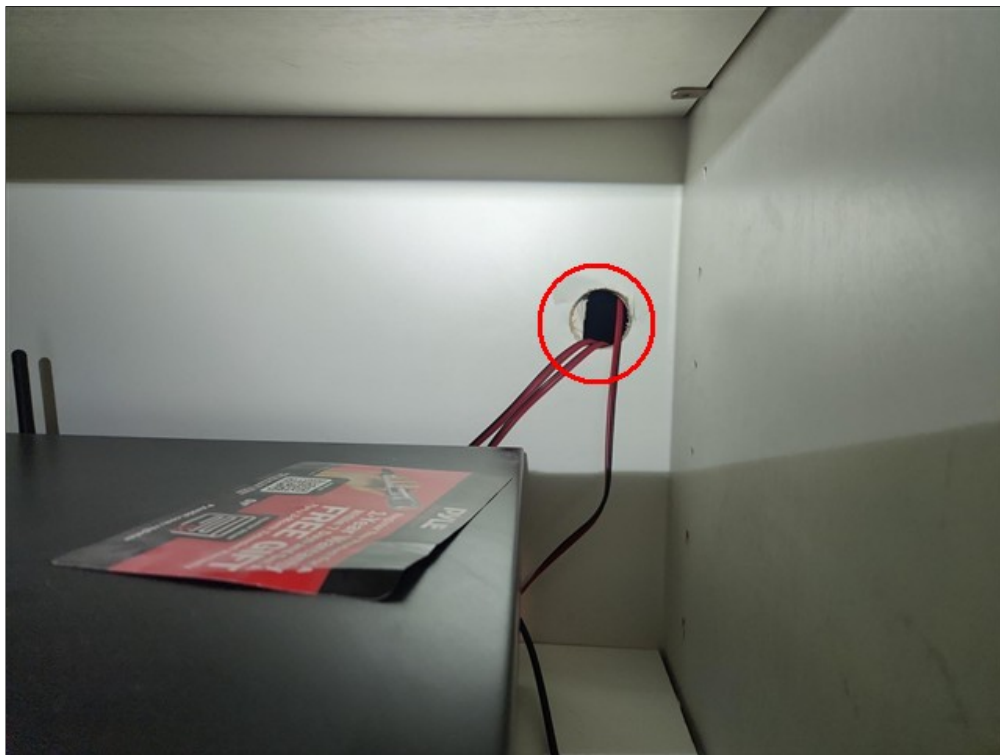
E. Second level game room closet has large hole in wall that should be sealed

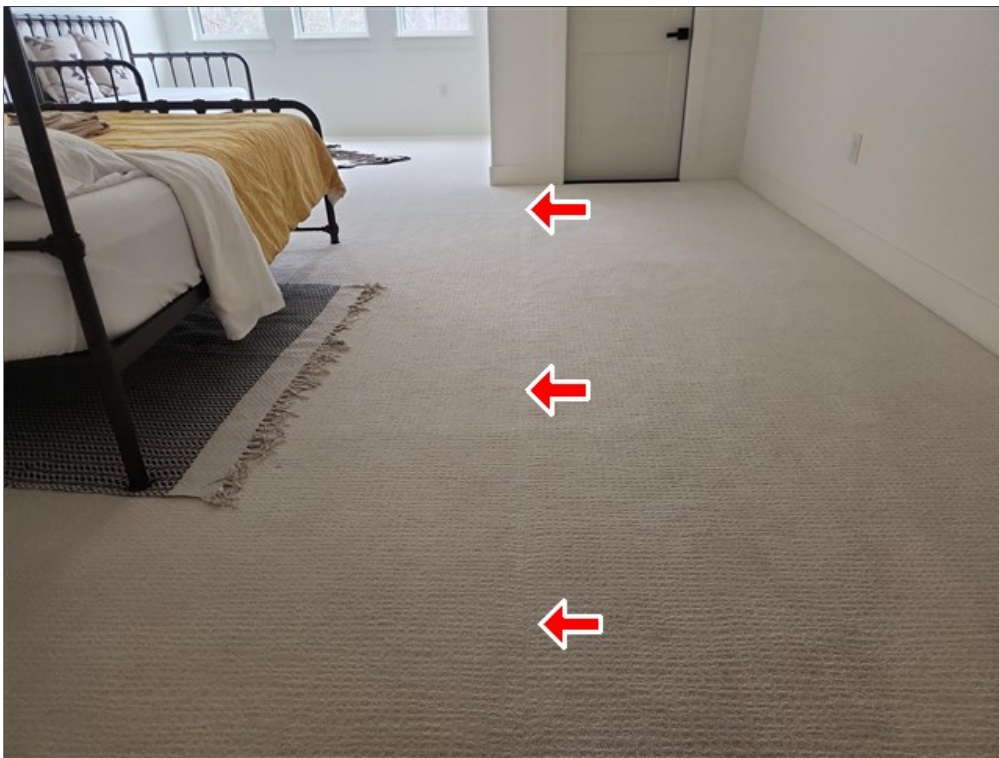
F. Carpet seem easily noticeable in second level right guest bedroom

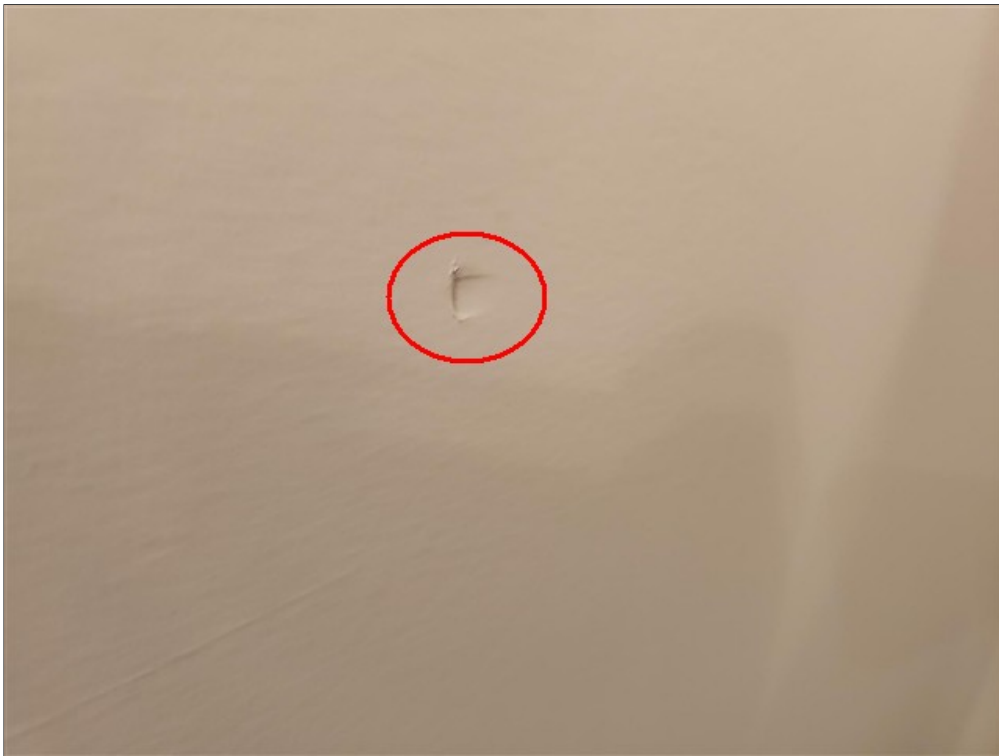
- Numerous doors throughout the home are missing doorstops. This has allowed for several walls to be damaged.

G. Example of missing doorstops

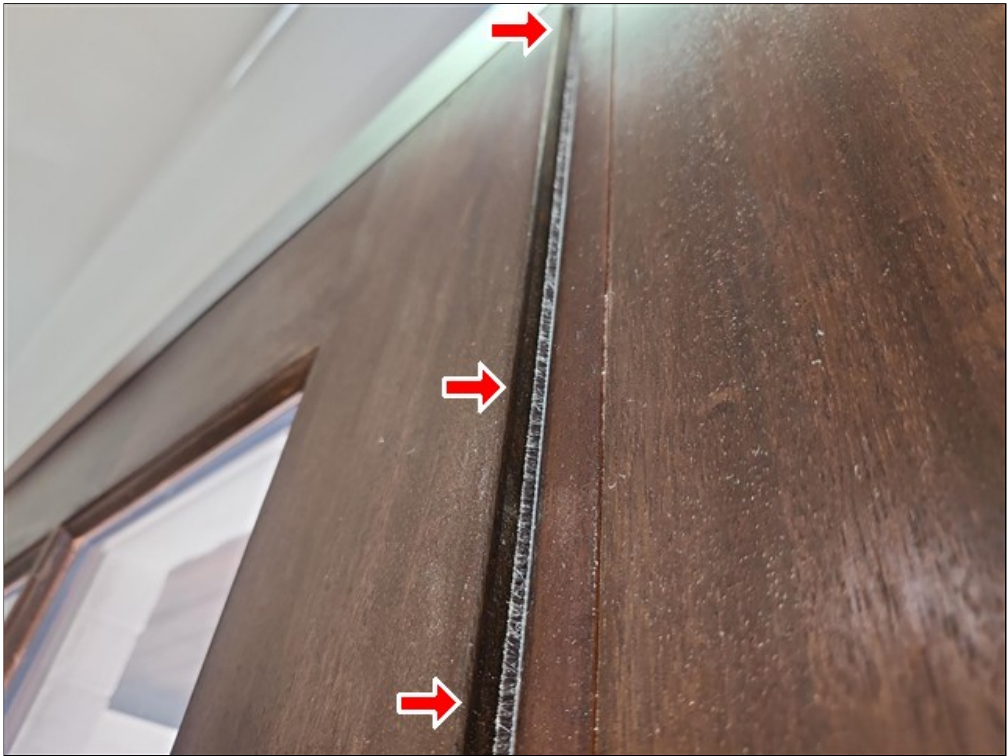
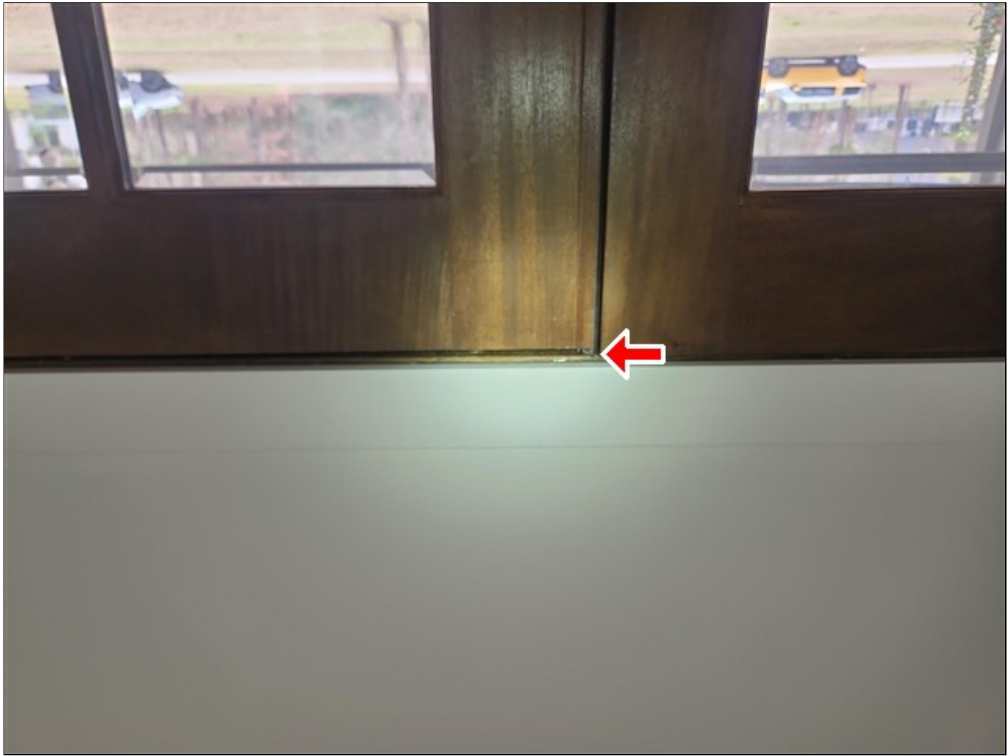
- The exterior door at the front of the home appears to not be square with the frame. One door is twisted causing the top to be pushed out approximately 3/4 inch when the bottom is flush, and a notably larger gap at the top of one door . This is also causing some air leakage around the door.

G. Exterior door at front of home appears to not be square with frame

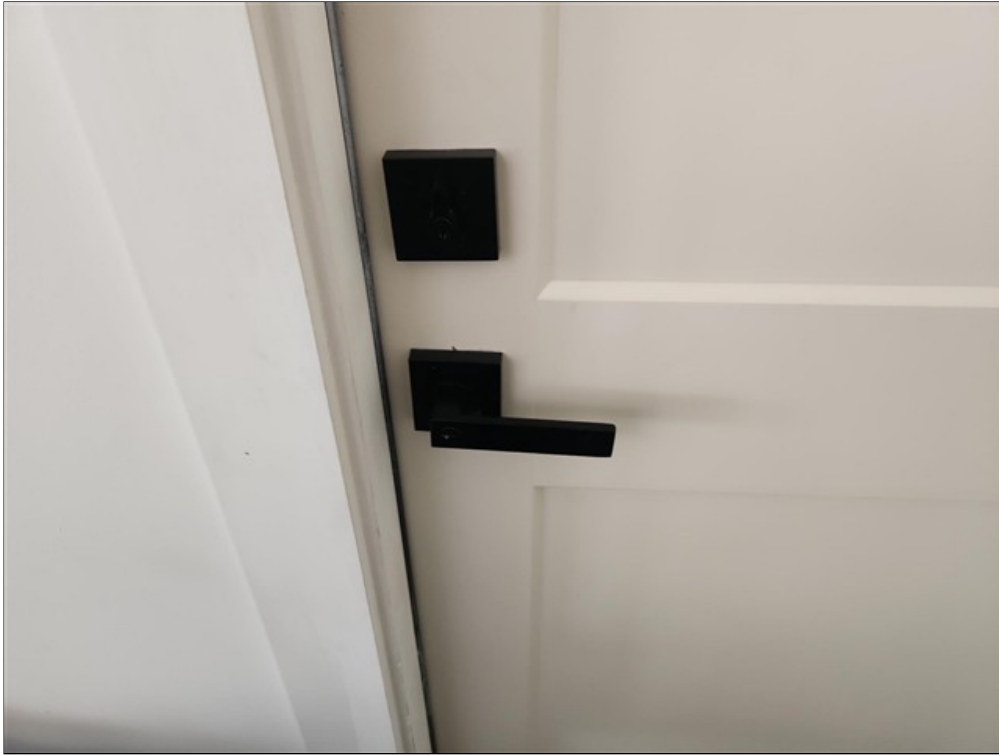
- The door handle hardware at the occupant garage door is loose.

G. Door handle at occupant garage door loose

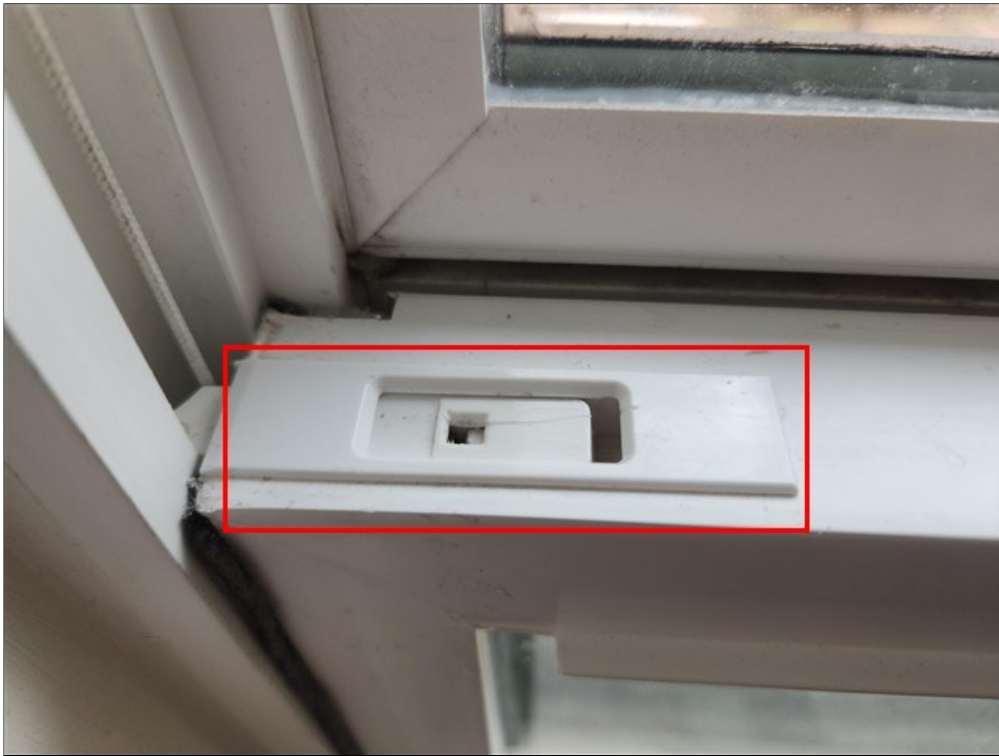
- One latch was missing (damaged) at the second level right guest bedroom right window .

H. One latch missing at second level right guest bedroom right window

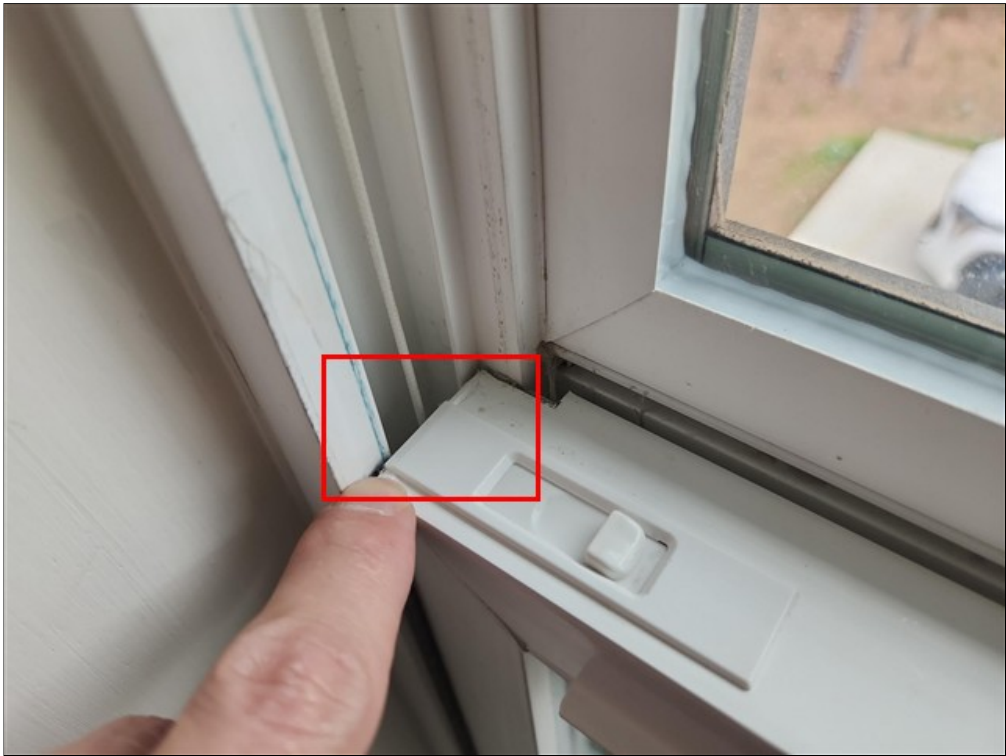
H. Far left window in second level right guest bedroom does not latch on left side

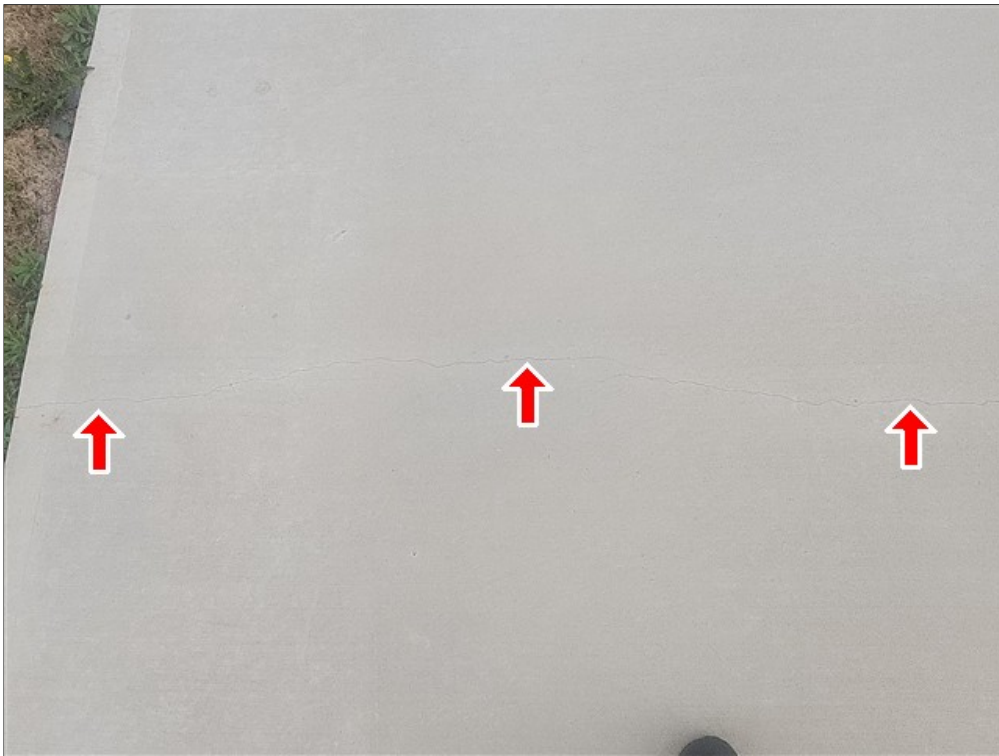
- Two concrete driveway pads are cracked across the entire pad and one of the two pads is also broken at one corner.

L. Photos showing two concrete driveway pads cracked across entire pad

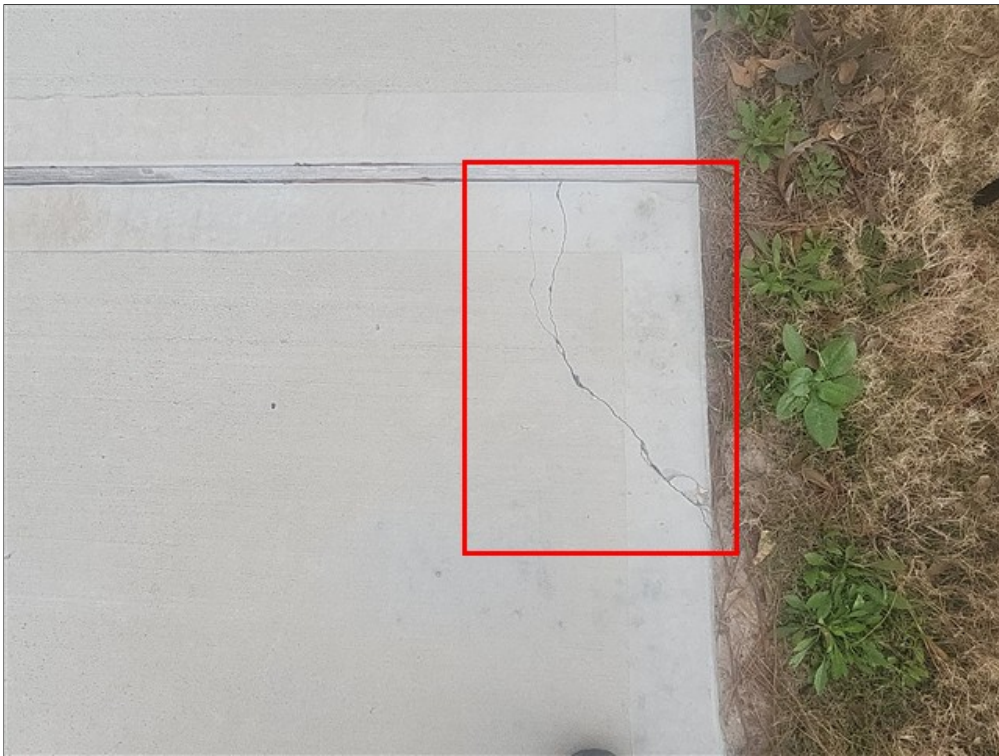
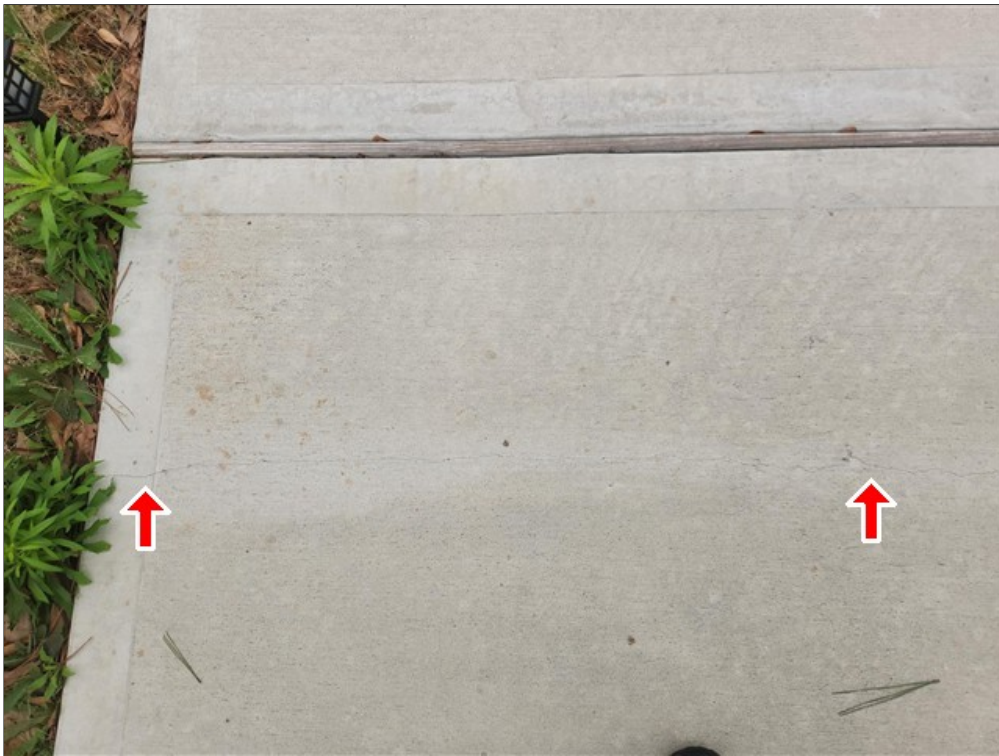
L. Photo showing concrete pad broken at one corner
