Inspection Report

Property Address:
7610 Trinity Pines Drive
Montgomery TX 77316

Home Data Inspection Services, PLLC

PROPERTY INSPECTION REPORT FORM

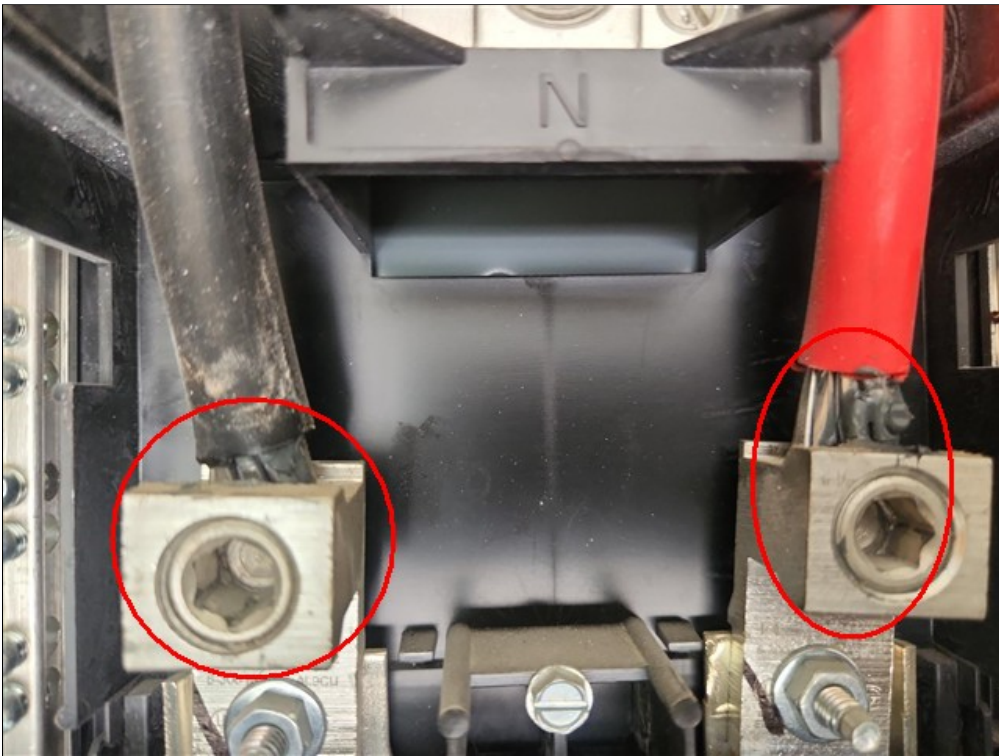
- The aluminum feeder wires are not properly coated with anti-oxidant paste to prevent corrosion.
- White wires used as line or hot wires should be identified as such by wrapping the wires with black or red electrical tape or marking the wires with marker at the breakers.
- Breaker ties are needed in the main panel enclosure at the shared branch circuits. Breaker ties are needed to assure electrical current at all conductors in a cable is shut off when a breaker is tripped. This is a small repair but is a safety hazard that should be corrected.

A. Aluminum feeder wires not properly coated with ant-oxidant paste

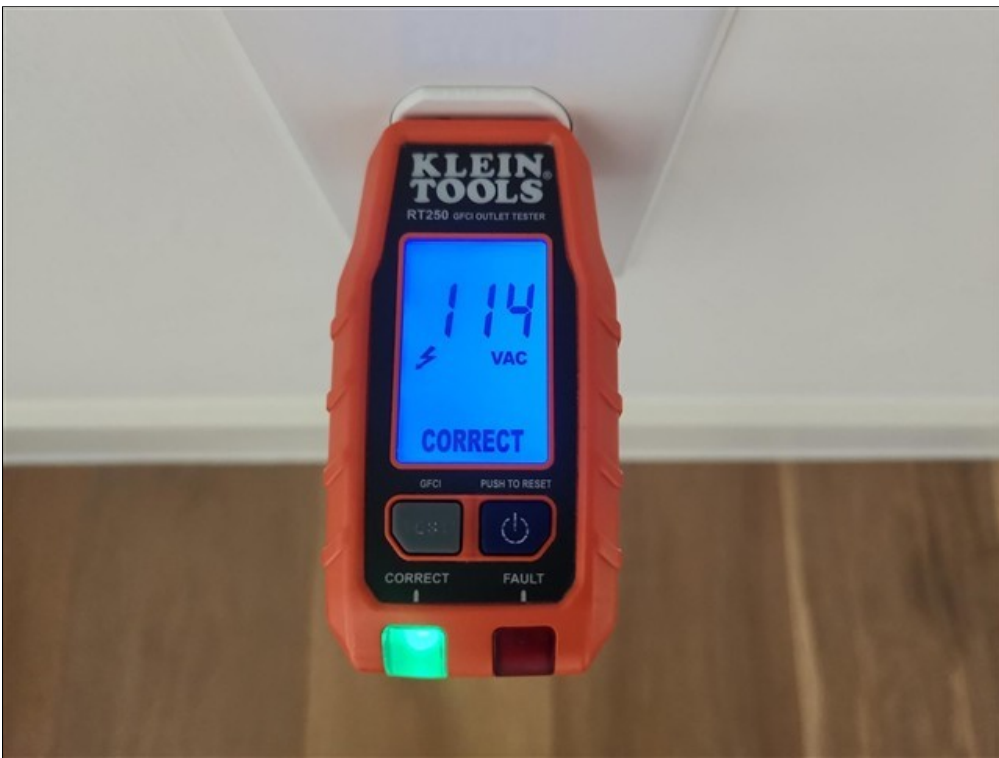
B. Some receptacles inside and outside of master bedroom have varying voltages

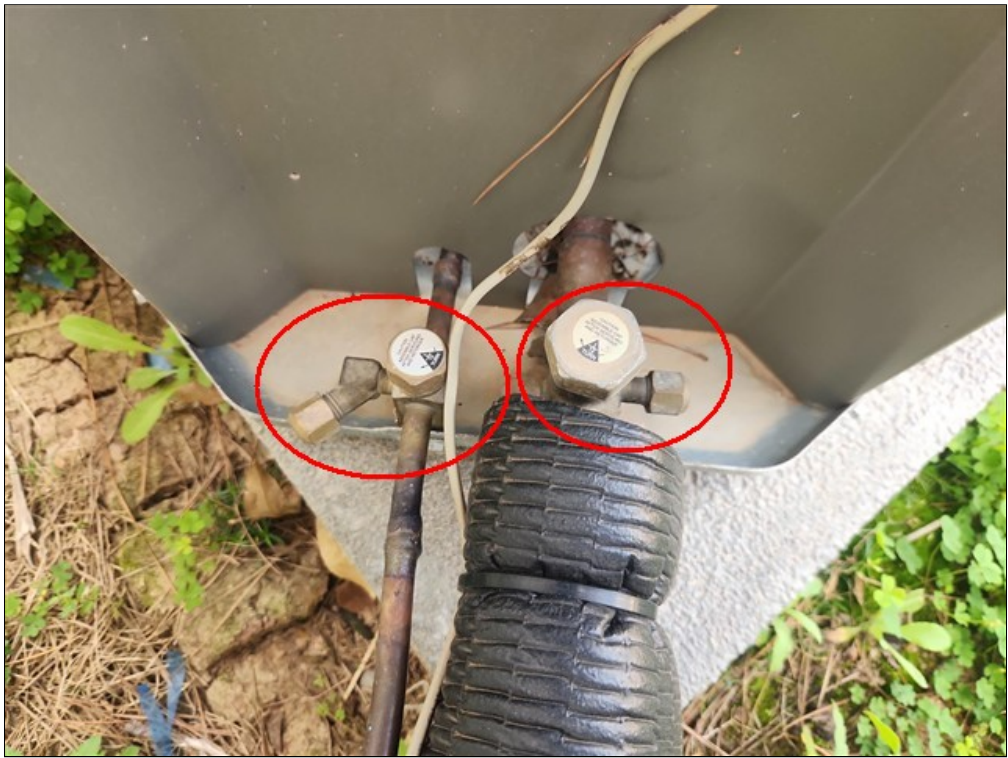
- 'Tamper-proof' locking caps for AC refrigerant ports are missing. As of 2009, HVAC systems are required to have a locking 'tamper-proof' cap on all units in residential and commercial dwellings. Residential and multifamily occupants may be subject to significant fines stemming from the lack of locking caps. Only a licensed HVAC technician may install or remove the locking cap.

B. Missing locking caps at refrigerant ports

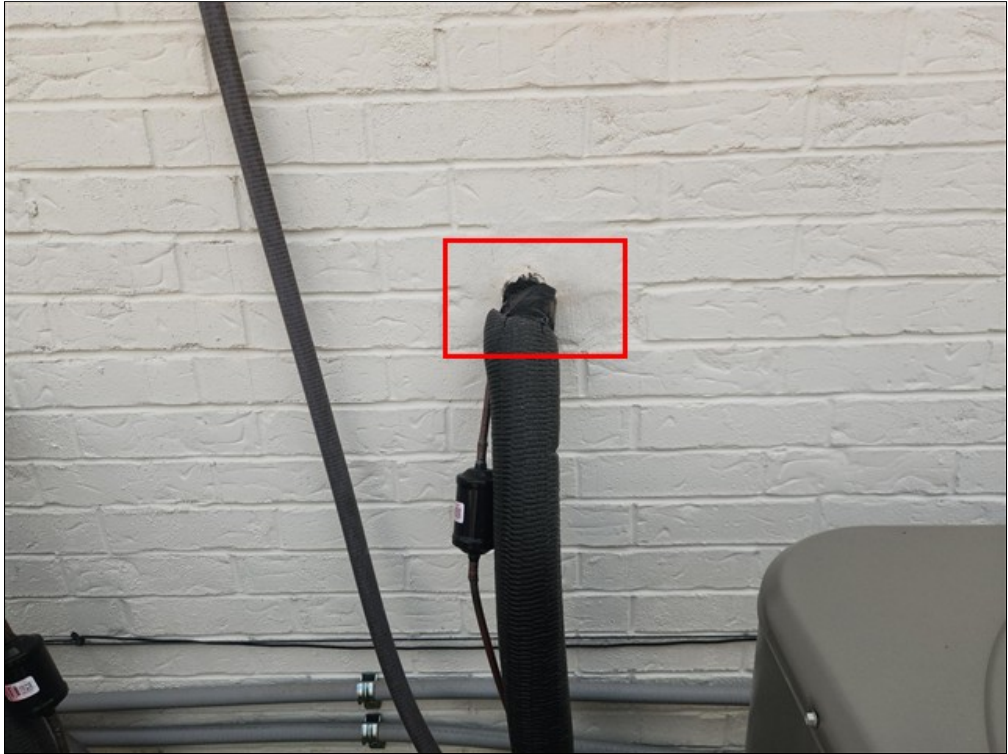
- A refrigerant hood is needed at the AC condensing unit refrigerant lines. Refrigerant hoods should be installed and caulked on the top and sides only. Refrigerant hoods help protect the lines from damage and help prevent moisture, insects and vermin from entering the home if properly installed. A qualified contractor should be consulted regarding this installation.

B. Refrigerant hood needed

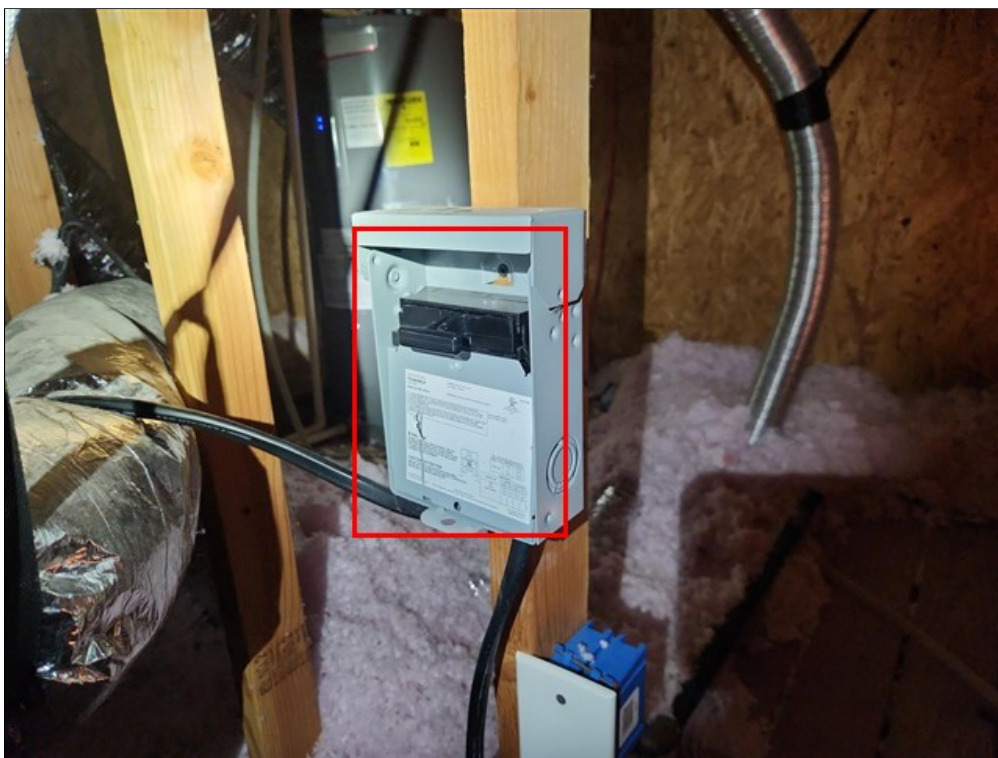
B. Cover plate missing for disconnect

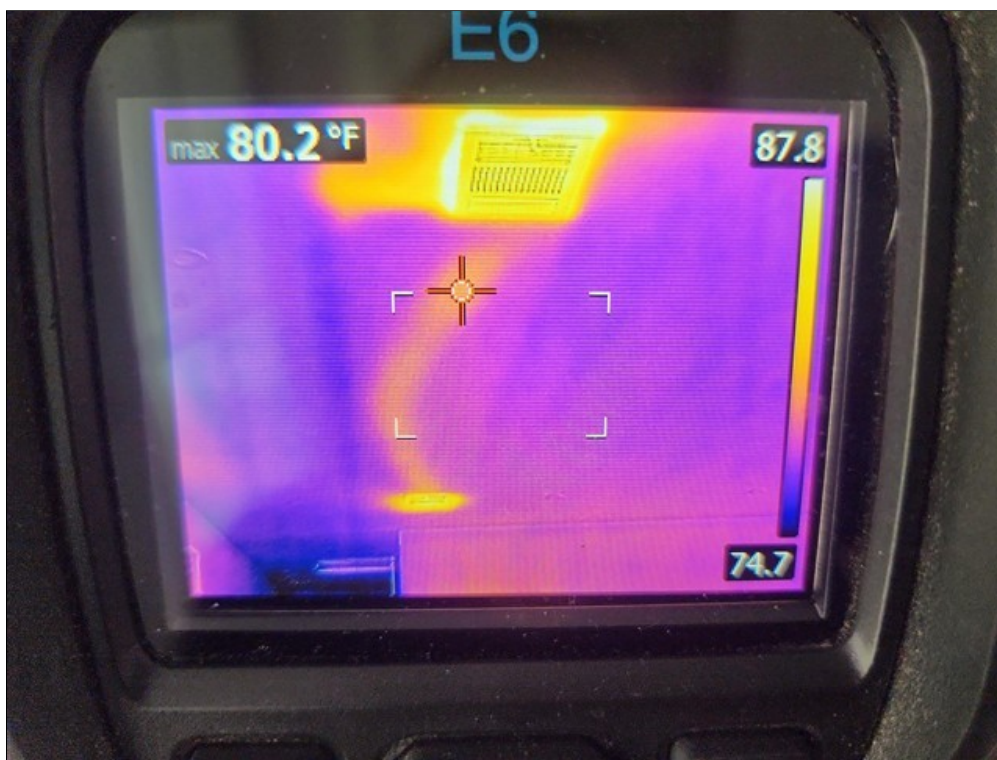
C. Thermal anomaly of what appears to be a duct resting on ceiling drywall

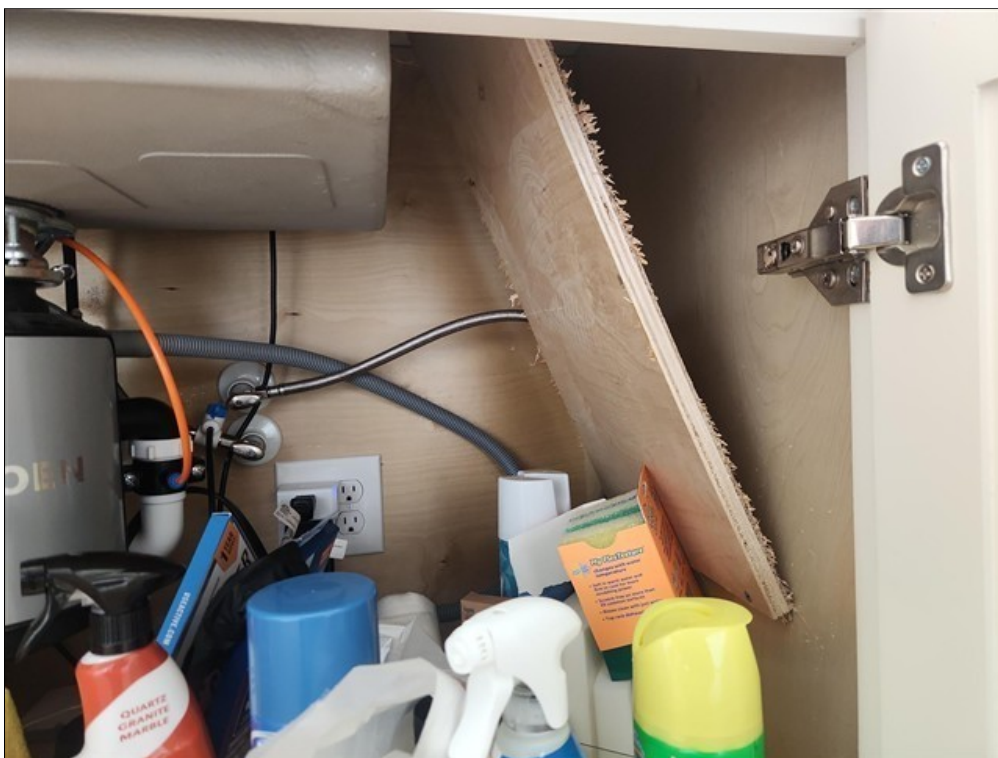
A. Unusually large "braces" installed in kitchen cabinet to support sink

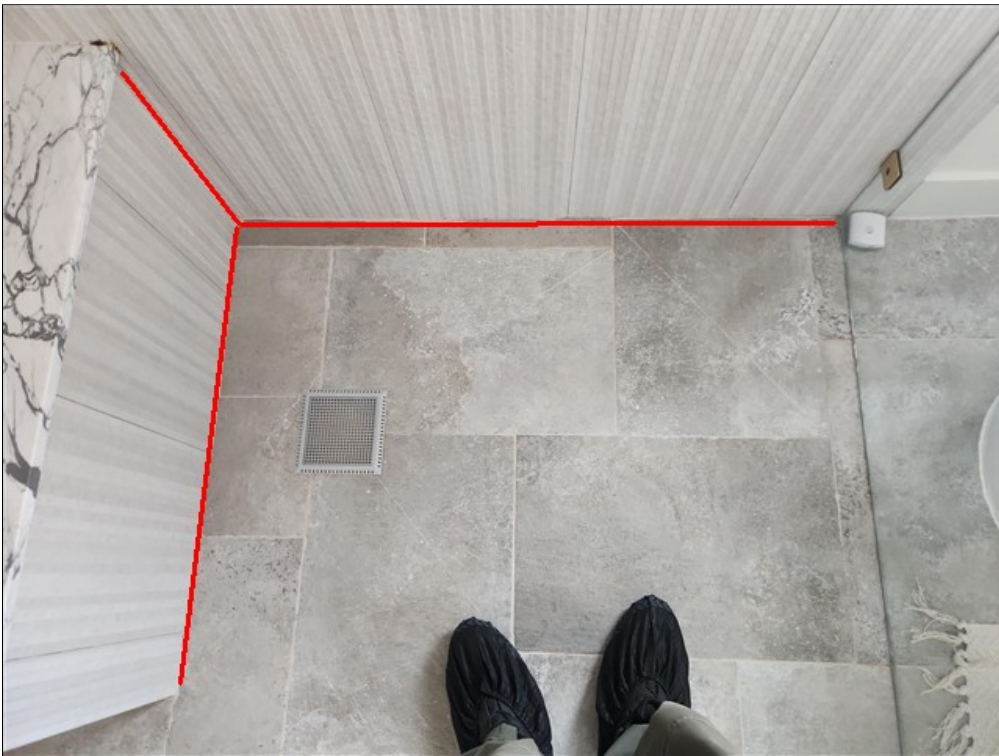
A. Caulking improvements needed in shower enclosure

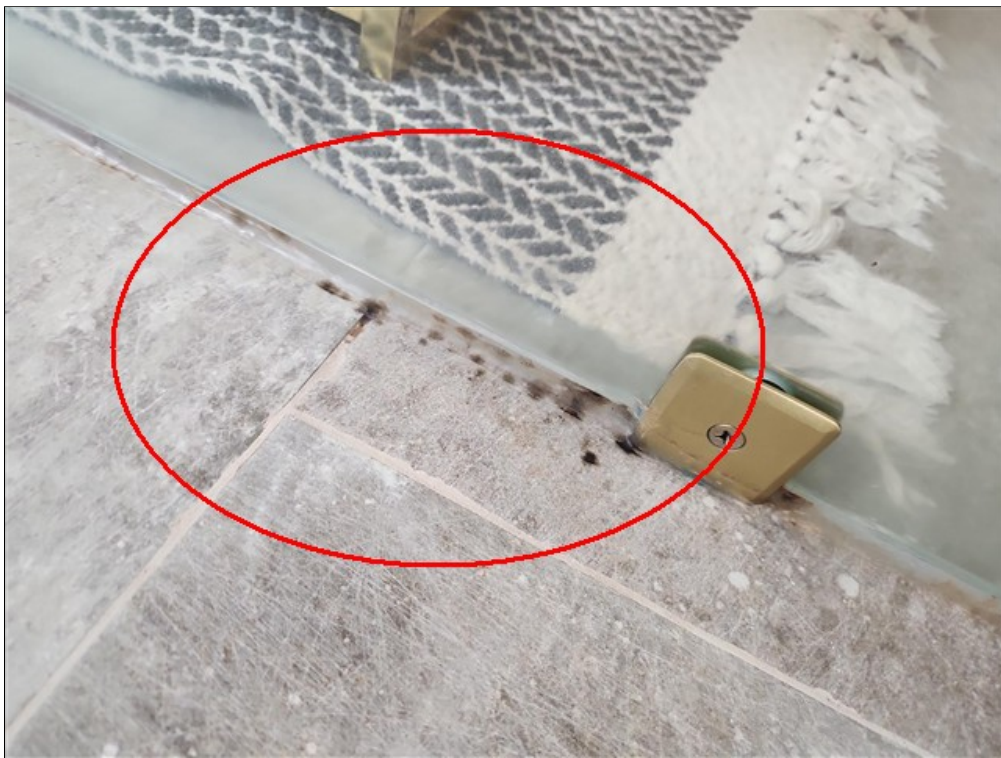
A. Mildewed caulking at shower glass to floor transition

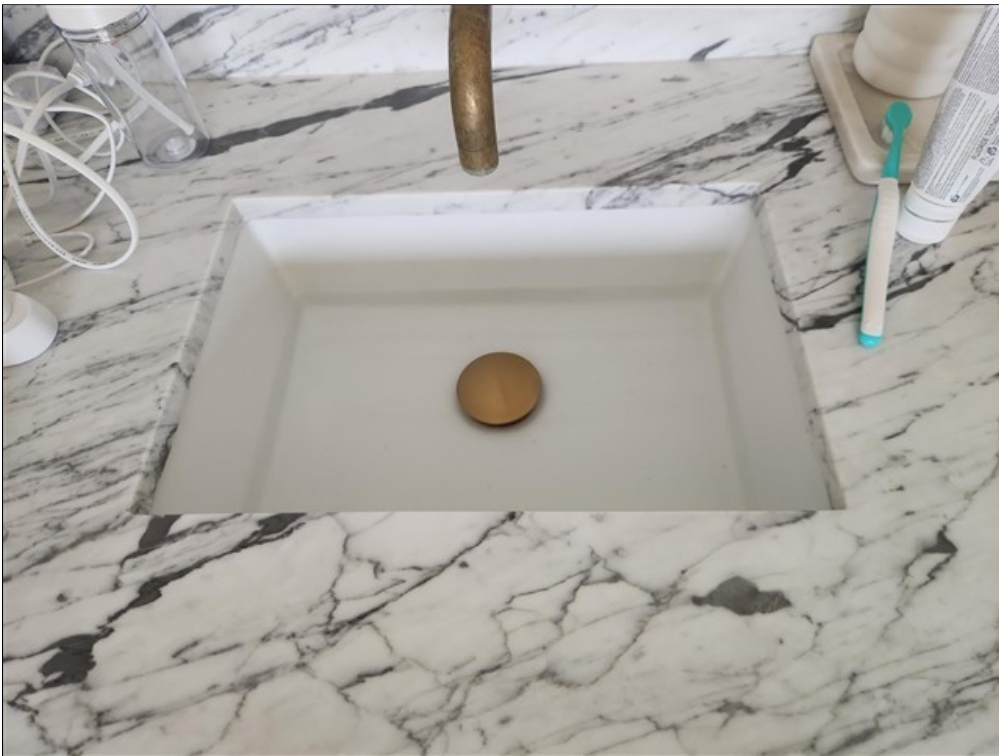
A. Slow drain at sink

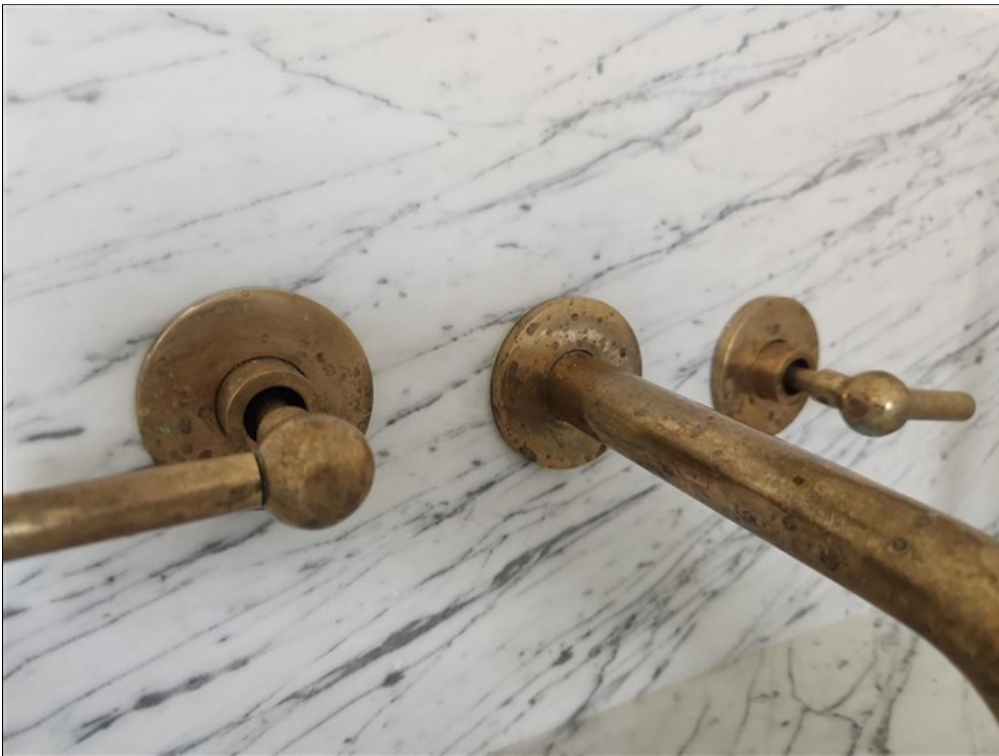
A. Corrosion observed at sink faucet and water valve handles

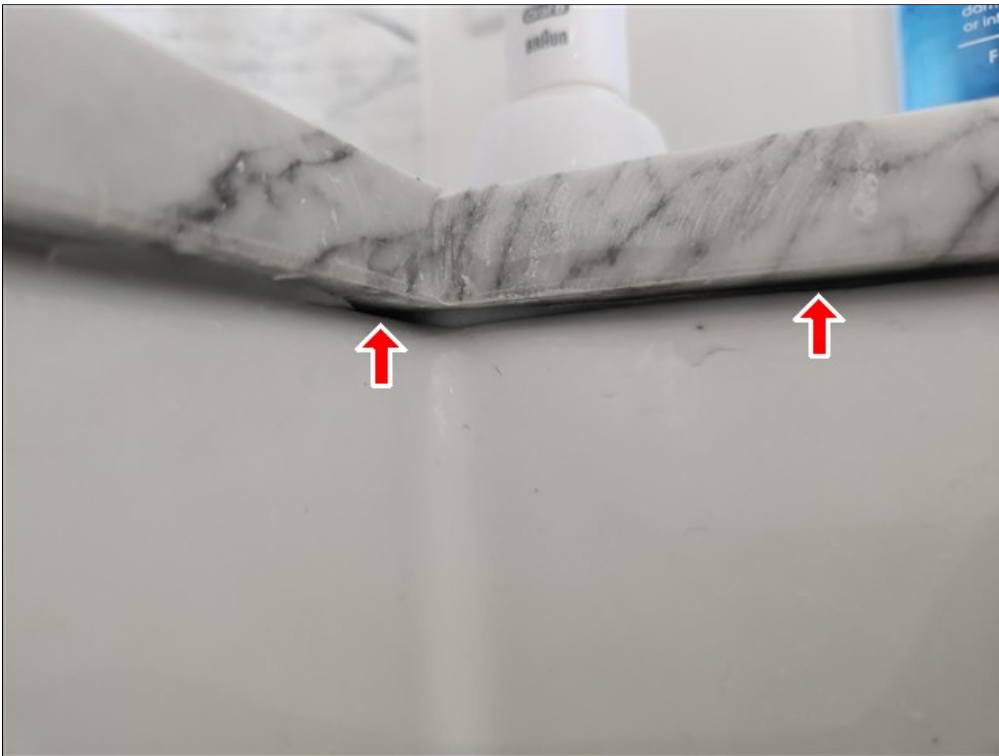
A. Caulking improvements needed at undermount sink to countertop transitions

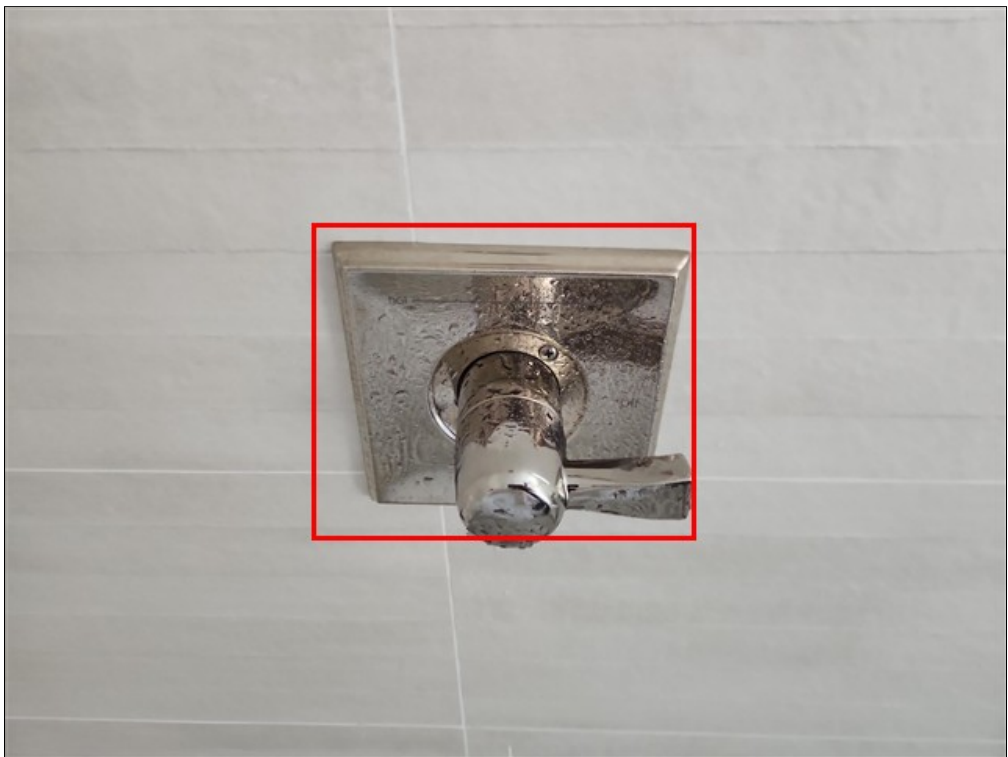
A. Caulking improvements needed around base of the bathtub water valve cover plate

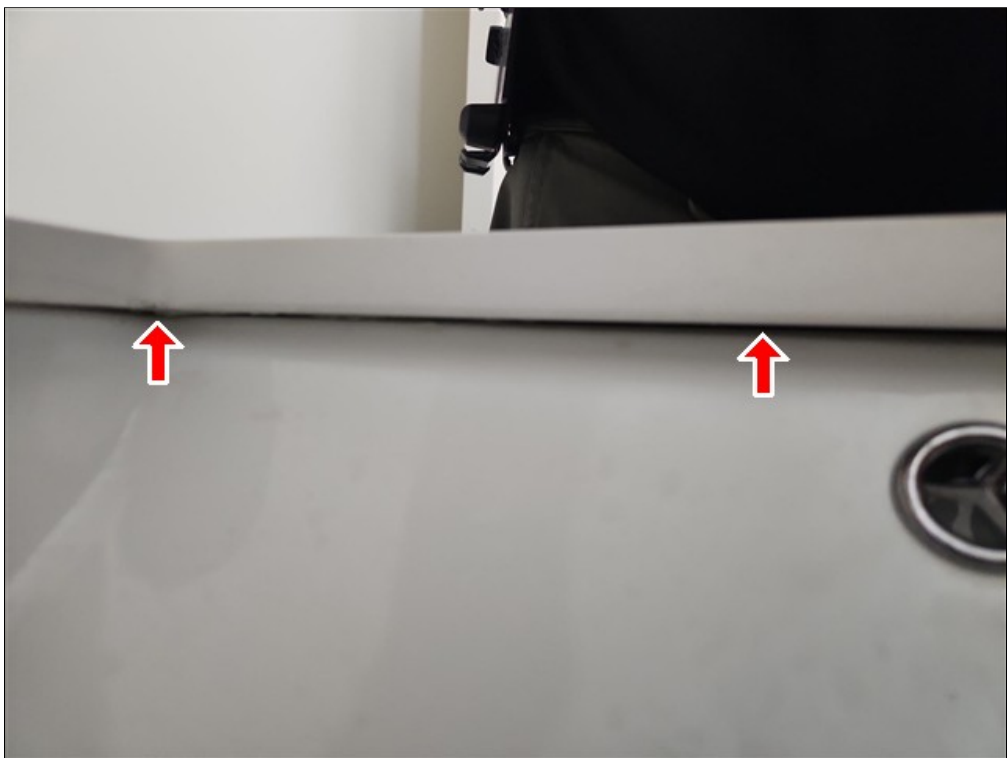
A. Caulking improvements needed at undermount sink to countertop transition

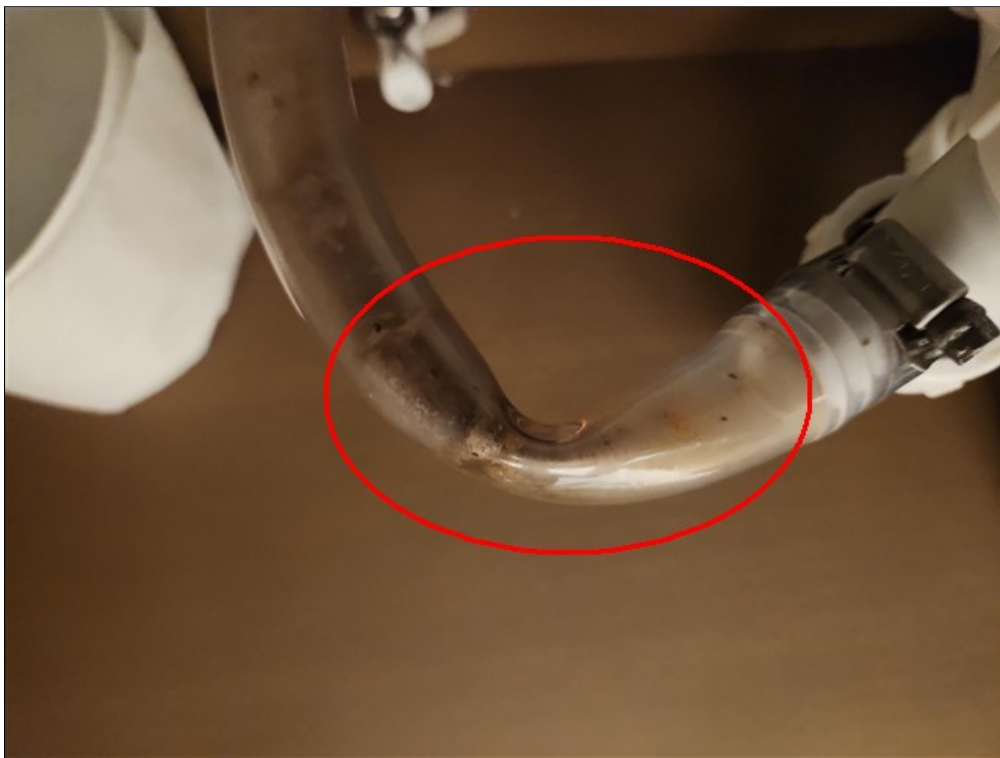
A. The primary condensate drain line pinched and clogged

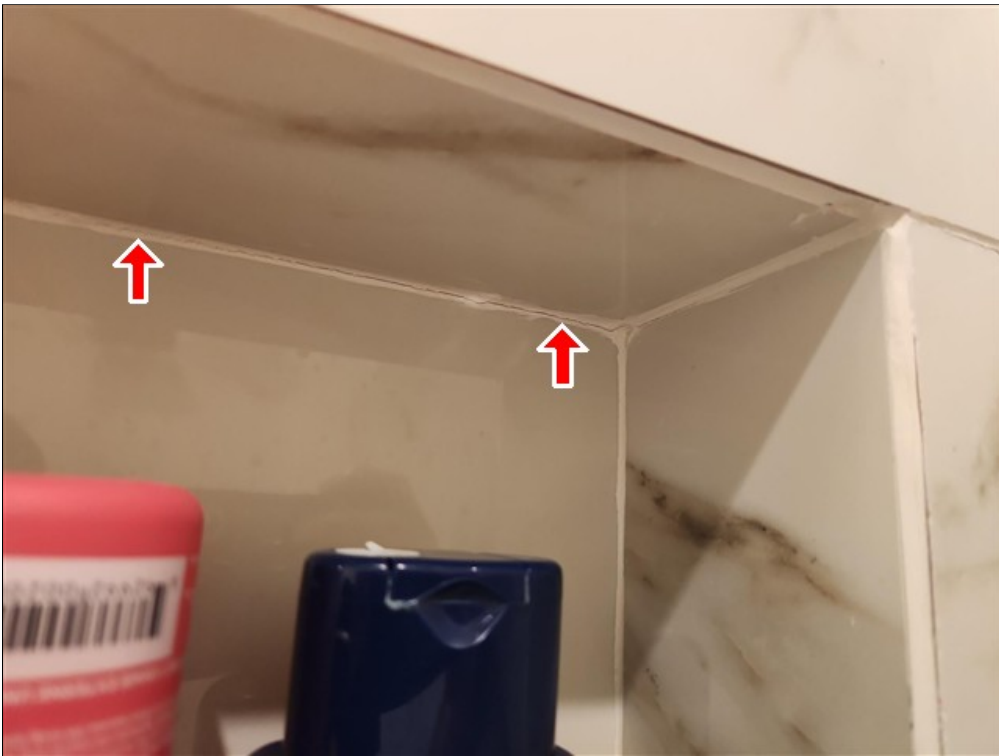
A. Caulking improvements needed at shower walls

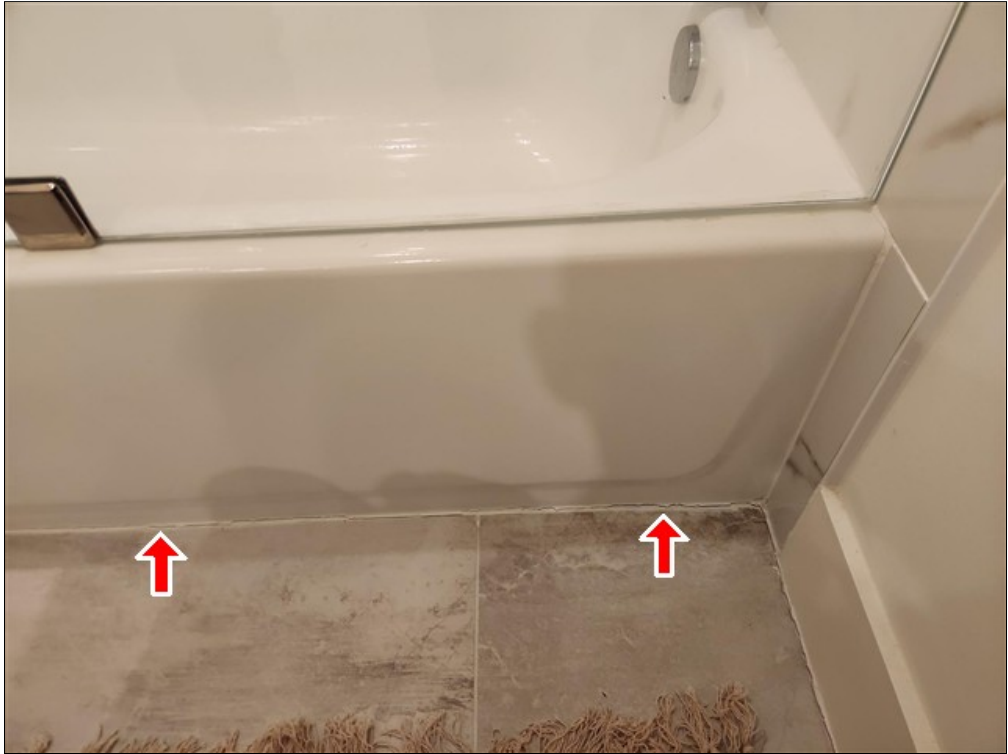
A. Caulking improvements needed at the tub to floor transitions

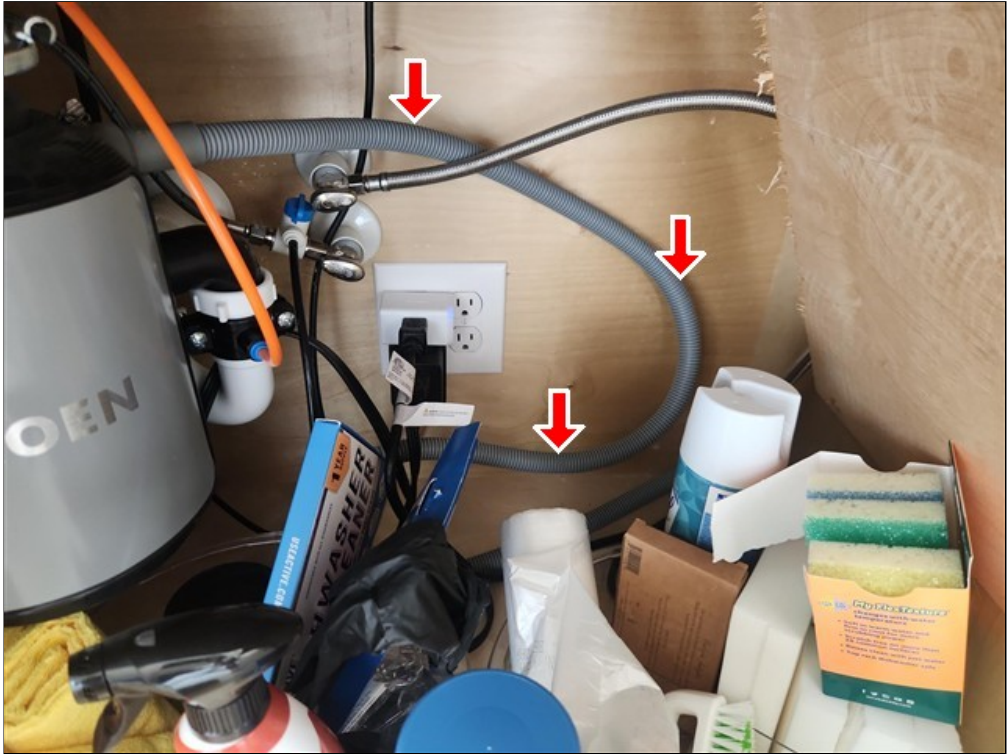
A. Dishwasher missing high loop

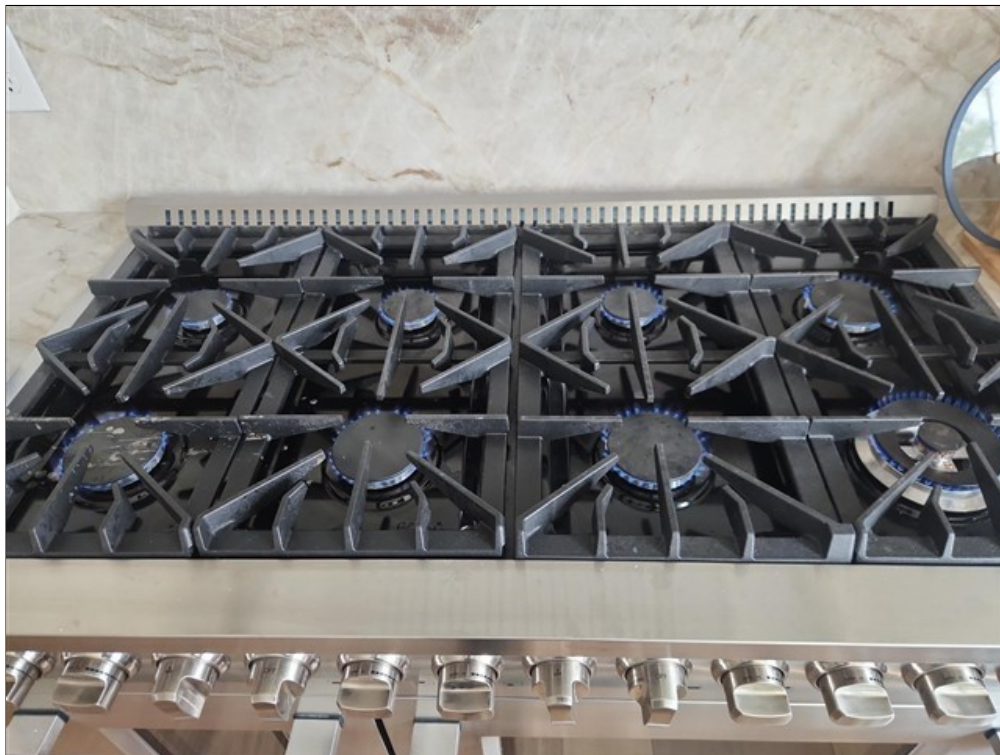
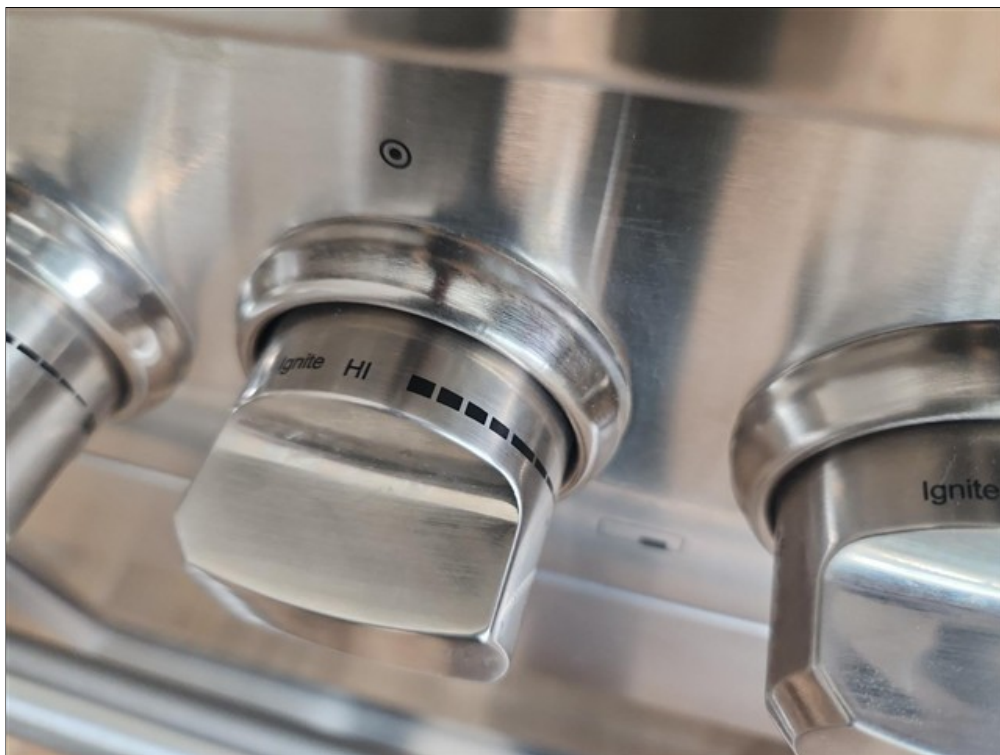
- All of the burners serving the cooktop portion of the range have a very low flame on the highest gas setting .

D. Burners serving cooktop have low flame when on highest gas setting
