RESIDENTIAL INSPECTION

7610 Trinity Pnes Dr
Montgomery, TX 77316

PROPERTY INSPECTION REPORT FORM

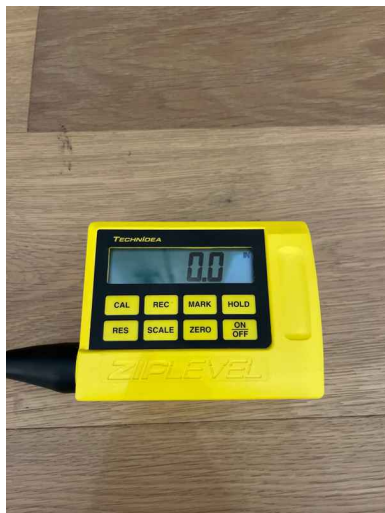
Front entry

The foundation of the home appears to be performing as designed at the time of inspection.

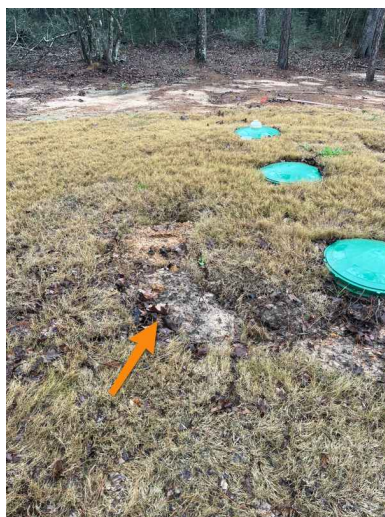
Rear of home

Erosion is occurring in areas. I recommend a qualified contractor repair as needed.

Recommendation: Contact a qualified professional.

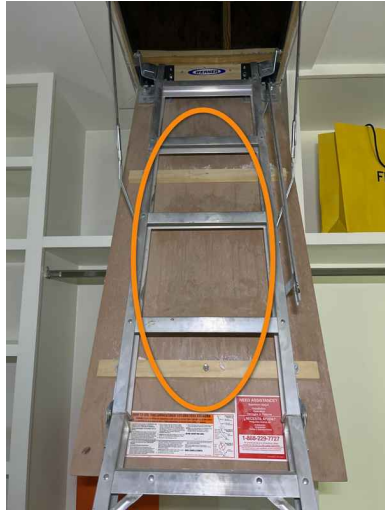
Master closet

The attic stairs are missing insulation. This is not considered today's standard. I recommend a qualified person repair as needed.

Recommendation: Contact a qualified professional.

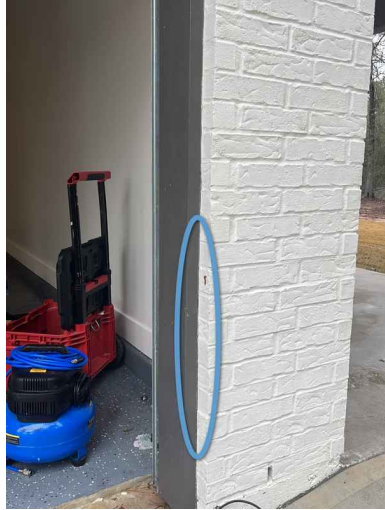
Right side of home

1: Missing caulking

Caulking is missing in areas. I recommend a qualified person repair as needed.

Recommendation: Contact a qualified professional.

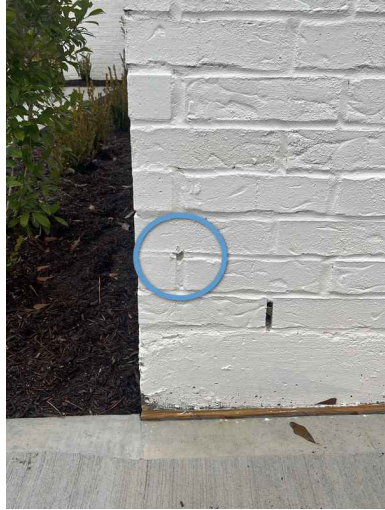
Right side of home

Touch up painting/texturing is needed in areas. I recommend a qualified contractor repair as needed.

Recommendation: Contact a qualified professional.

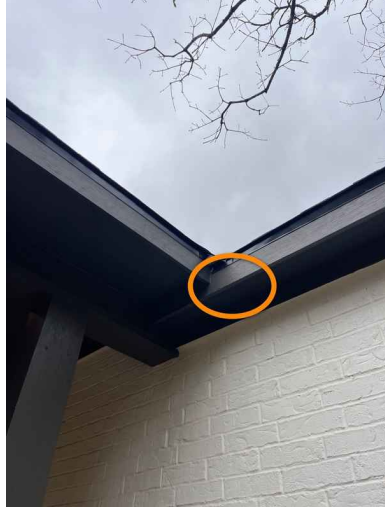
Rear of home

4: Exterior siding damaged in areas

The exterior siding is damaged in areas. I recommend a qualified contractor repair as needed.

Recommendation: Contact a qualified professional.

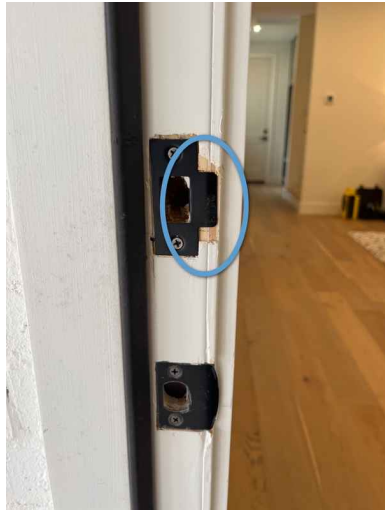
Back door

5: Trim is damaged in areas

The interior trim is damaged or has failing paint in areas. This damage is considered cosmetic. I recommend a qualified contractor be consulted for further evaluation and repair as needed.

Recommendation: Contact a qualified professional.

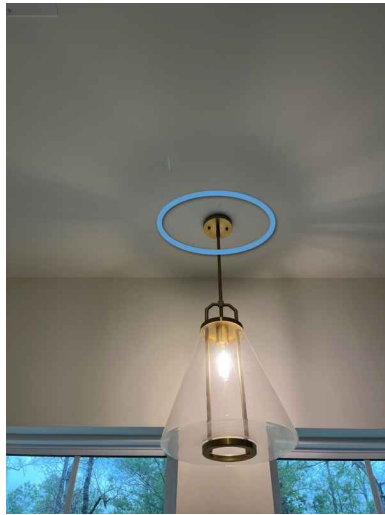
Utility room

Touch up painting/texturing is needed in areas. I recommend a qualified contractor repair as needed.

Recommendation: Contact a qualified professional.

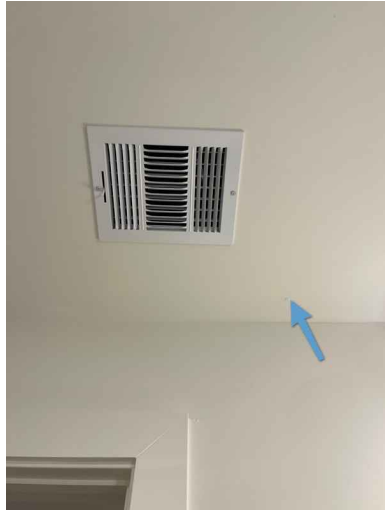
2nd Floor Guest bathroom

The drywall on the ceiling has "Nail pops" in areas caused by settlement. This is considered cosmetic. I recommend a qualified contractor be consulted for further evaluation and repair as needed.

Recommendation: Contact a qualified professional.

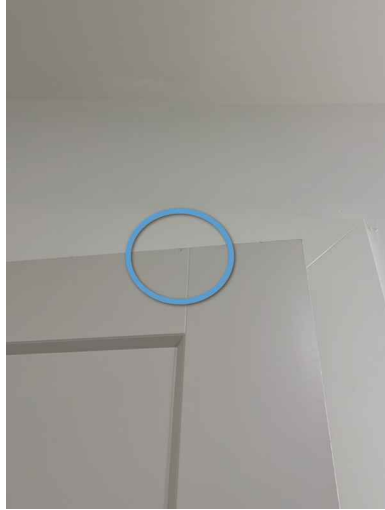
2nd Floor Guest bathroom

Touch up painting is needed in areas.

Recommendation: Contact a qualified professional.

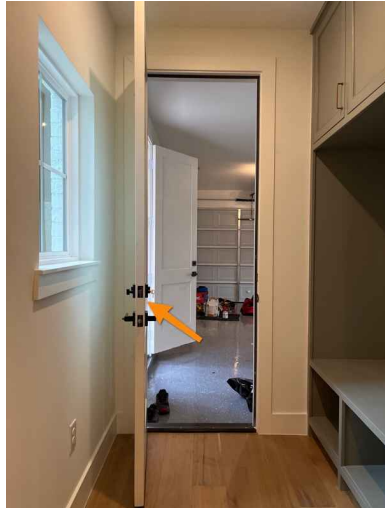
Garage

The door to the garage does not have a self closing hinge (Door does not close on its own). This is not today's standard. I recommend a qualified person repair as needed.

Recommendation: Contact a qualified professional.

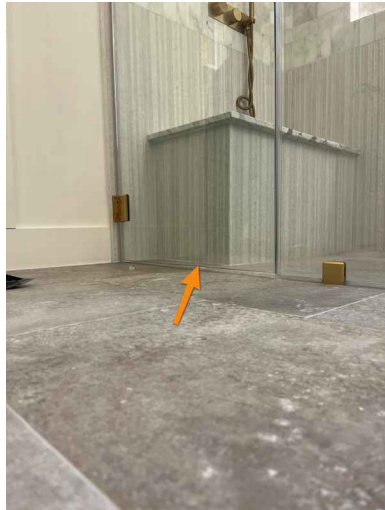
Master bathroom

5: Missing weather-stripping

The door is missing weather-stripping in areas. I recommend a qualified person repair as needed.

Recommendation: Contact a qualified professional.

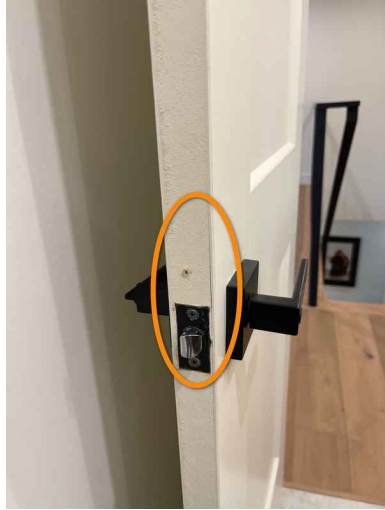
2nd Floor Guest bathroom

6: The door is damaged

The door is damaged in areas. I recommend a qualified person repair or replace as needed.

Recommendation: Contact a qualified professional.

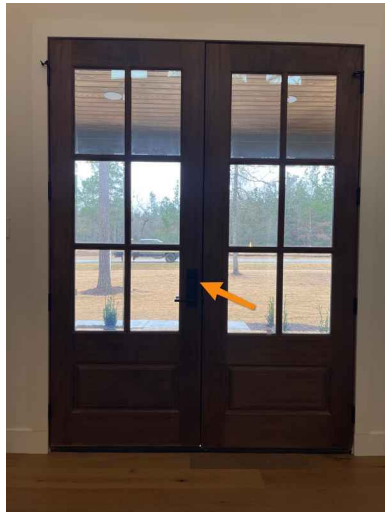
Front entry

The deadbolt lock does not latch properly. I recommend a qualified person repair as needed.

Recommendation: Contact a qualified professional.

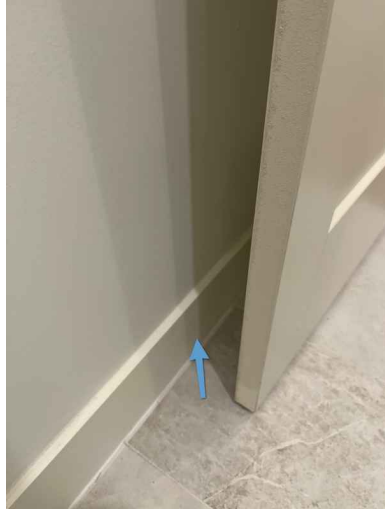
2nd Floor Guest bathroom

8: Doorstops are missing

There are doorstops missing in areas. This is a small repair. I recommend a qualified person repair as needed.

Recommendation: Contact a qualified professional.

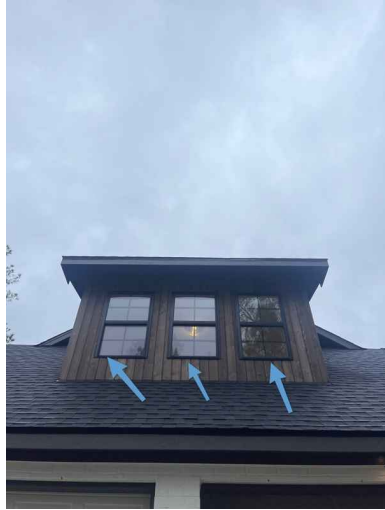
Right side of home

1: Missing window screen(s)

One or more windows are missing a screen. Recommend replacement.

Recommendation: Contact a qualified window repair/installation contractor.

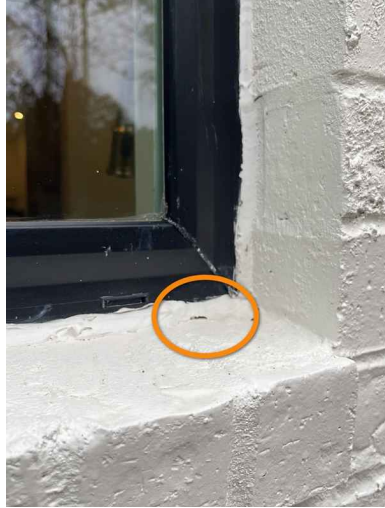
Rear of home

2: The window caulking is missing/deteriorated

The window is missing caulking in areas. I recommend a qualified person repair as needed.

Recommendation: Contact a qualified professional.

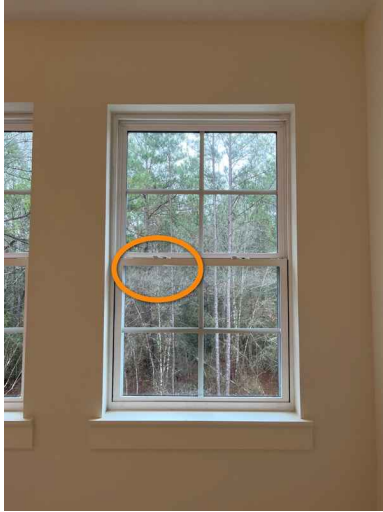
Guest bedroom, right side of home

3: Window frame is damaged in areas

Recommendation: Contact a qualified professional.

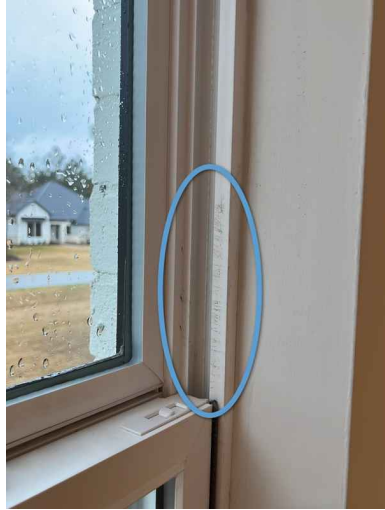
Guest bedroom, front of home

The window frame has scratches in areas.

Recommendation: Contact a qualified professional.

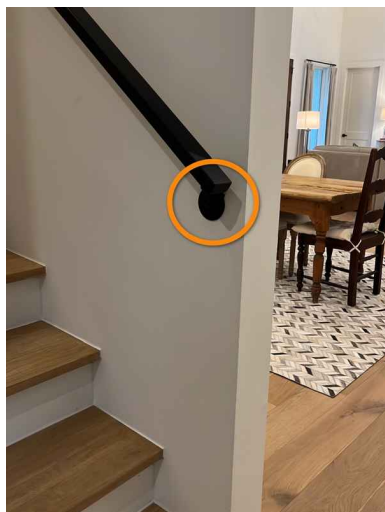
Stairs

1: The handrail is missing a corner piece

The handrail/guardrail for the stairs does not terminate into the wall for added support. This is not considered today's standard. I recommend a qualified contractor be consulted for further evaluation and repair as needed.

Recommendation: Contact a qualified professional.

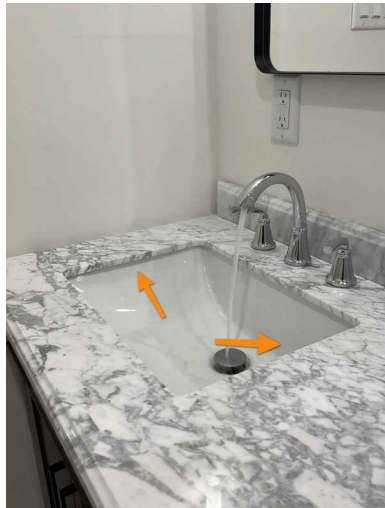
2nd Floor Guest bathroom

There are areas of the home that have grout or caulking that is missing or deteriorated. I recommend a qualified contractor be consulted for further evaluation and repair.

Recommendation: Contact a qualified professional.

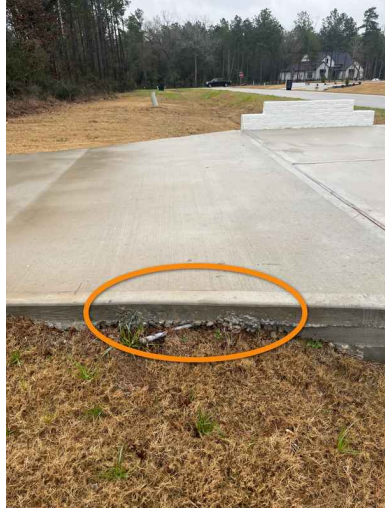
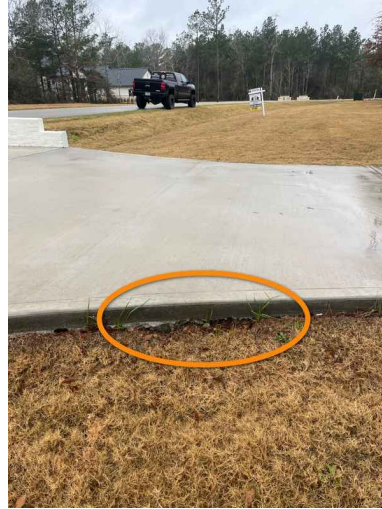
Front of home

2: Driveway spalling

The concrete for the driveway is spalling and needs routine maintenance in areas. I recommend a qualified contractor repair as needed.

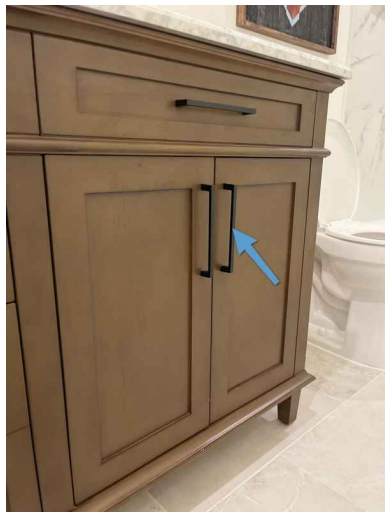
2nd Floor Guest bathroom, right cabinet

3: Cabinet handle is loose

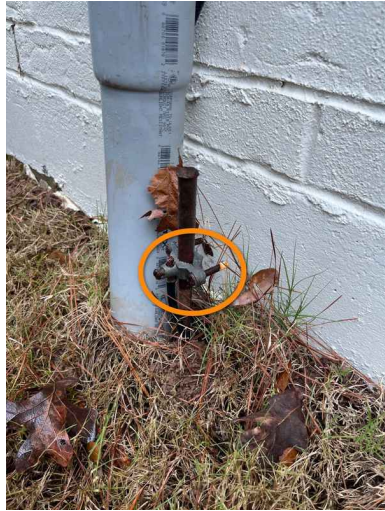
Left side of home

1: Improper grounding clamp

The grounding rod is using an outdated or improper grounding clamp. I recommend a qualified electrician be consulted for further evaluation and repair as needed.

Recommendation: Contact a qualified professional.

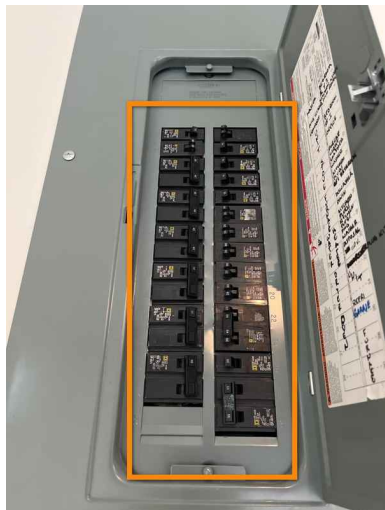
Main service panel

2: Surge Protector

The main service panel does not have a whole home surge protector installed. This is not considered today's standard. I recommend a qualified electrician be consulted for further evaluation and repair.

Recommendation: Contact a qualified professional.

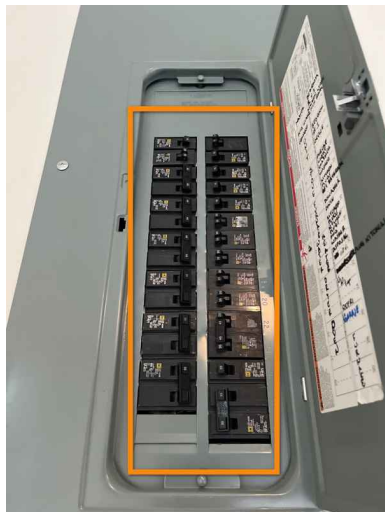
Main service panel

AFCI (Arc fault circuit interrupter) breakers are not present in required areas at the main electrical service panel. This is not todays standard. I recommend a qualified electrician be consulted for further evaluation and repair as needed.

Recommendation: Contact a qualified professional.

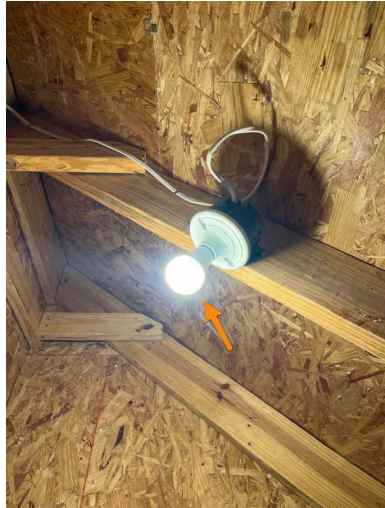
Walk in attic

The light fixture in the attic is missing a cage cover. I recommend a qualified person repair or replace as needed.

Recommendation: Contact a qualified professional.

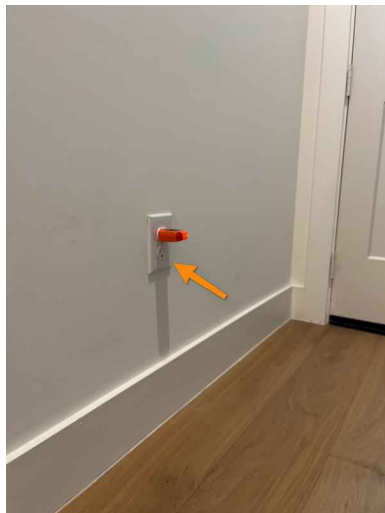
Hallway near garage

5: Loose outlet

The outlet is loose in areas. I recommend a qualified electrical contractor repair as needed.

Recommendation: Contact a qualified professional.

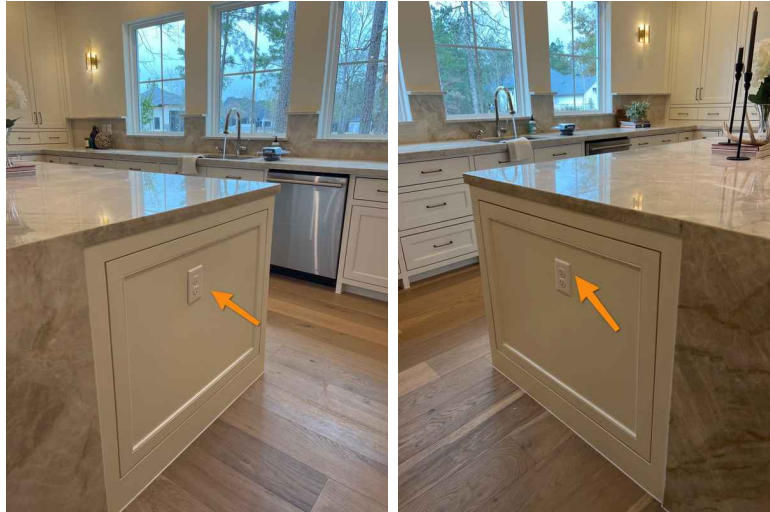
Kitchen

Outlets were observed to be installed under the countertops in areas. This is not considered today's standard. This is for your information. I recommend a licensed electrician be consulted for further evaluation and repair if desired.

Recommendation: Contact a qualified professional.

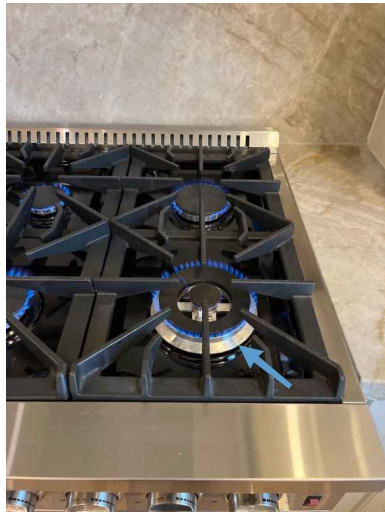
Front right burner

1: Burner missing components

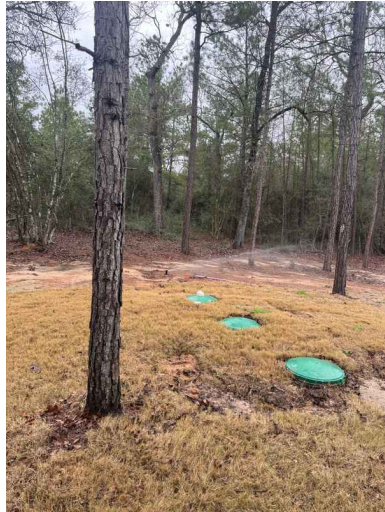
Aerobic heads functioning

I inspected the property in the location of the drain field area. There were no signs of failure or blockage and the grounds appear normal. I did visually locate the septic tank system, however the inside of the tank and the drain lines were not inspected for size or condition. Changes in water volume can sometimes have an impact on septic tanks that before were working properly. Most septic contractors recommend that if the septic tank hasn't been pumped and inspected in the last 4-5 years, you should have it pumped and inspected visually during the inspection process to determine it's true condition.
