Inspection Report

Property Address:
7610 Trinity Pines Drive
Montgomery TX 77316

Home Data Inspection Services, PLLC

PROPERTY INSPECTION REPORT FORM

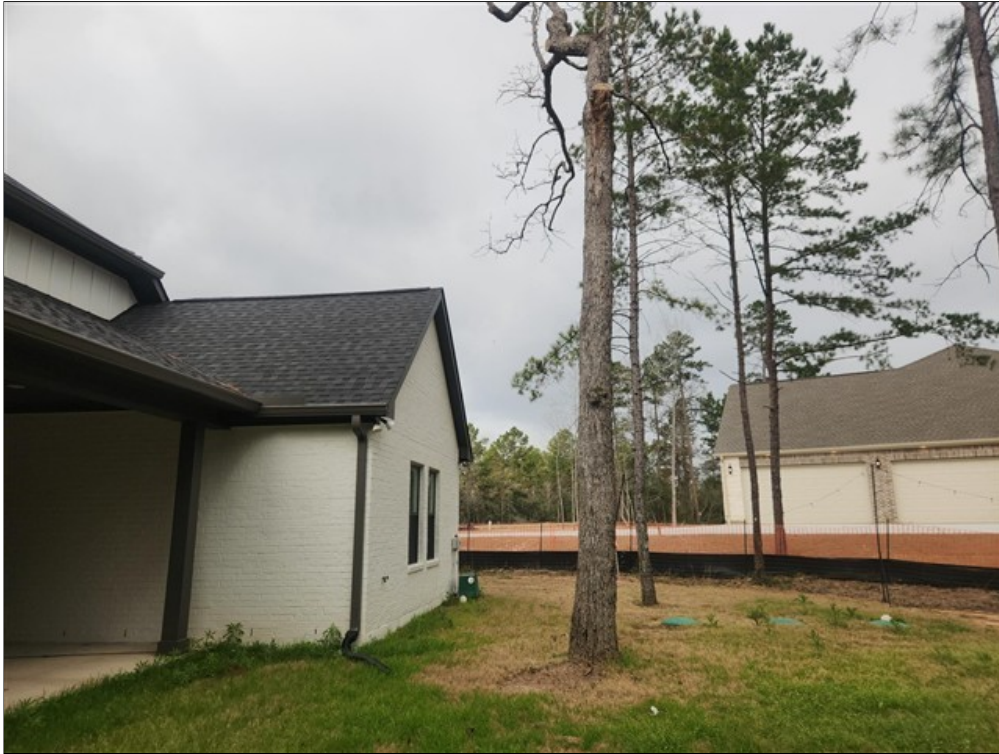
- Tree/tree root(s) were observed near the foundation. Opinions vary regarding the minimum allowable distance between trees and a foundation. The size and species of the tree should be considered. It should also be noted that some experts believe tree removal may negatively affect the foundation. If concerned with this condition, a structural engineer and/or a professional arborist should be consulted.

A. Photos showing location of trees near foundation

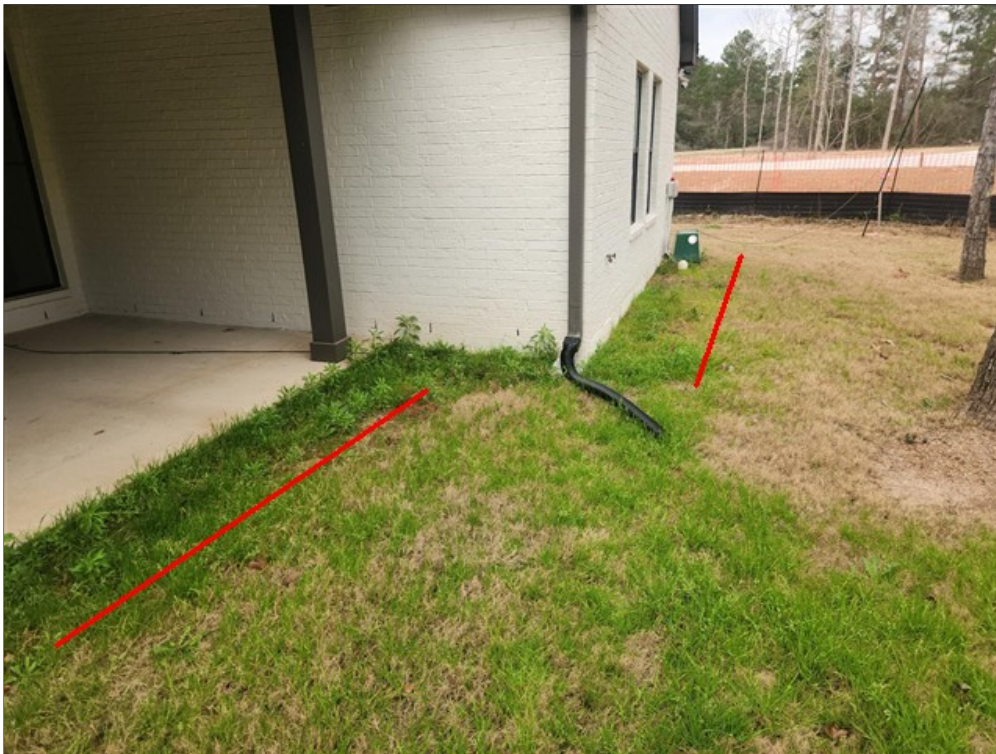
B. Photo showing area in need of grading improvements

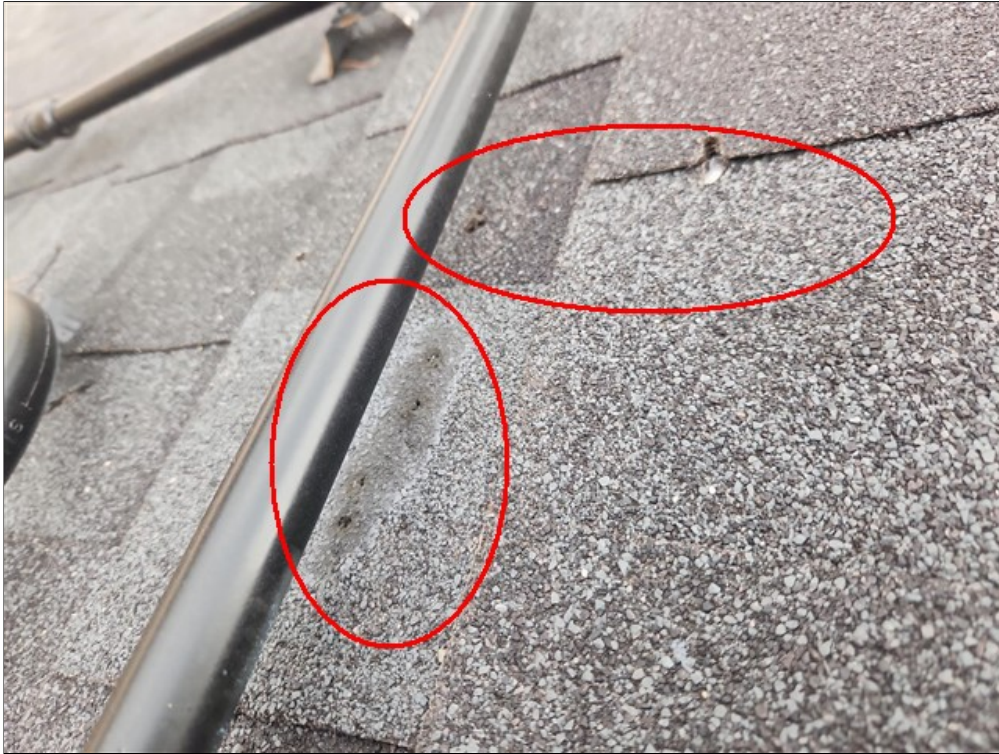
- Several shingles were observed to have holes through them. In most of these instances a metal (unpainted) flashing could be seen through the holes in the shingles but the inspector recommends either all of these damaged shingles have the holes sealed or be replaced.

C. Photos of damaged shingles (holes in shingles)

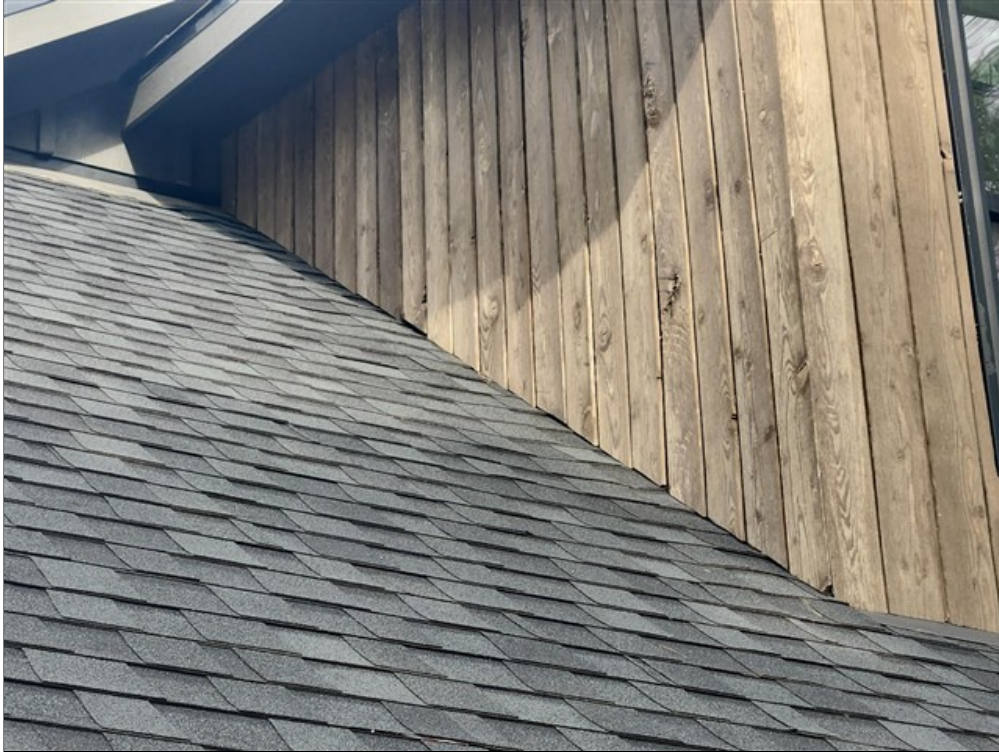
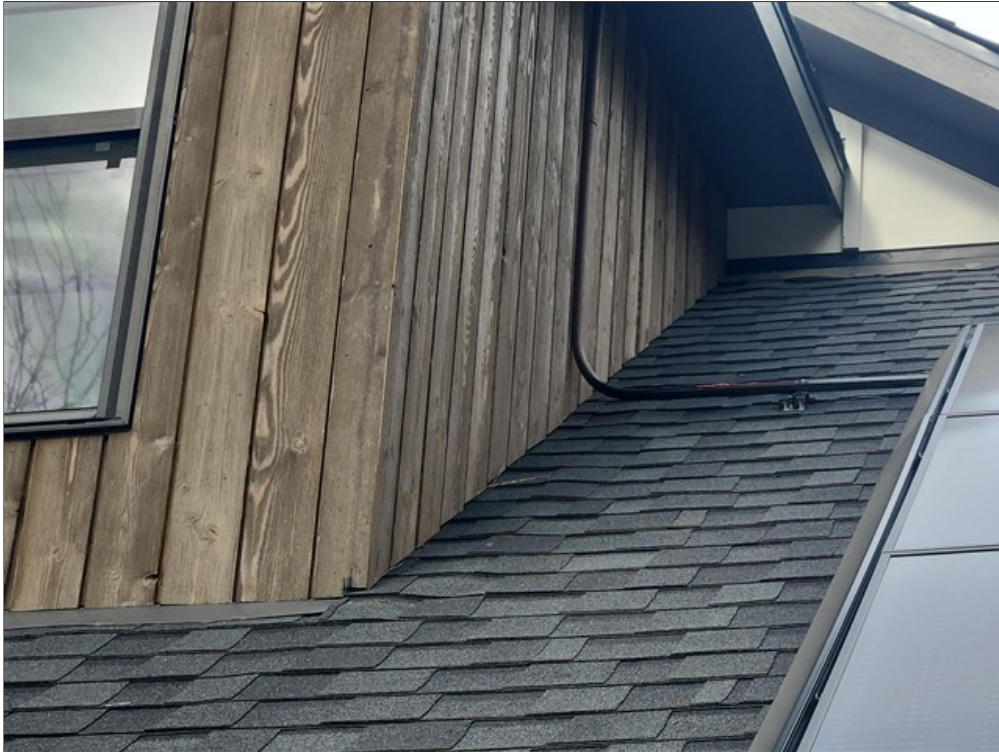
- The clearance of the wood siding and/or trim at some of the roof to wall transitions was observed to be insufficient. This condition leaves the siding and/or trim vulnerable to rot.

C. Photos showing wood siding has inadequate clearance from shingles in several locations

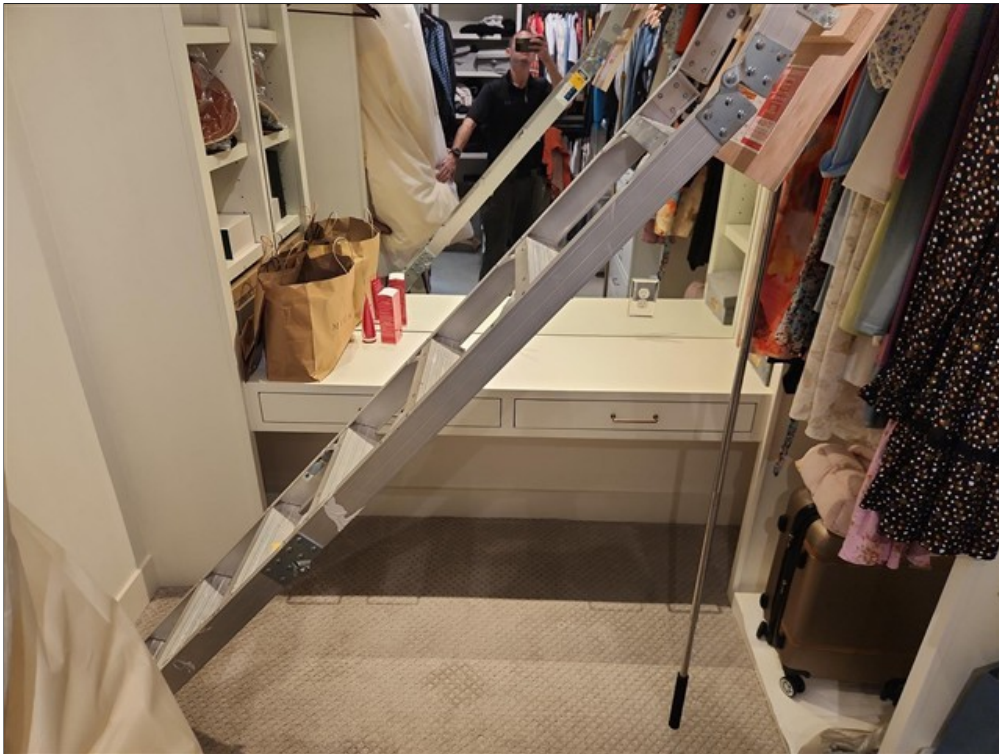
- Attic pull down ladder in master bedroom closet is improperly installed/improper length which is causing the ladder to not fully extend as required by the manufacturer .

D. Attic pull down ladder in master closet is improperly installed/improper length

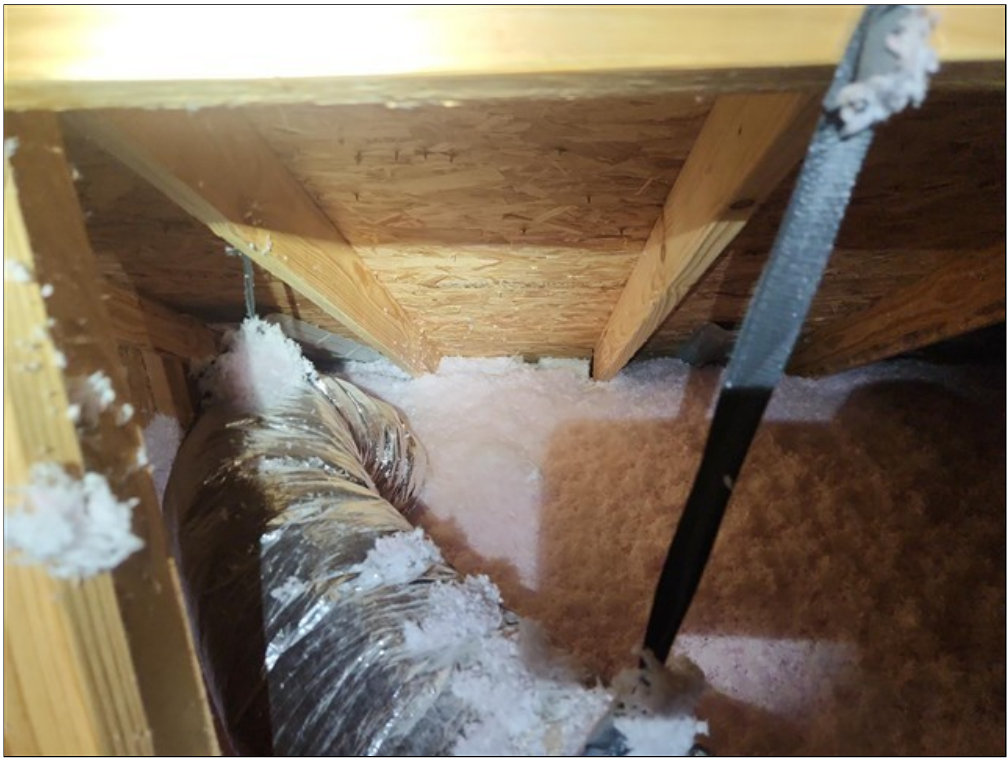
- Baffles were observed to be missing in some areas of the attic.

D. Baffles missing in attic

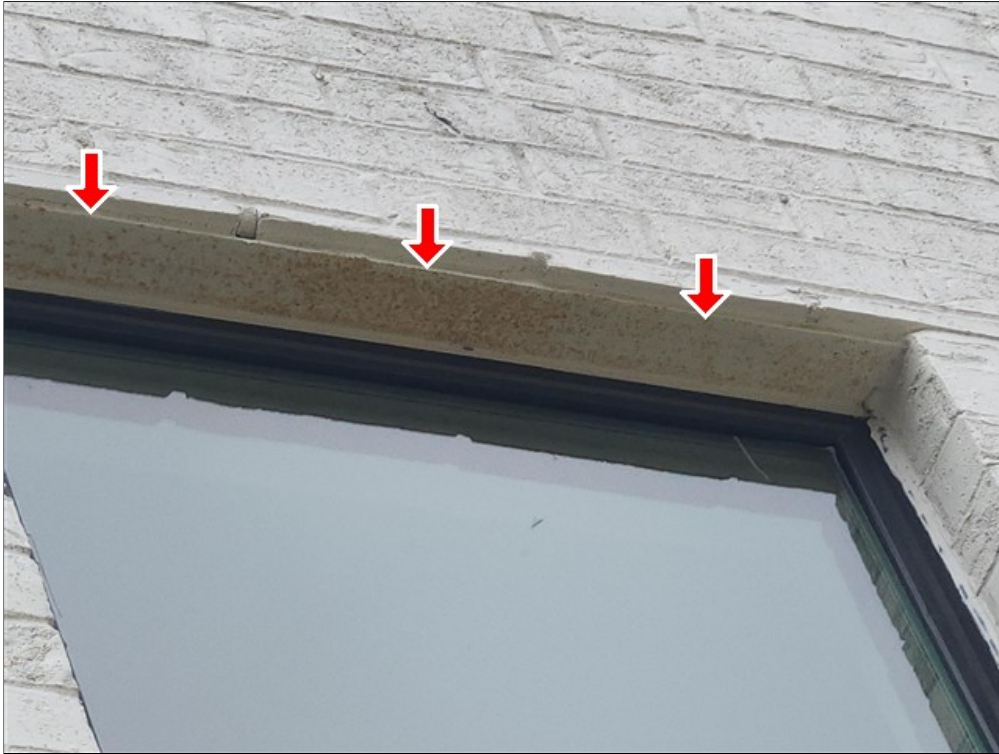
- Steel lintels above several windows were observed to be rusting at the time of the inspection.

E. Photos showing steel lintels above windows rusting

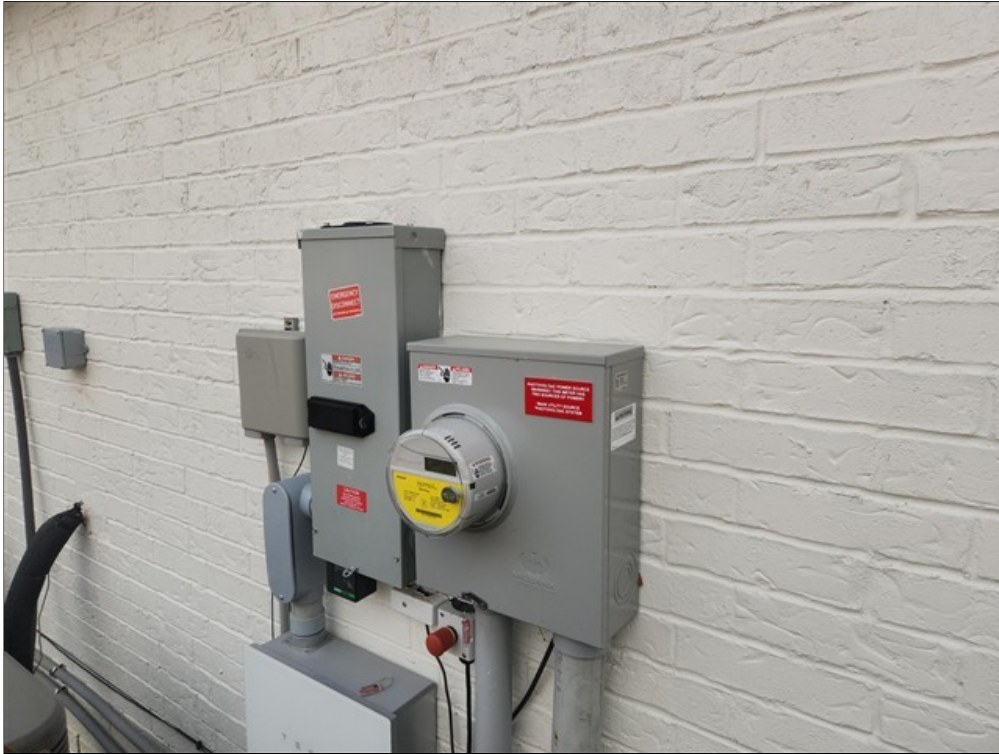
E. Caulking needed at top and sides of meter enclosure and main breaker

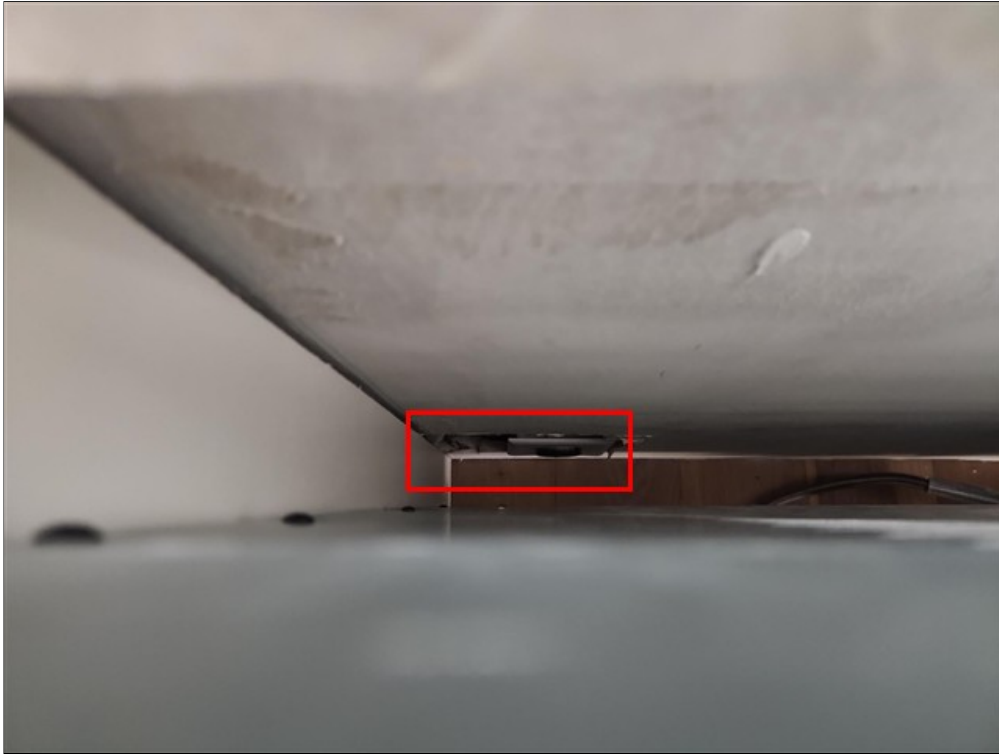
- An excessively large hole was observed in the wall around the receptacle behind the range.

E. Excessively large hole in wall around receptacle behind range

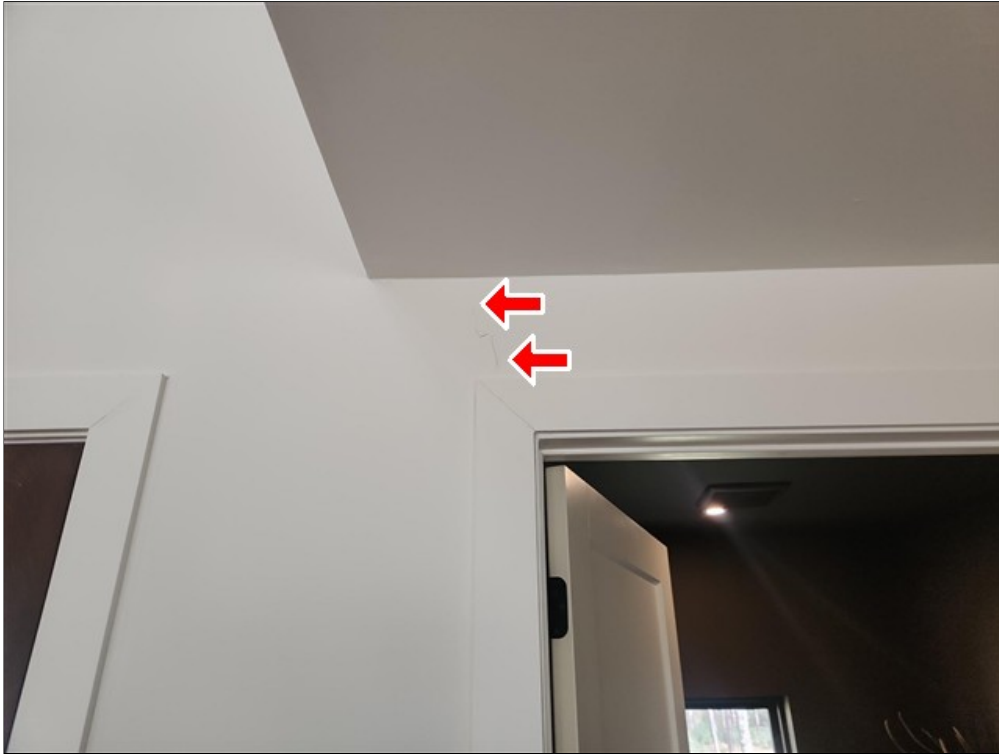
- (4)
- A drywall crack was observed in the wall above the powder room door.

E. Drywall crack in wall above powder room door

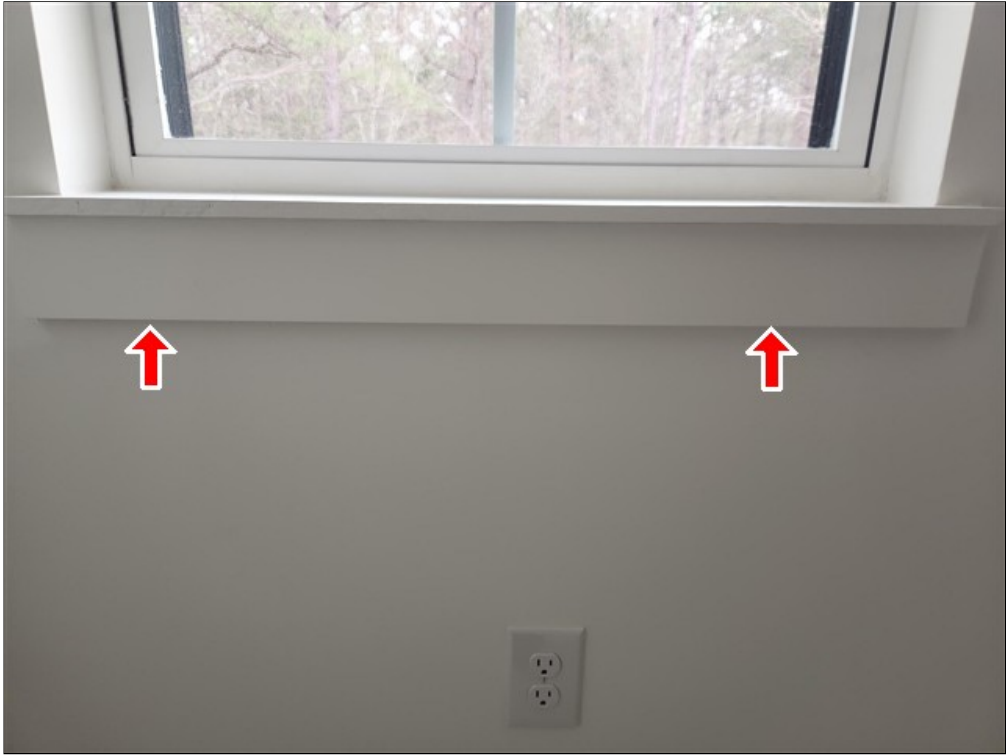
- Caulking was observed to be missing from the underside of window stool trim throughout home.

E. Example of caulking improvements needed at underside of window stool trim throughout the home

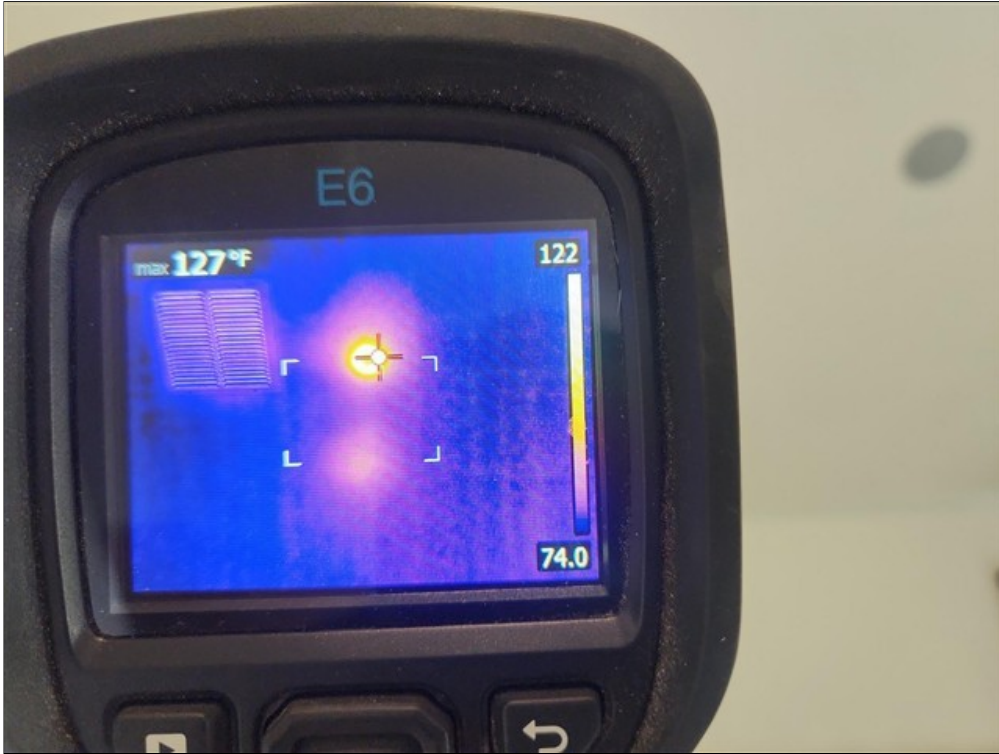
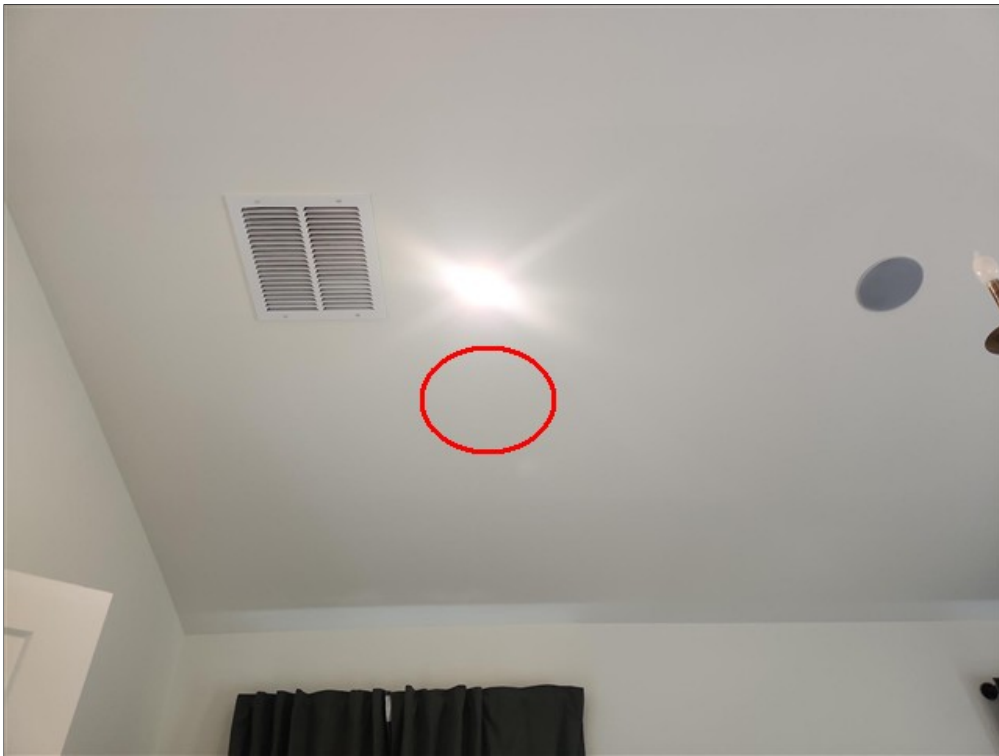
- During the thermal imaging scan of the home a thermal anomaly was detected at the ceiling in the master bedroom near a light fixture. This area could not be reached to test with a moisture meter. The current home owner should be consulted regarding this condition if further information is required.

F. Thermal anomaly at master bedroom ceiling near light fixture

F. Photo showing area of thermal anomaly

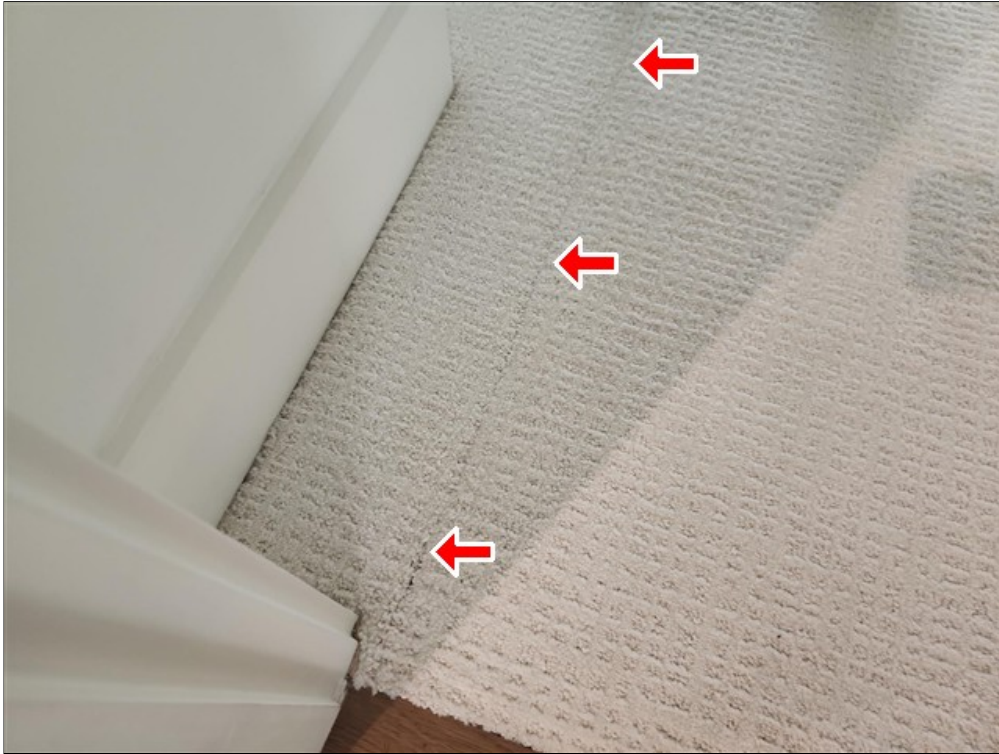
- (2)
- The carpet seam is easily noticeable in the second level right guest bedroom.

F. Carpet seem easily noticeable in second level right guest bedroom

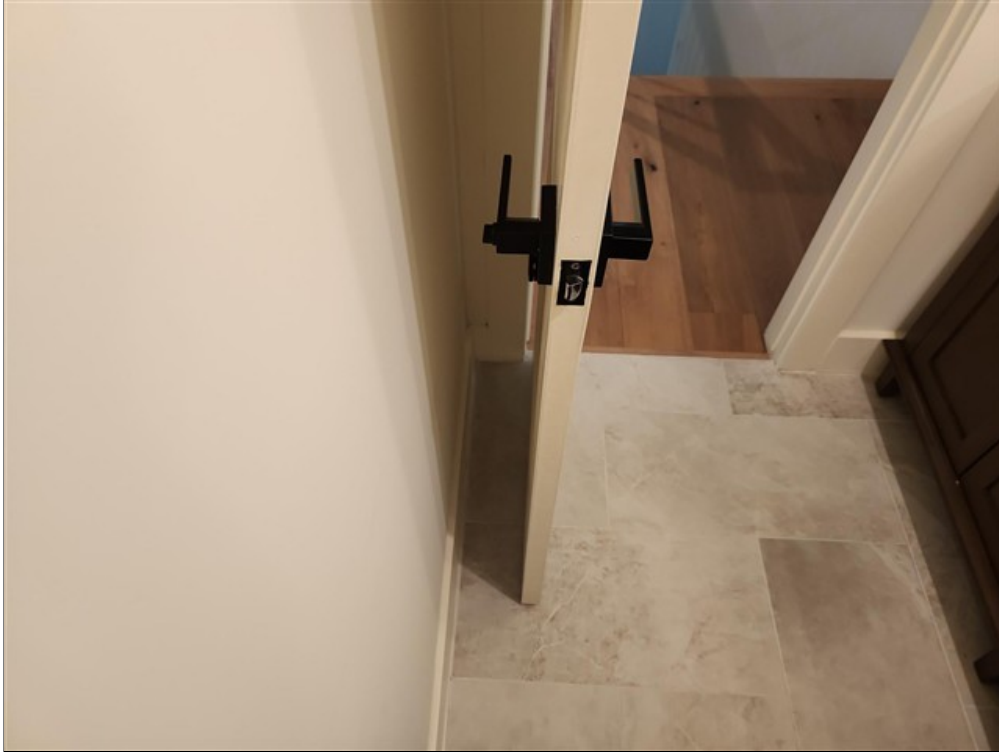
- Numerous doors throughout the home are missing doorstops. This has allowed for several walls to be damaged.

G. Example of missing doorstops

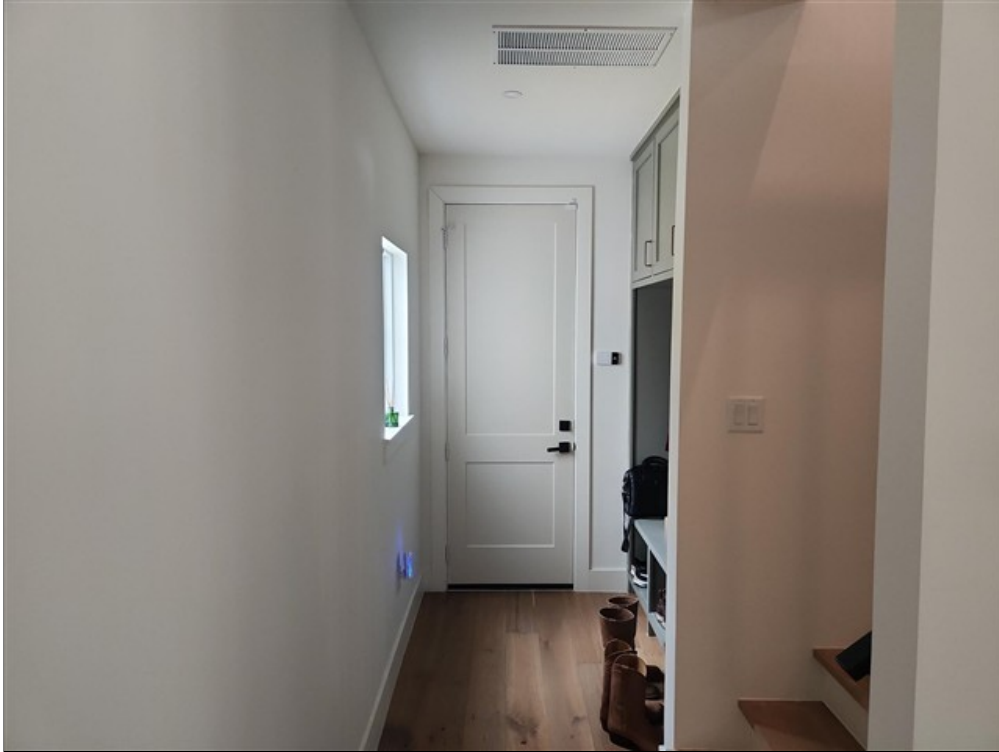
G. Occupant garage door not equipped with self closing hinges

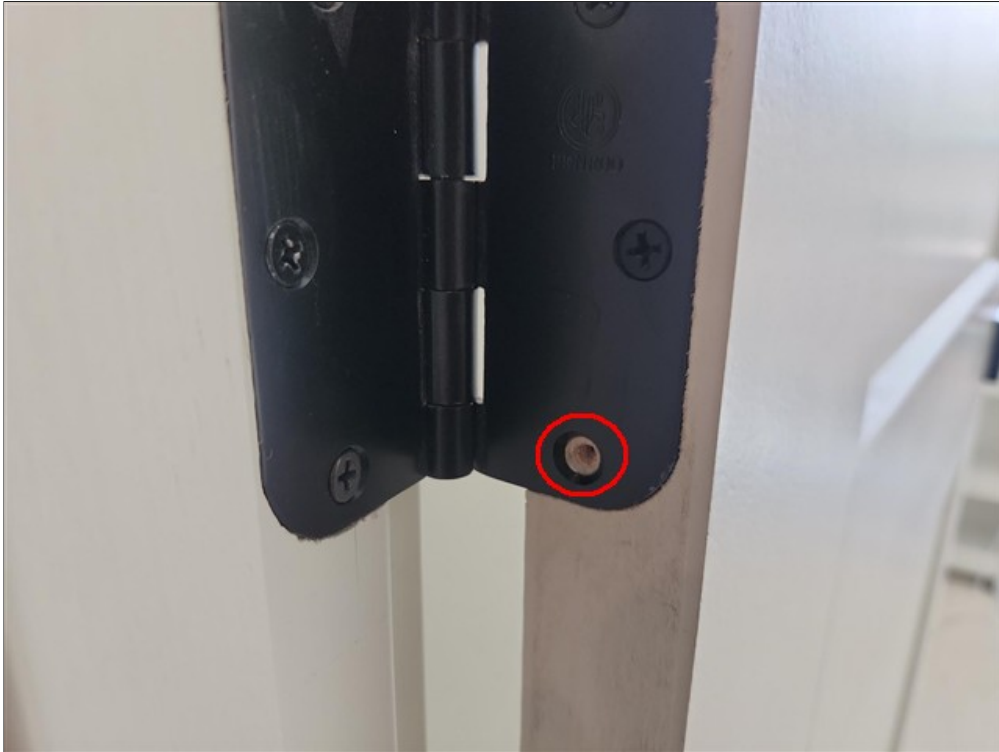
- (4) • The second level front guest bedroom door is missing a hinge screw.

G. Second level front guest bedroom door missing hinge screw

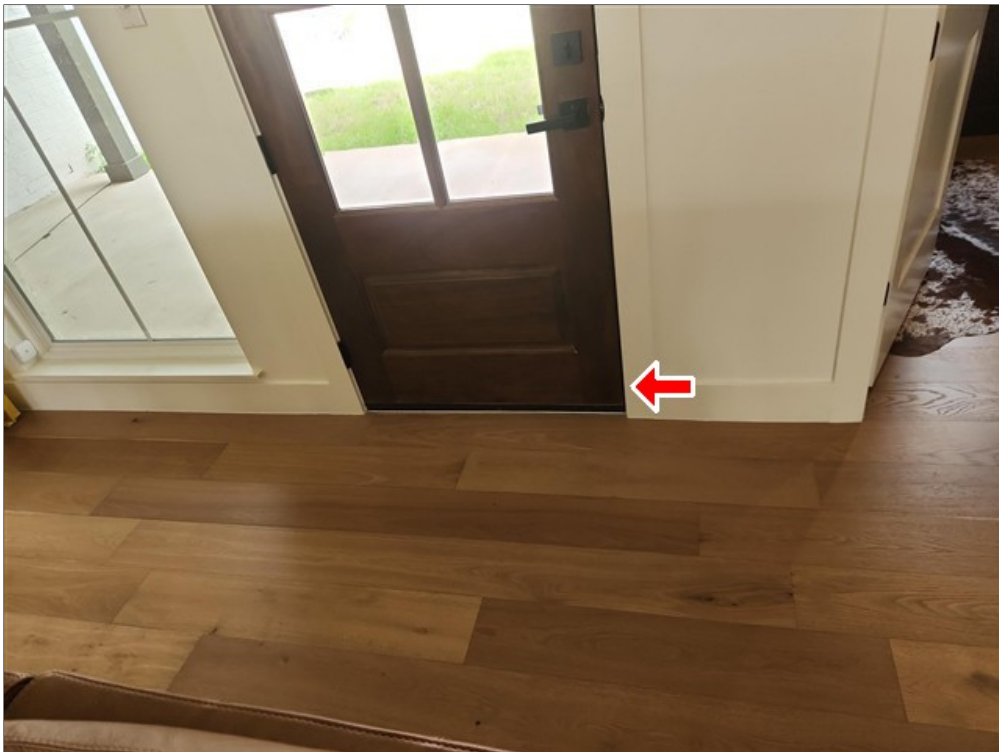
- The rear exterior door rubs at the jamb/bottom when operated.

G. Rear exterior door rubs at jamb/bottom when operated

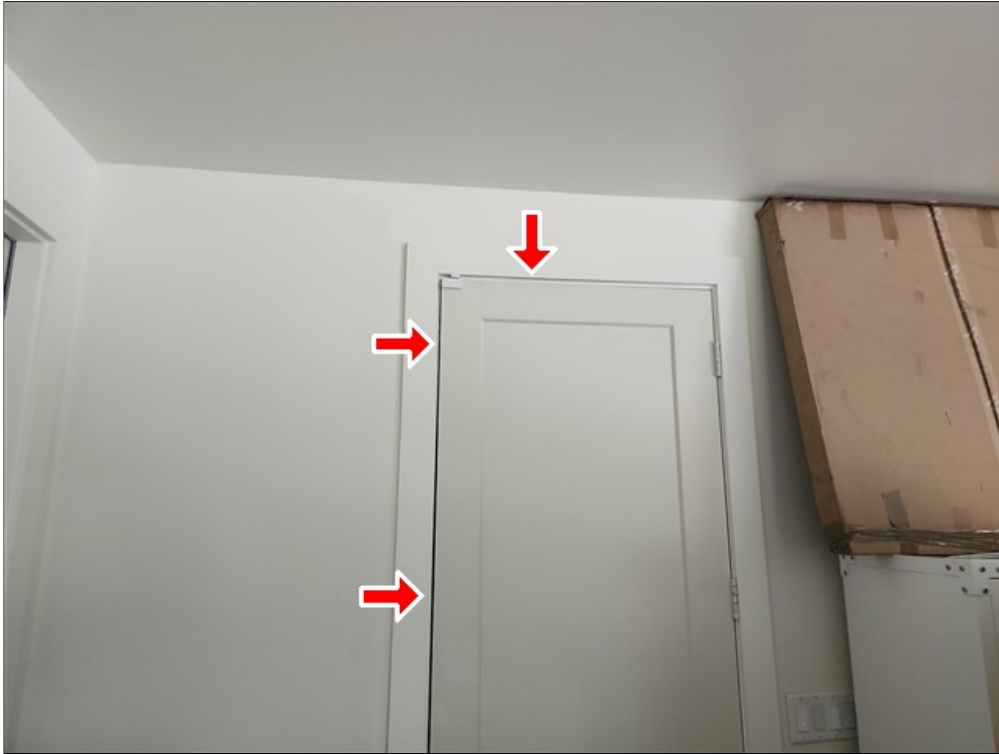
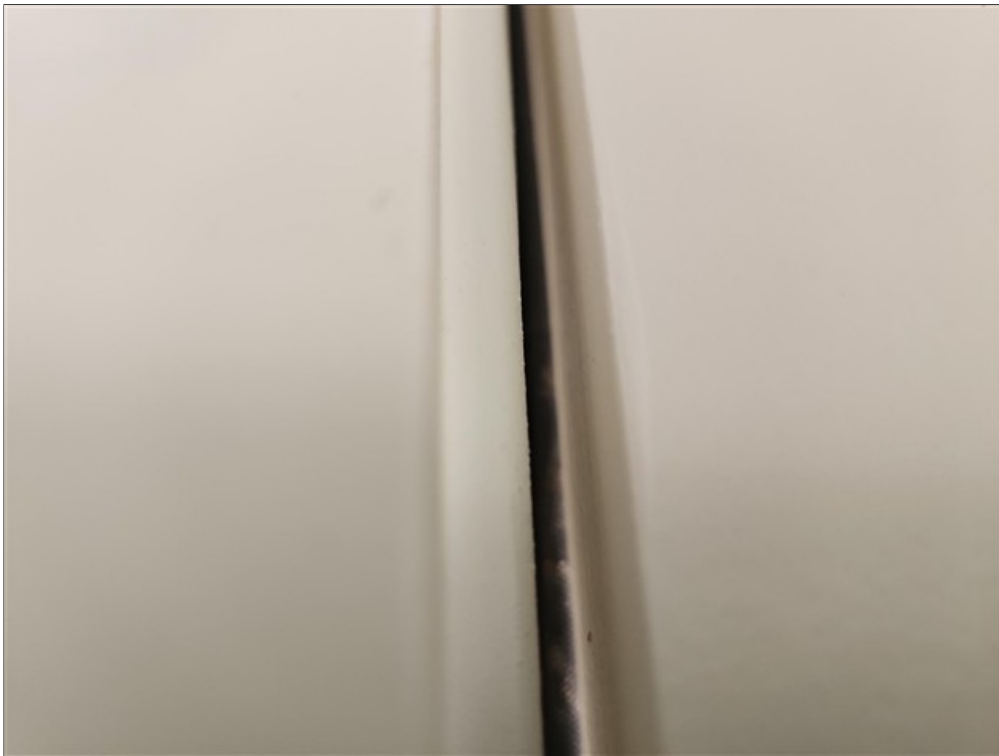
G. Excessive air gaps at exterior door in garage

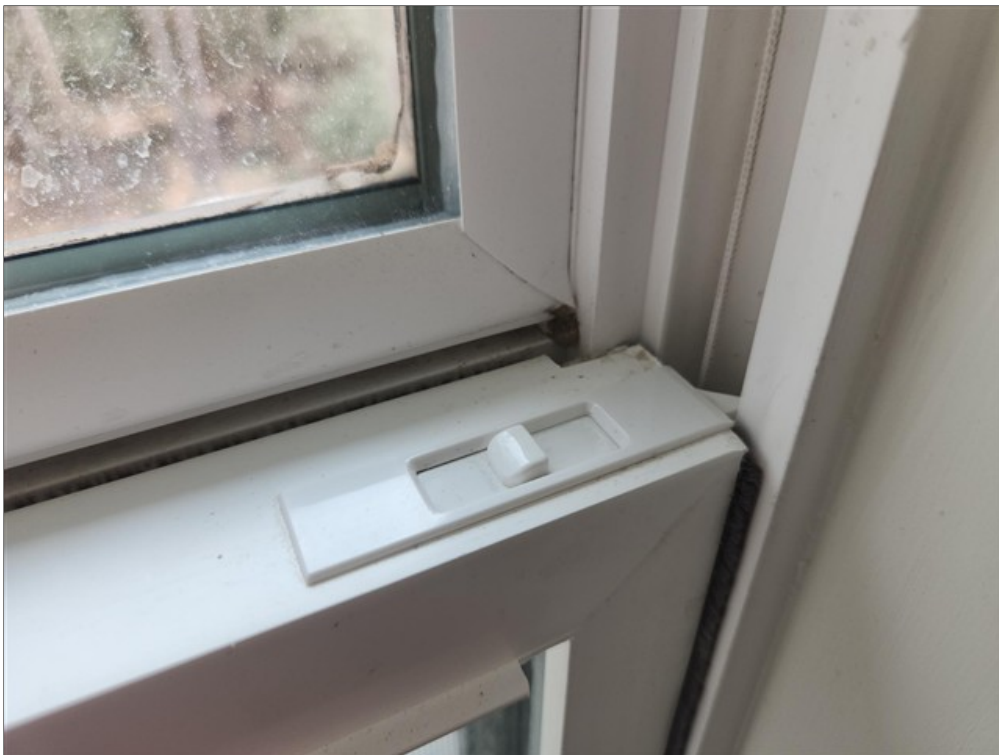
H. One latch missing at second level right guest bedroom right window

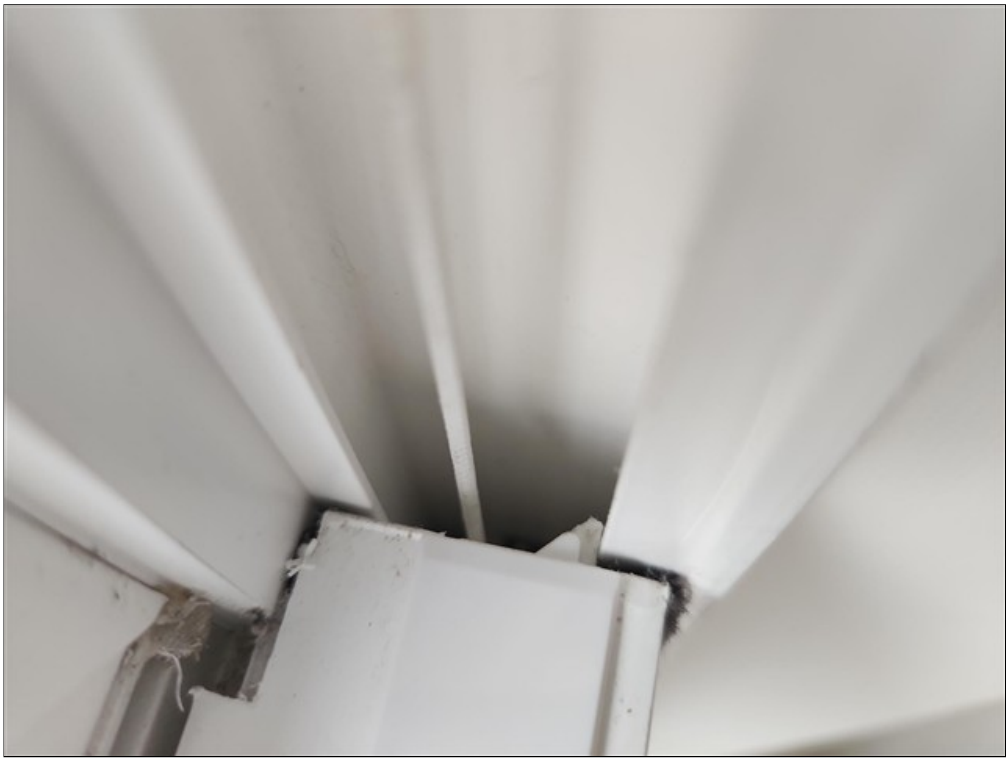
H. Far left window in second level right guest bedroom does not latch on left side

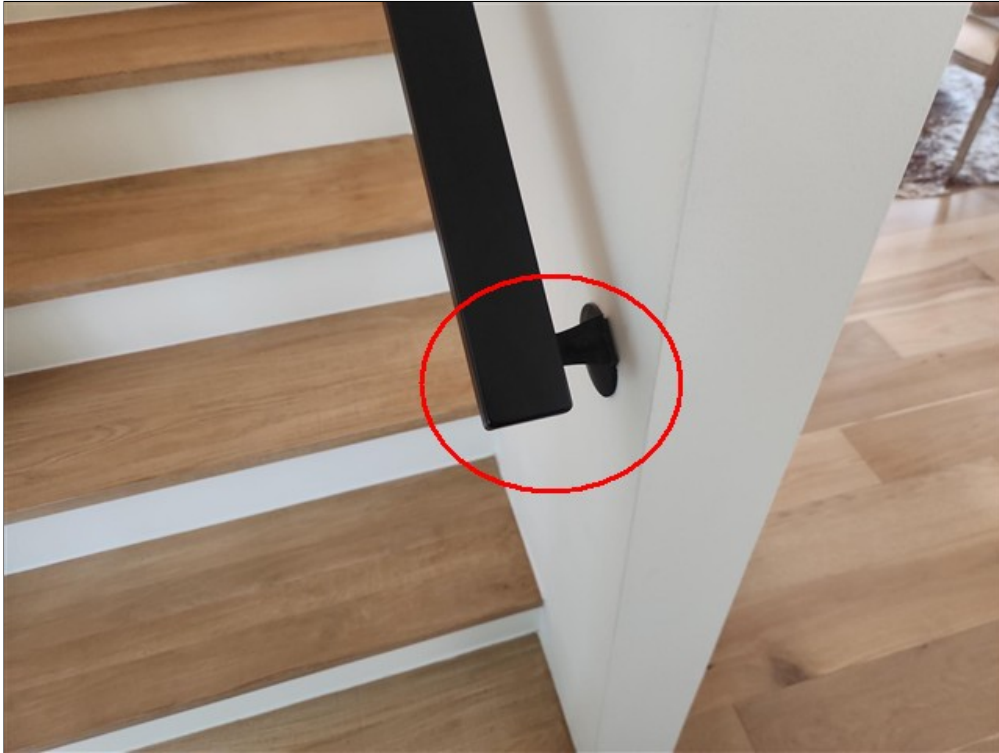
- The hand rail at the stairs does not terminate to the wall or to a newel post. This is considered a safety hazard.

I. Hand rail does not terminate to wall or newel post

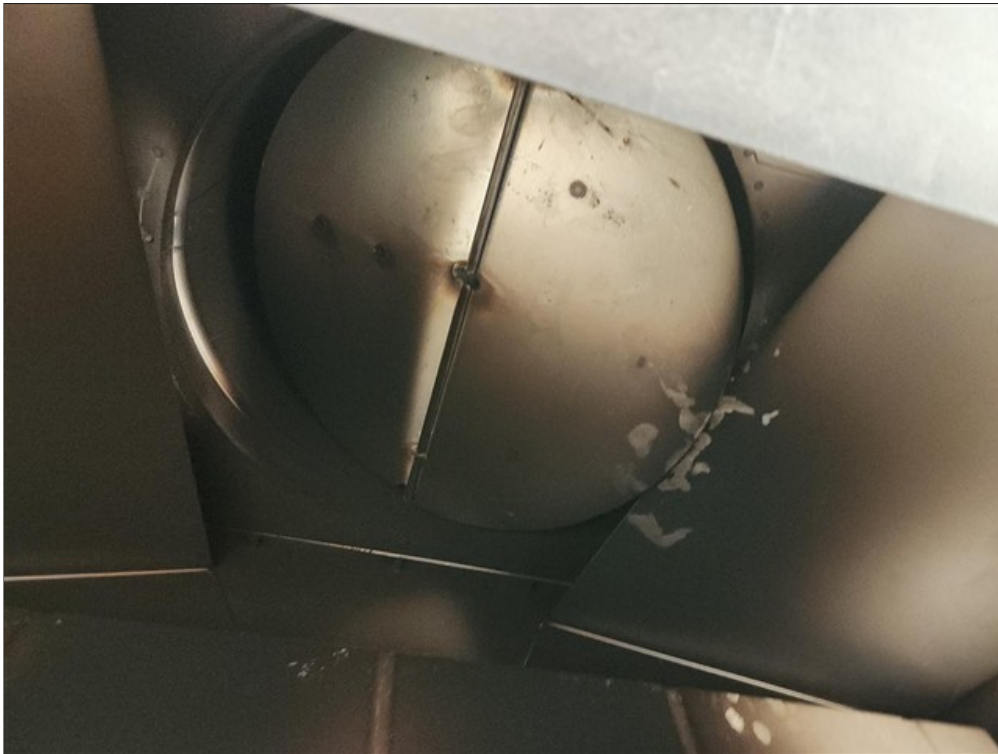
- The fireplace does not have damper stop installed. Damper stops are needed for fireplaces that are burning hydrocarbon fuels to assure carbon monoxide fumes are vented out of the home.

J. Fireplace missing damper stop

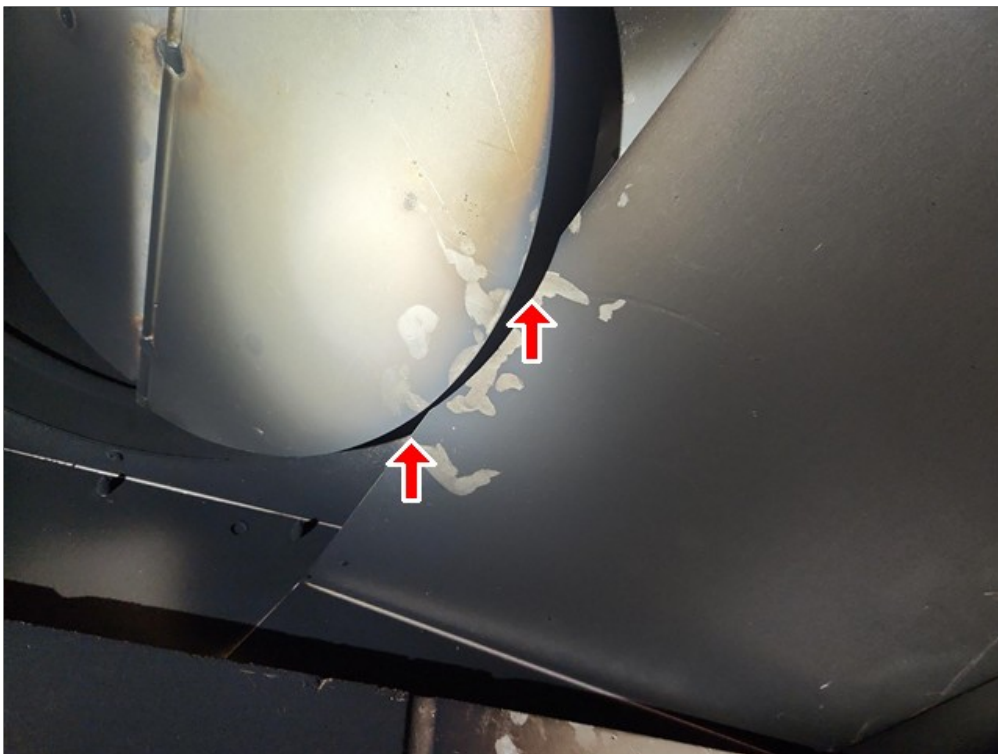
- The fireplace damper is being blocked by part of the metal fireplace frame.

J. Damper being blocked by part of metal fireplace frame

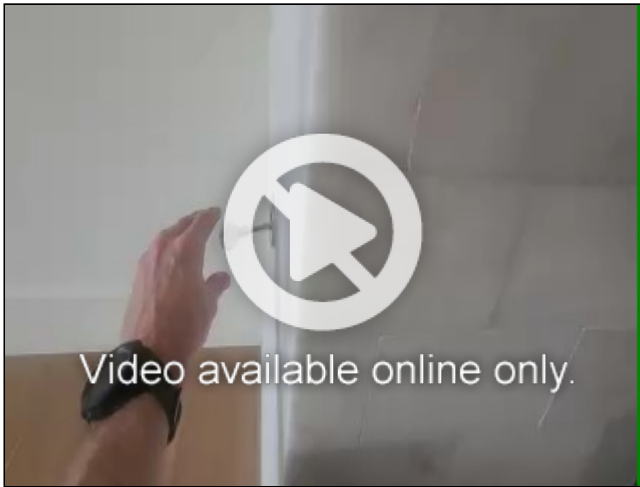
- Fireplace gas distribution bar makes very loud, high pitched, whistling sound when operating.

J. Video showing fireplace gas distribution bar making unusual noises when operated (Video can only be viewed in web presentation or summary format)

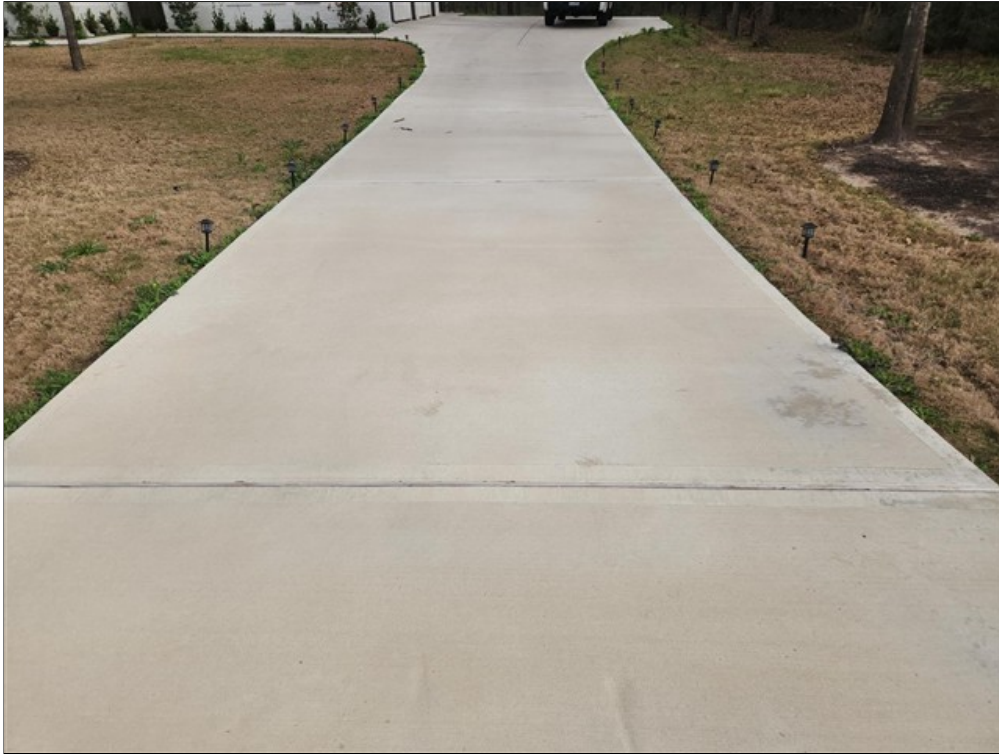
- Two concrete driveway pads are cracked across the entire pad and one of the two pads is also broken at one corner.

L. Photos showing two concrete driveway pads cracked across entire pad

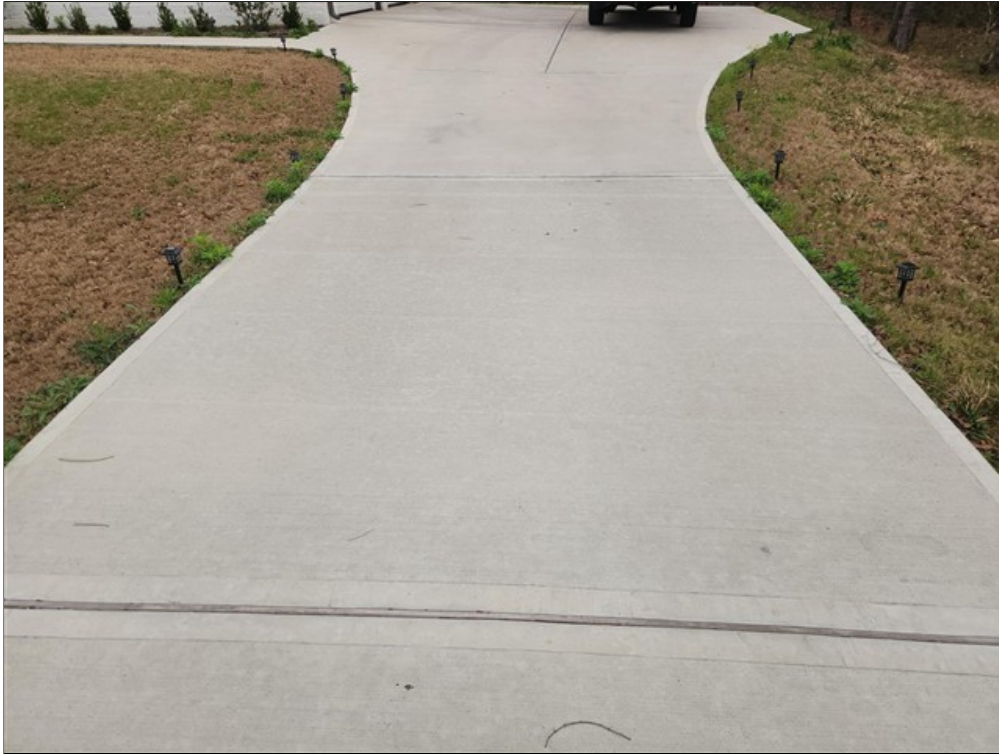
L. Photo showing concrete pad broken at one corner
