Inspection Report

Property Address:
7610 Trinity Pines Drive
Montgomery TX 77316

Home Data Inspection Services, PLLC

PROPERTY INSPECTION REPORT FORM

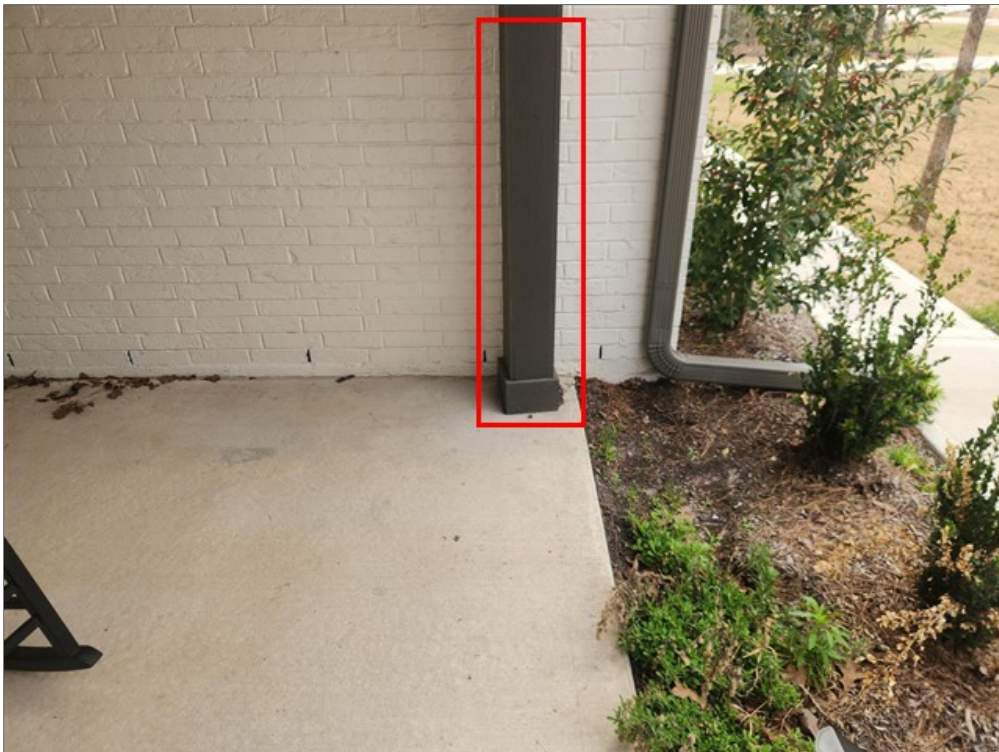
- One front porch column is notably twisted.

L. Porch column notably twisted

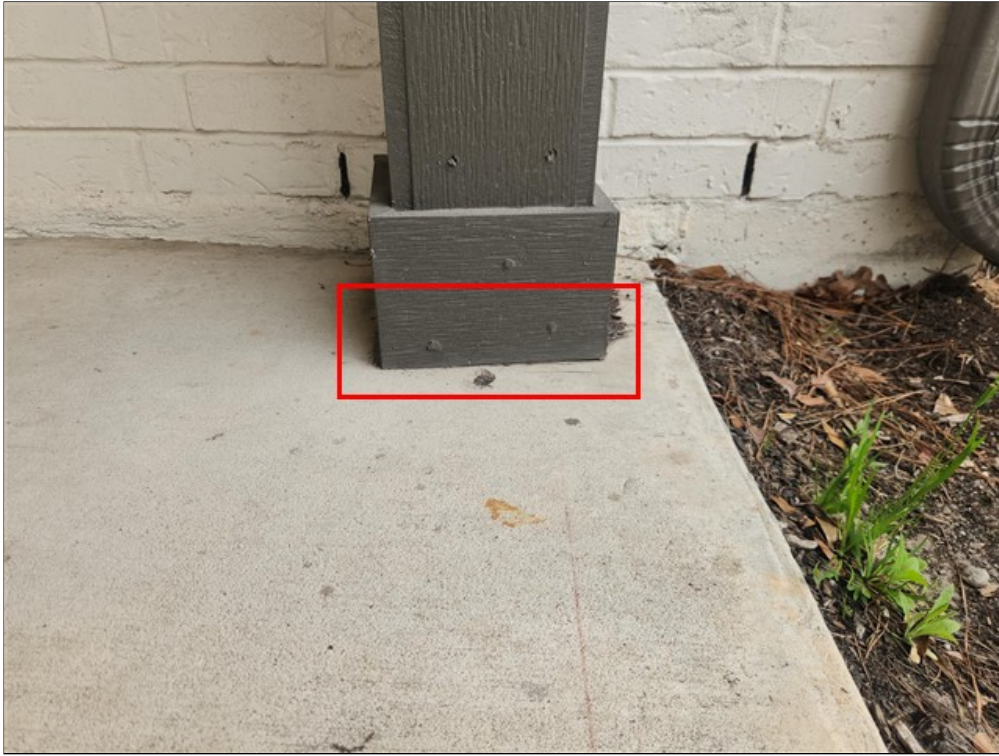
- Trim at front porch columns in direct contact with concrete flatwork.

L. Trim at front porch columns in direct contact with concrete flatwork

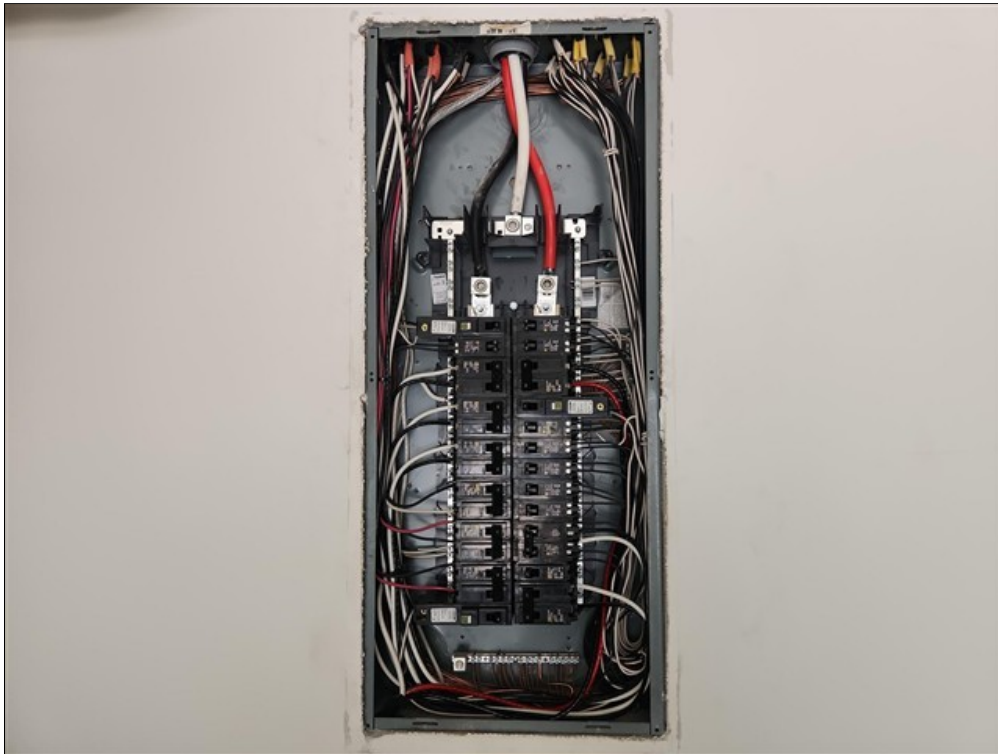
- The main panel enclosure was inspected with the deadfront cover removed. Conditions needing repair were observed. These repairs should be performed by a licensed electrician. Additional defects may be discovered when inspected by the licensed electrician.
- Arc Fault is / was either not installed at all or incomplete according to current standards. These devices are considered safety items and this condition should be further investigated by a licensed electrician.

A. Overall photo of main panel enclosure with dead front cover removed

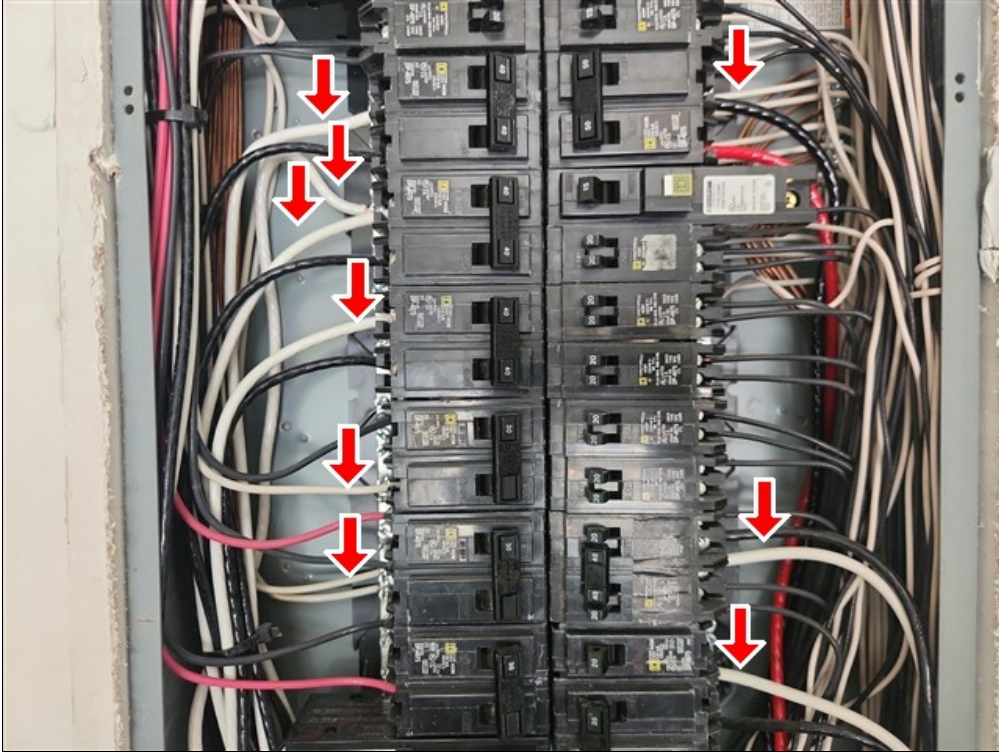
- The aluminum feeder wires are not properly coated with anti-oxidant paste to prevent corrosion.
- White wires used as line or hot wires should be identified as such by wrapping the wires with black or red electrical tape or marking the wires with marker at the breakers.
- Breaker ties are needed in the main panel enclosure at the shared branch circuits. Breaker ties are needed to assure electrical current at all conductors in a cable is shut off when a breaker is tripped. This is a small repair but is a safety hazard that should be corrected.

A. White wires used as line or hot wires should be identified

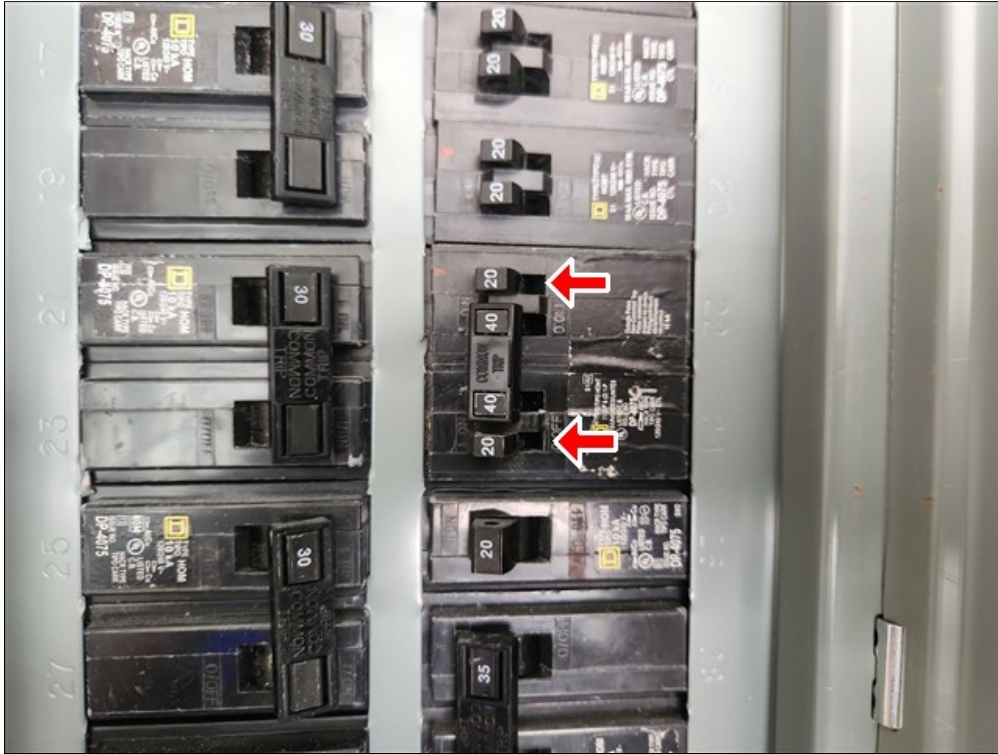
A. Possible missing breaker tie

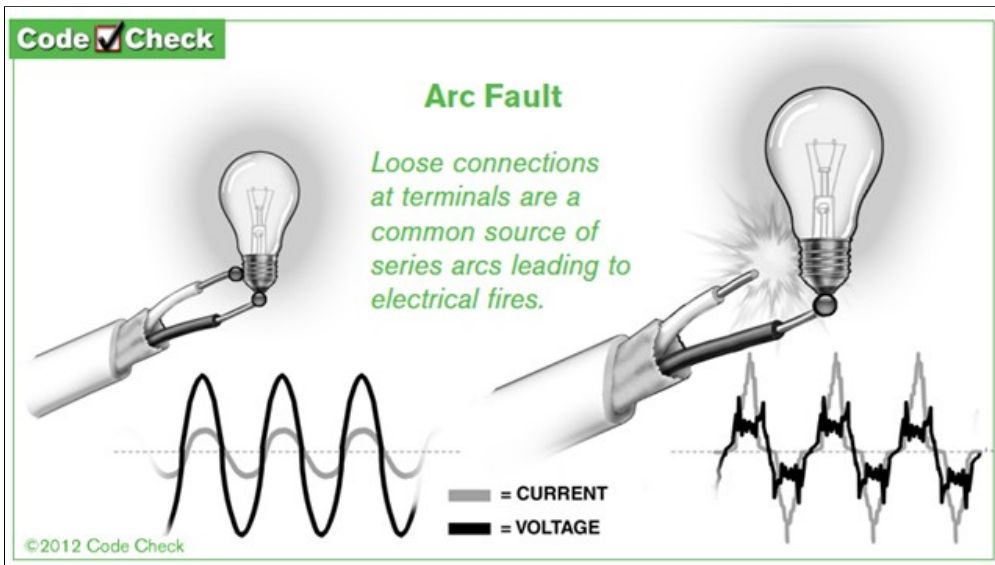
This home does not meet current arc-fault circuit-interrupter (AFCI) requirements. This is an "as built" condition, but Per TREC standards of practice we are required to report this condition as a deficiency. Some items reported as Deficient may be considered upgrades to the property. For more information, refer to Texas Real Estate Consumer Notice Concerning Recognized Hazards, form OP-1

A. Arc Fault Diagram

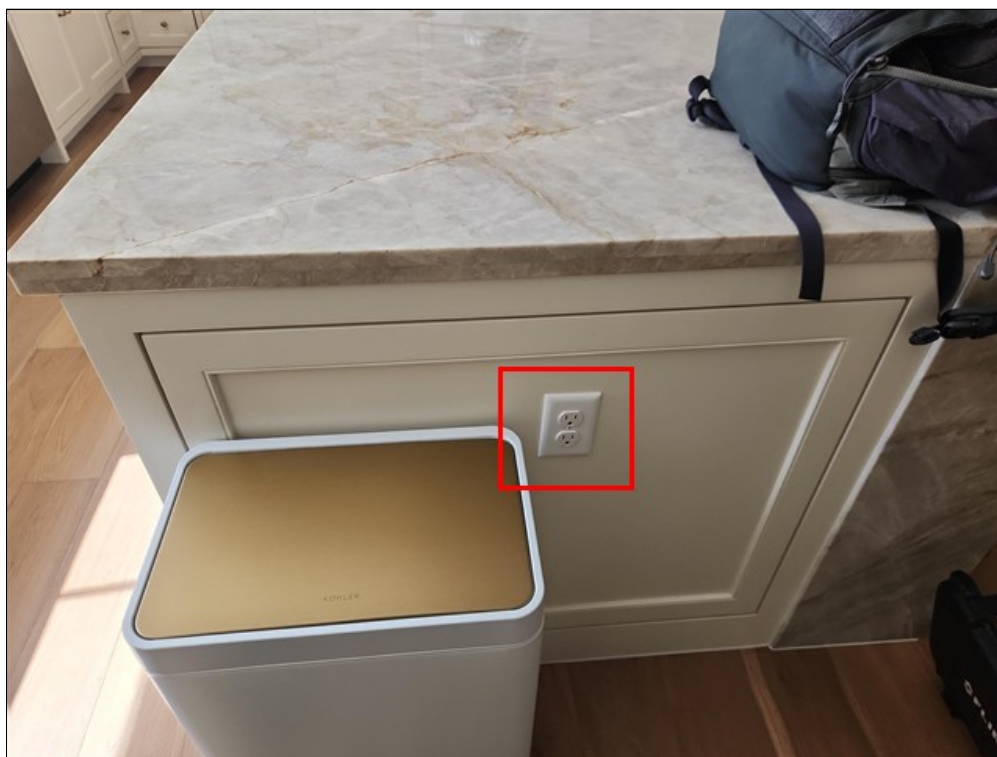
- Receptacles installed at ends of kitchen island. Additionally, these receptacles are not GFCI protected.

B. Receptacles installed in ends of kitchen island - also not GFCI protected

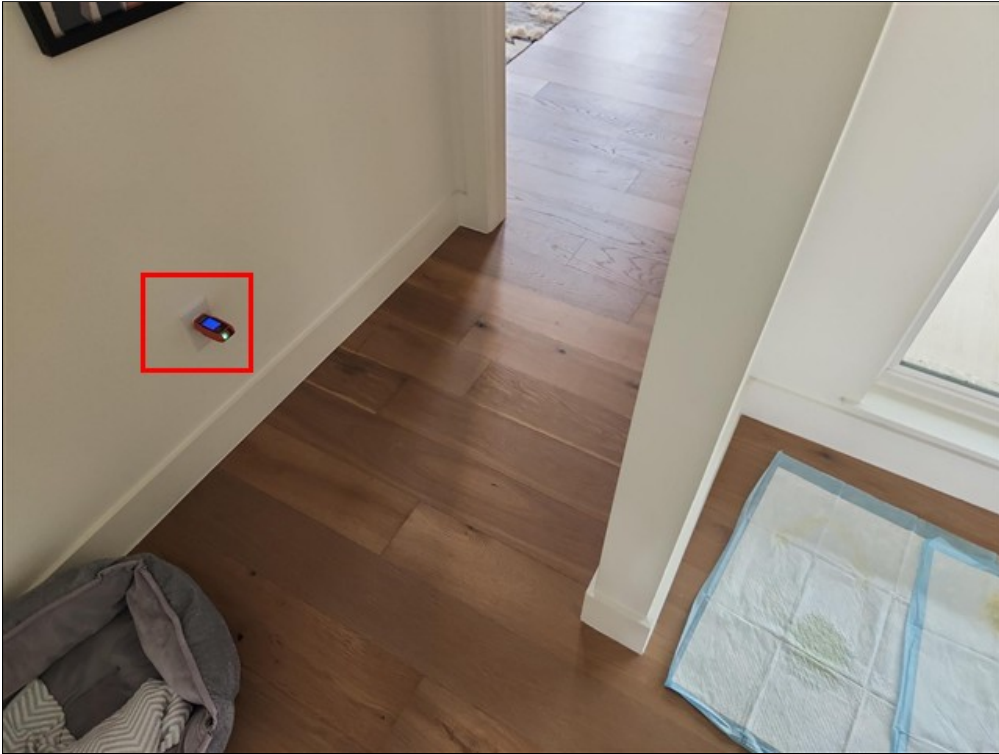
B. Some receptacles inside and outside of master bedroom have varying voltages

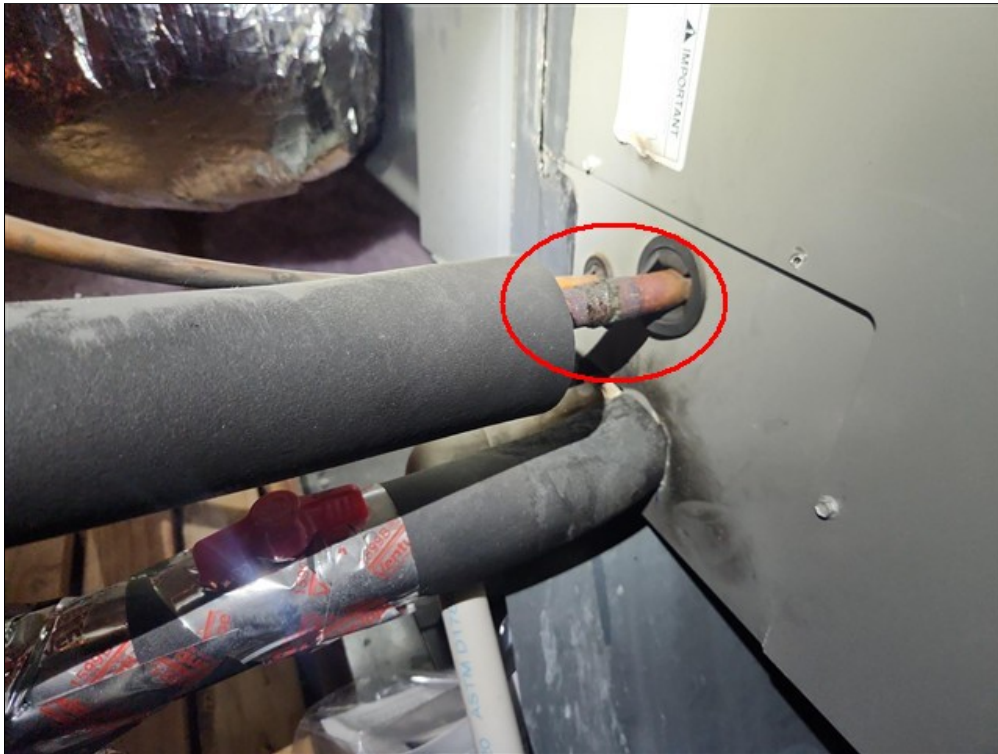
- Mastic improvements were observed to be needed at the HVAC equipment in the attic in the following locations: where refrigerant line passes through evaporator case. Inadequate sealants can allow for air leakage in these areas decreasing the efficiency of the system and allowing for condensation to form and continuously drip in unwanted locations which can lead to other undesirable conditions. An HVAC service professional should be consulted regarding repairs.

B. Mastic improvements needed where refrigerant line enters evaporator case

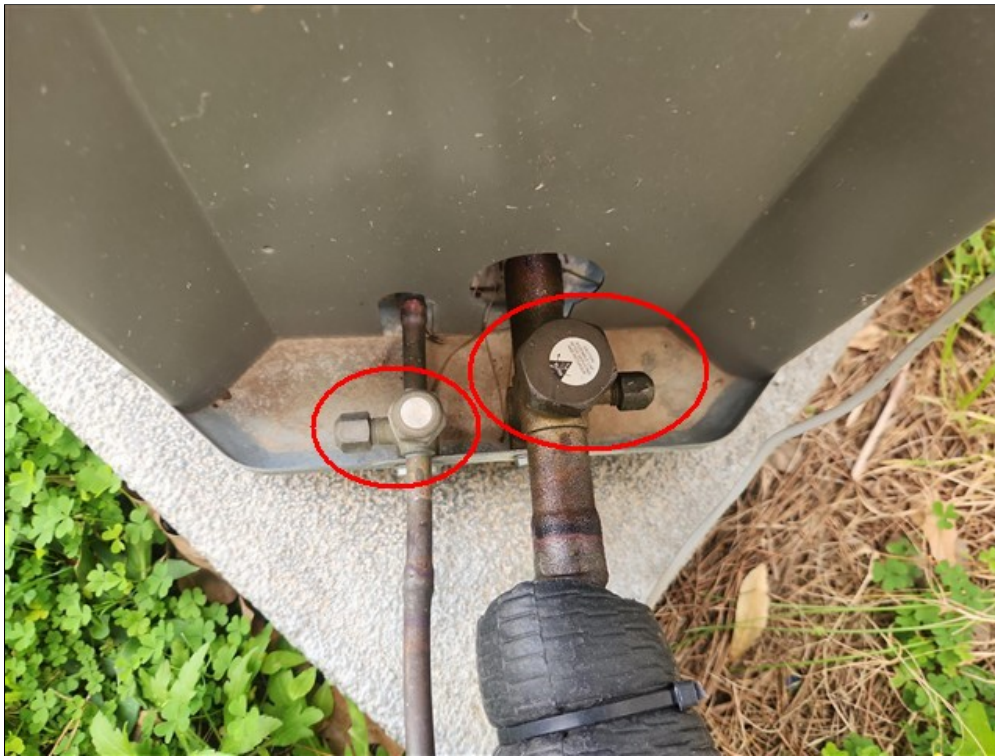
- 'Tamper-proof' locking caps for AC refrigerant ports are missing. As of 2009, HVAC systems are required to have a locking 'tamper-proof' cap on all units in residential and commercial dwellings. Residential and multifamily occupants may be subject to significant fines stemming from the lack of locking caps. Only a licensed HVAC technician may install or remove the locking cap.

B. Locking caps missing at refrigerant ports

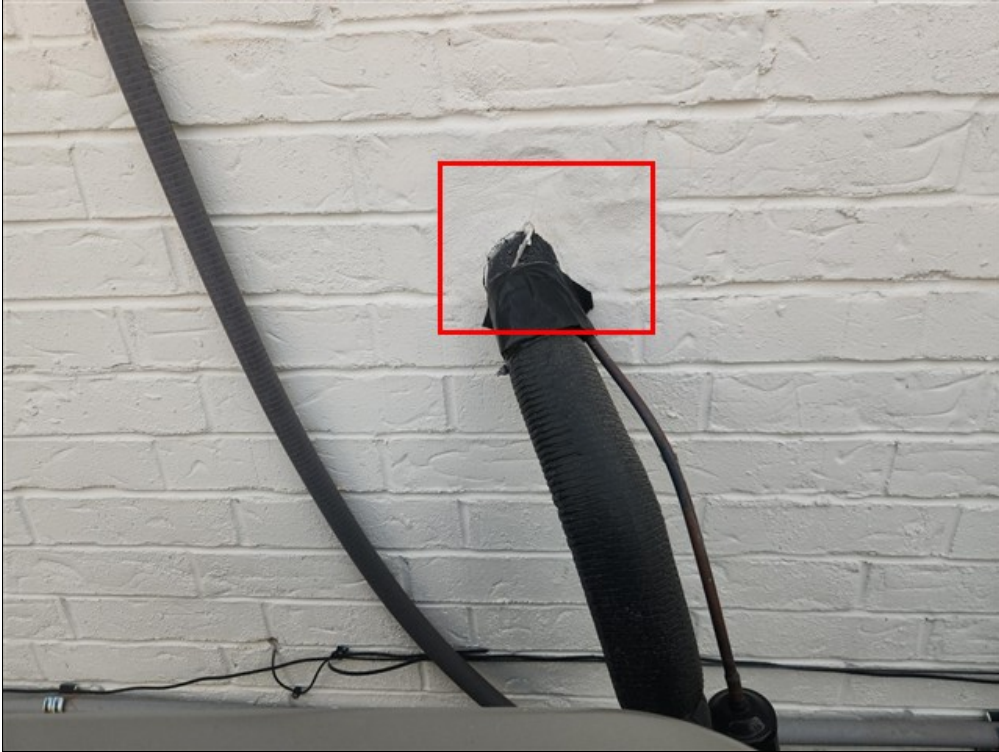
- A refrigerant hood is needed at the AC condensing unit refrigerant lines. Refrigerant hoods should be installed and caulked on the top and sides only. Refrigerant hoods help protect the lines from damage and help prevent moisture, insects and vermin from entering the home if properly installed. A qualified contractor should be consulted regarding this installation.

B. Refrigerant hood needed

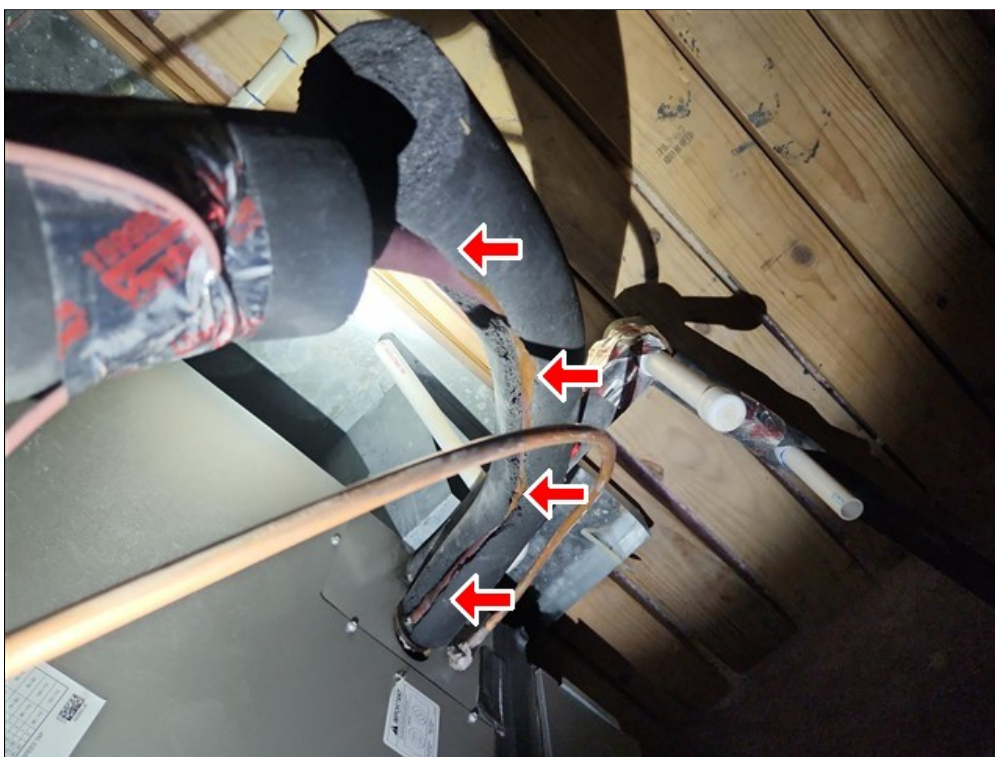
- Insulation improvements were observed to be needed around the AC refrigerant lines at the visible sections of refrigerant line in the attic.
- The conduit serving the the wiring to the disconnect is detached from the disconnect housing

B. Insulation improvements needed at refrigerant line in attic

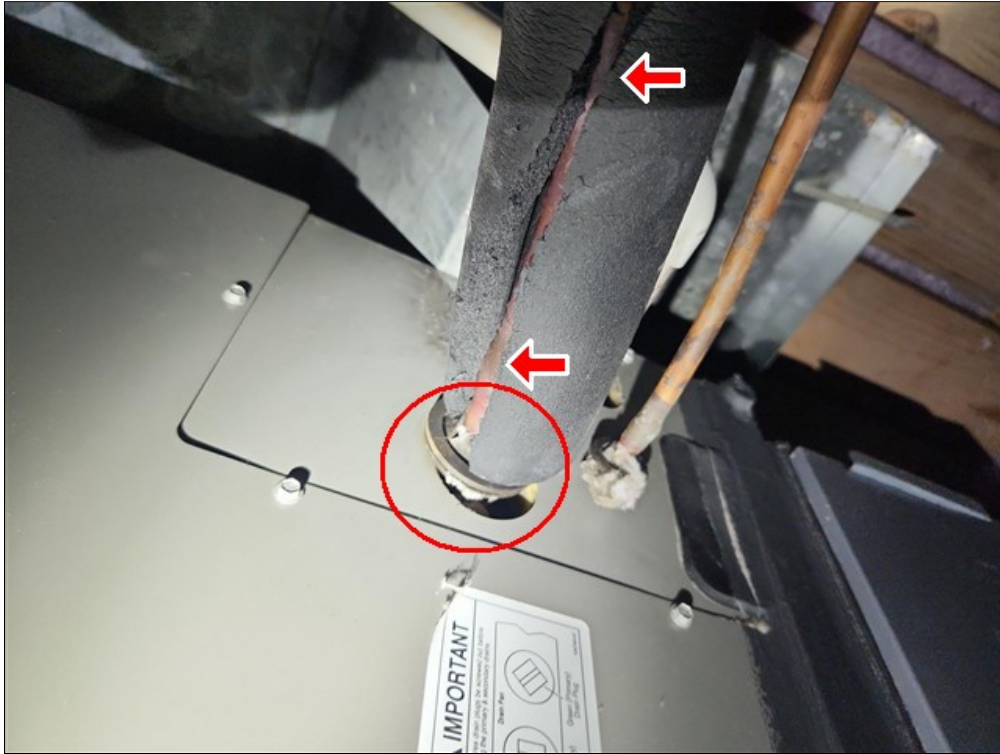
B. Mastic improvements needed where refrigerant line enters evaporator case

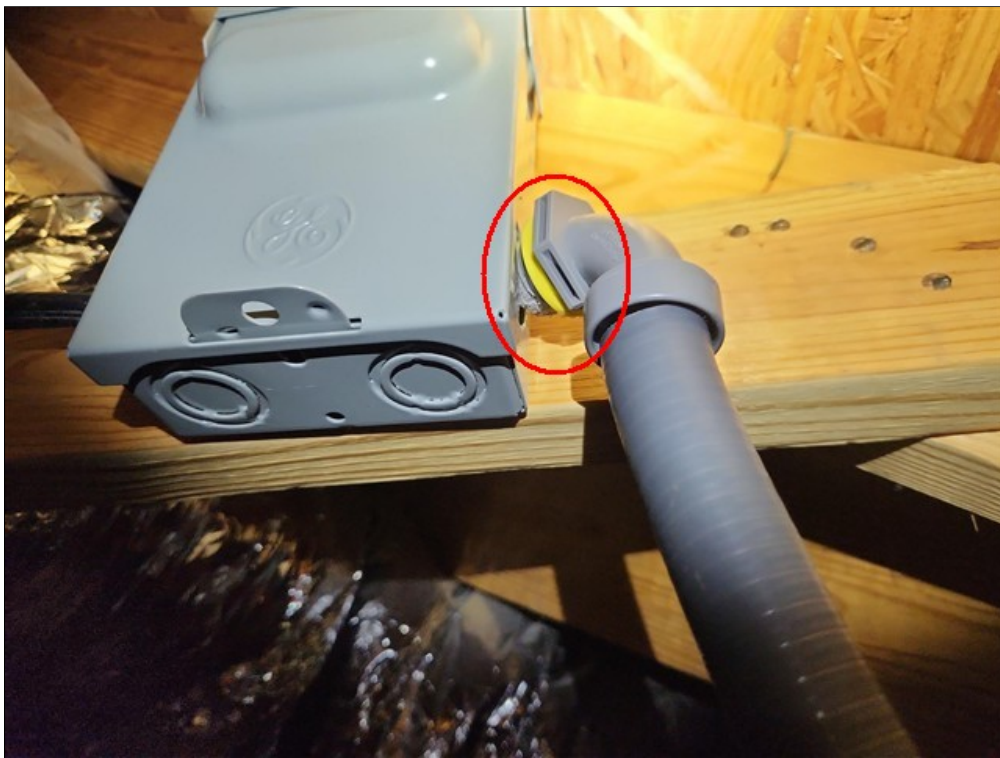
B. Conduit serving wiring to disconnect is detached from disconnect housing

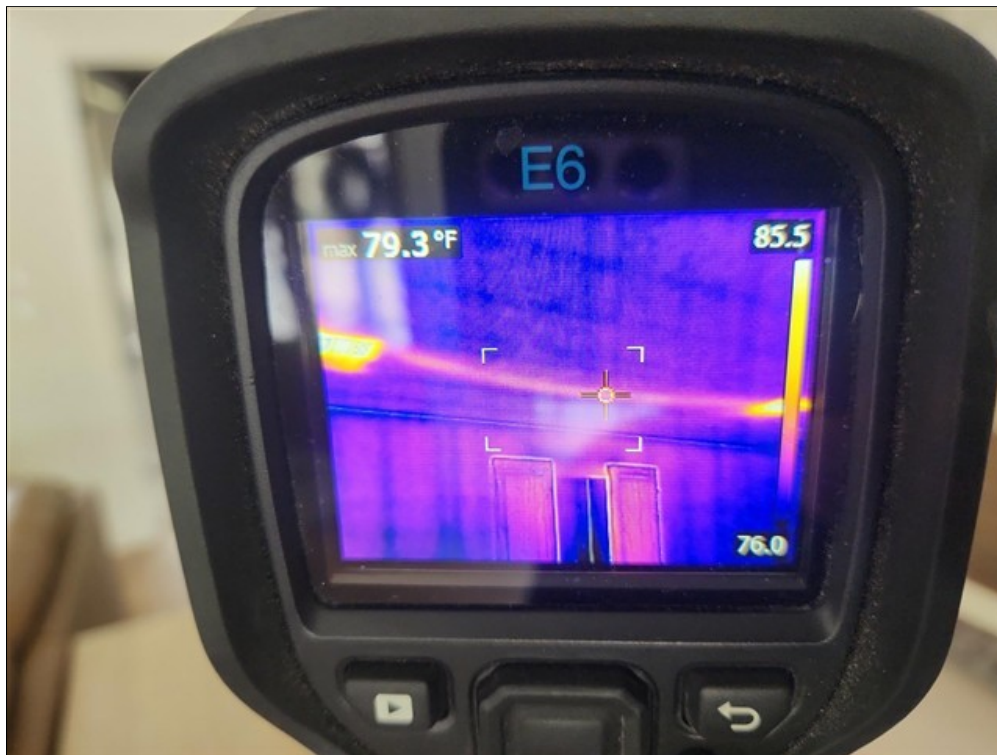
- During the thermal scan the inspector observed what appears to be a duct between two HVAC supply grilles is resting on the ceiling drywall.

C. Thermal anomaly of what appears to be a duct resting on ceiling drywall

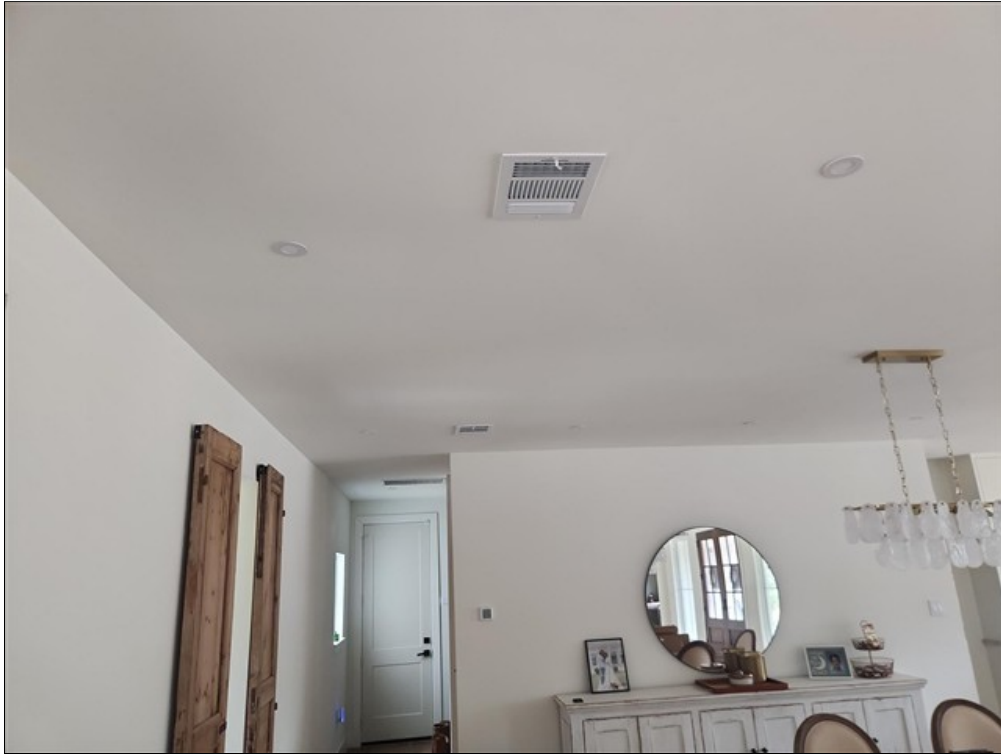
C. Area of thermal anomaly

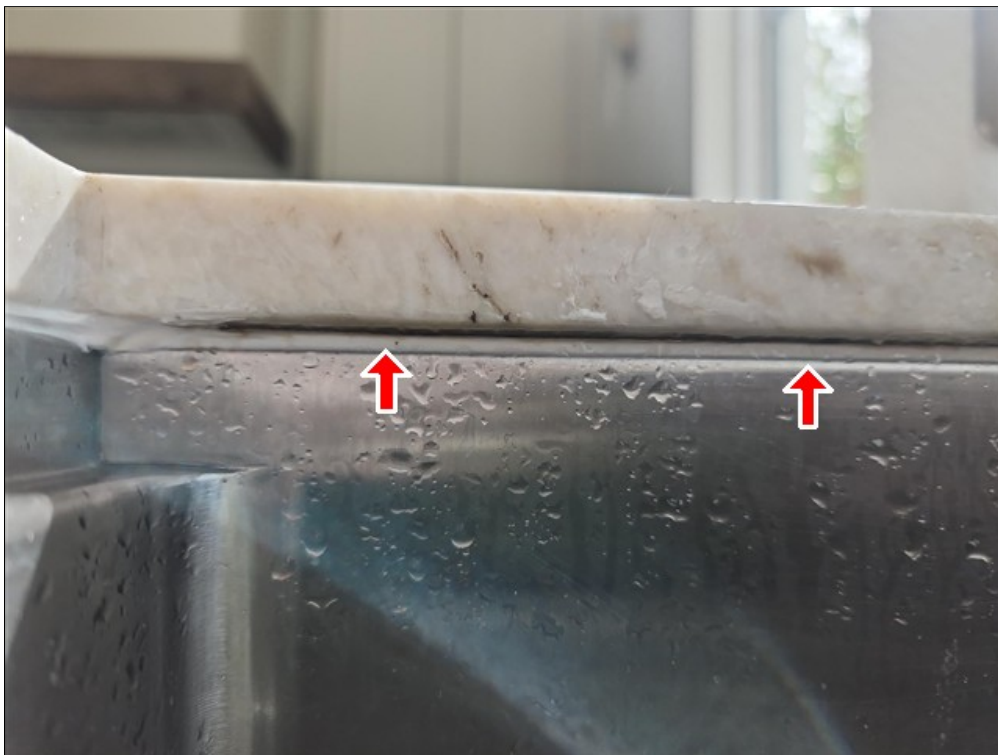
- Caulking improvements are needed at the transition between the countertop and undermount sink. This is not only a potential place for water to leak beneath the sink but also considered a fouling area, where bacteria can accumulate over time.
- Improper braces were observed to be installed to secure the undermount sink to the underside of the countertop. The proper clips/braces should be installed. Adhesives should never be solely relied upon, particularly in high humidity areas.

A. Caulking improvements needed at undermount sink to countertop transition

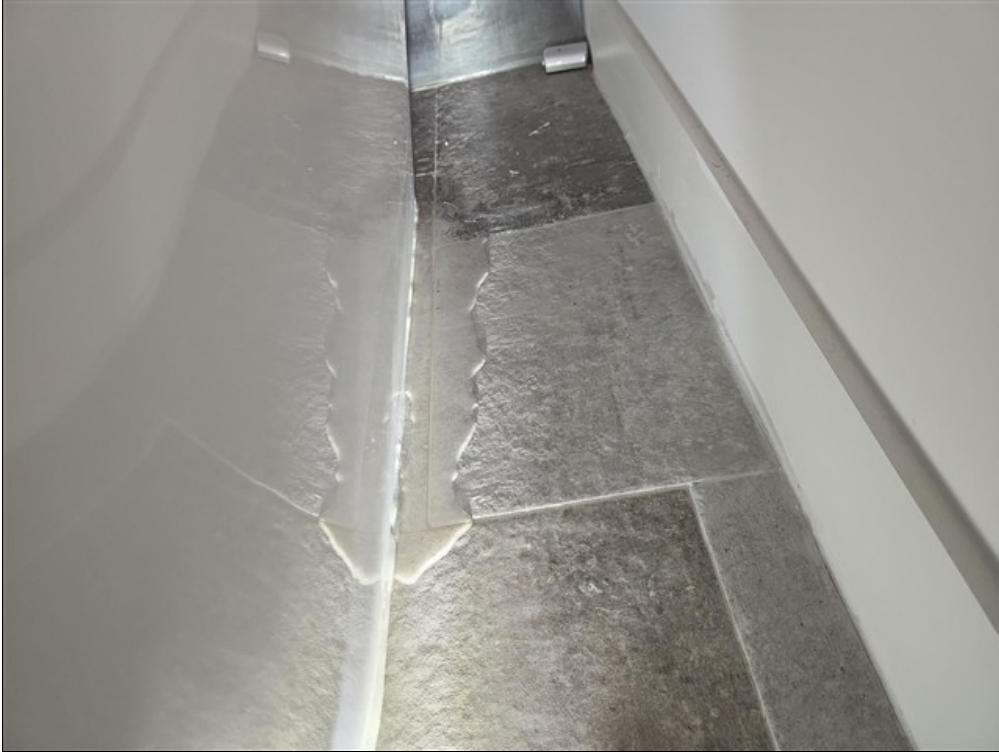
- A water leak was observed at a glass panel of the shower enclosure. Repairs should be undertaken.
- Caulking improvements are needed in the shower enclosure.

A. Water leak at glass panel of shower enclosure

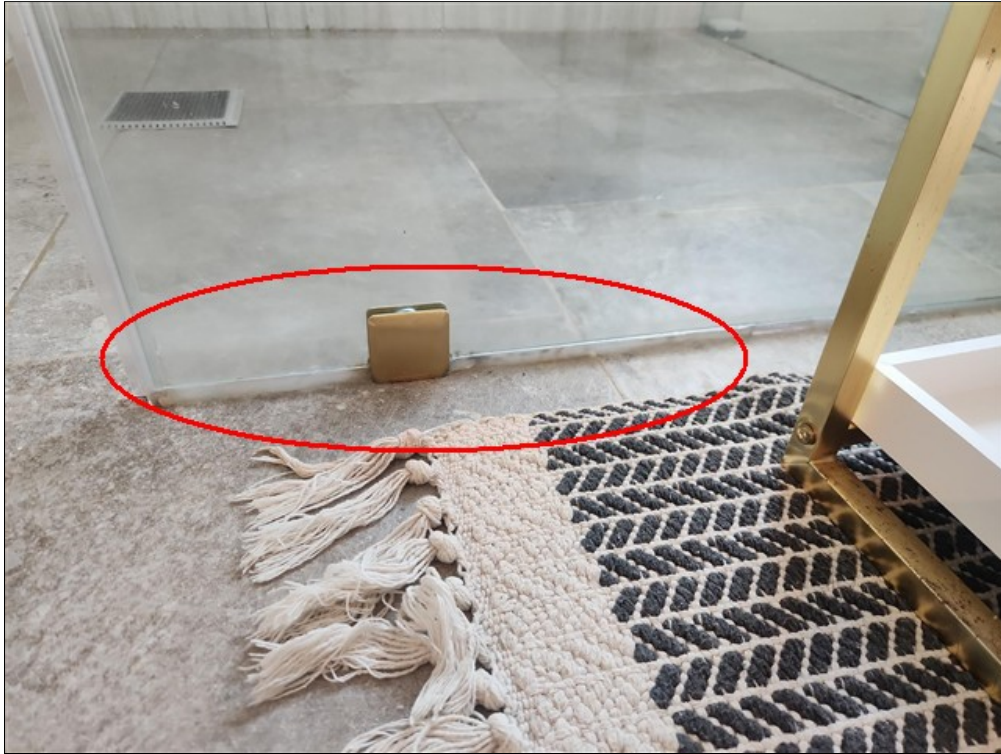
- The drain at one of the sinks drains slowly. The cause of this condition should be determined and repaired as needed.
- The gap between the floor and the bottom of the glass shower enclosure was observed to be approximately 1 inch. This is too large of a gap to be filled with caulking.

A. Leak at bottom of shower glass where caulking is filling 1 inch gap

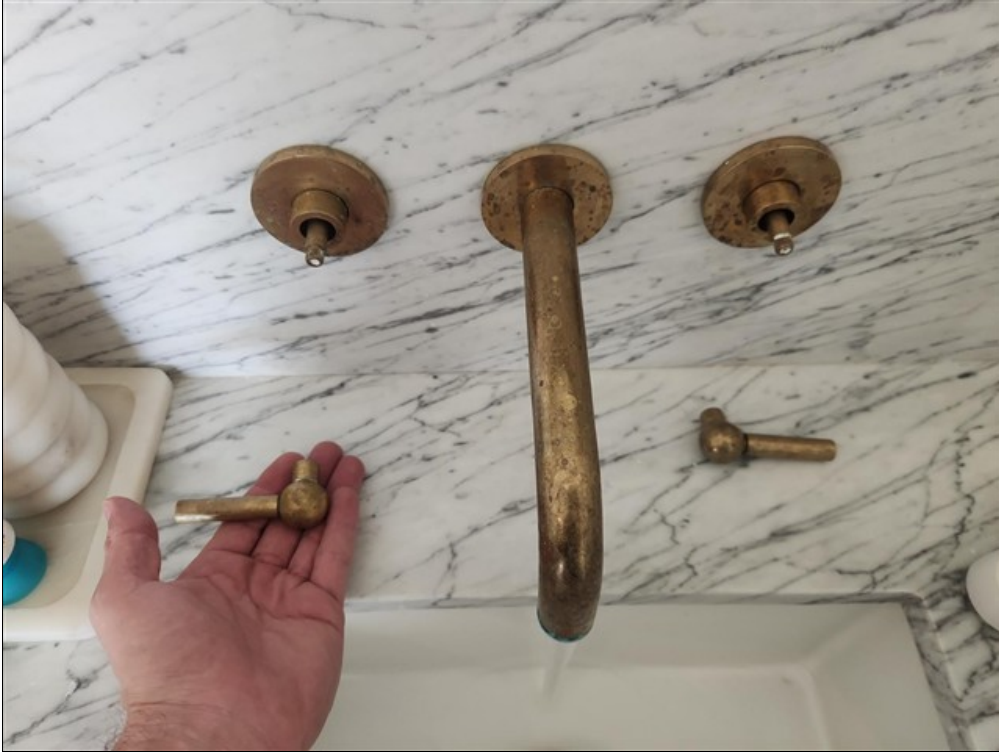
- The water valve handles serving the sink were observed to be detached.
- Corrosion observed at sink faucet and sink water valve handles.
- No clips/braces were observed to be installed to secure the undermount sink to the underside of the countertop. Adhesives should never be solely relied upon, particularly in high humidity areas.

A. Detached sink water valves

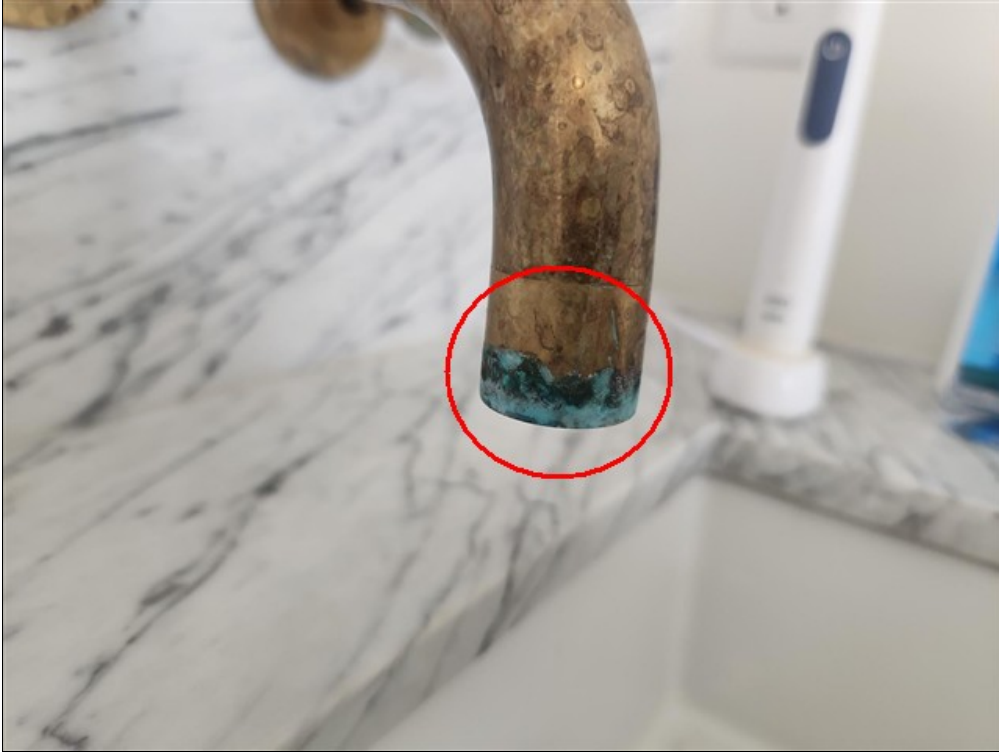
A. Corrosion observed at sink faucet

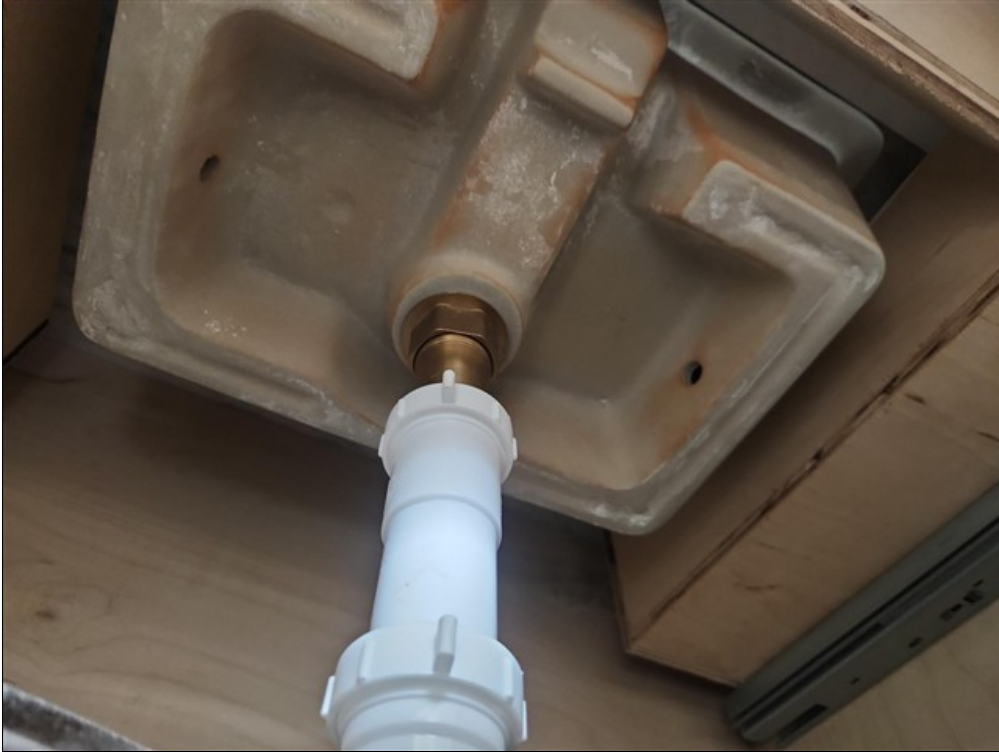
A. Undermount sink missing braces/clips

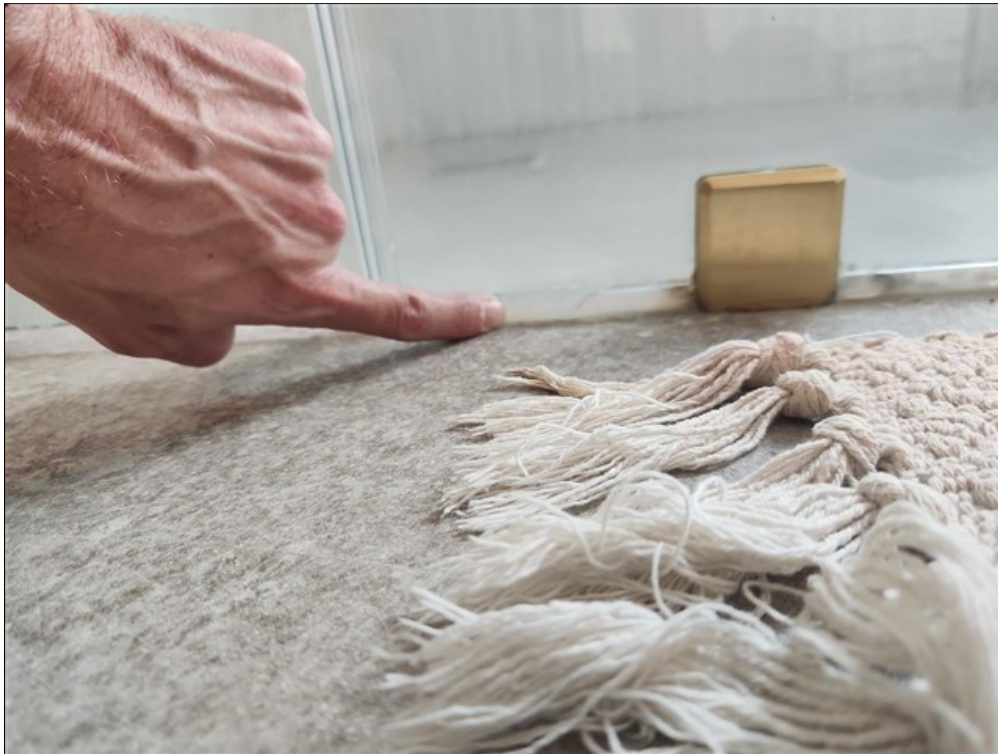
A. Gap between shower enclosure glass and floor approximately 1 inch - too large to be filled with caulking

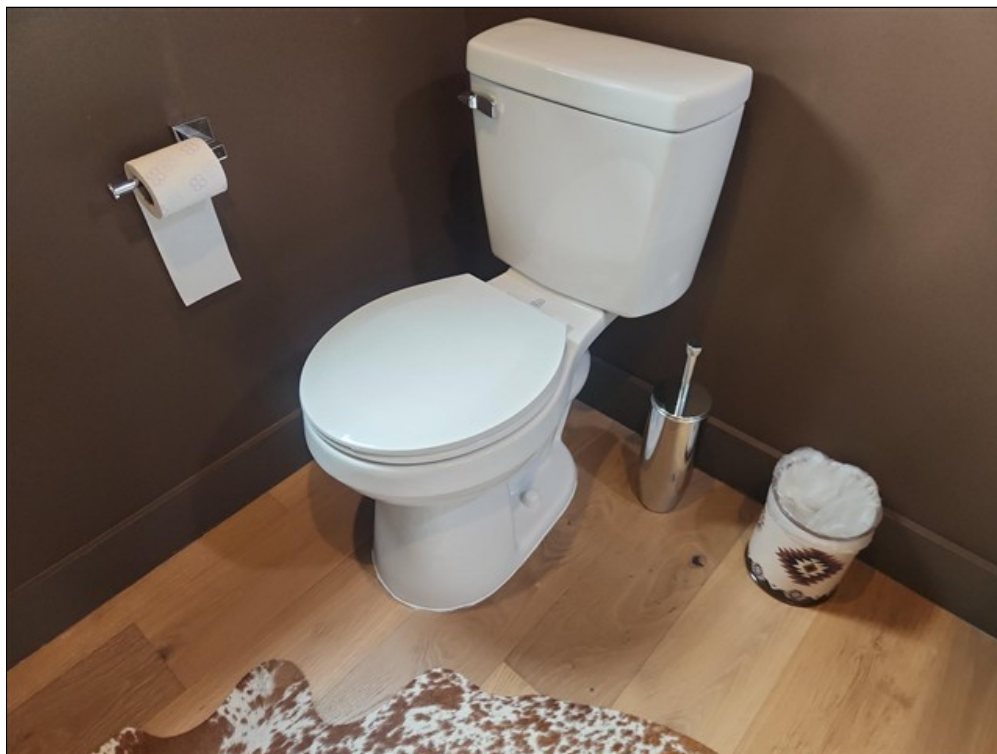
- The toilet was observed to be loose at the floor. The toilet should be removed and reset. The toilet and flange should be inspected for damage. When a toilet leaks at the floor is possible for the leak to go between the foundation and the flooring cover and cause damage that is not visible to the inspector at the time of inspection. Further repairs may be possible.

A. Toilet loose at floor

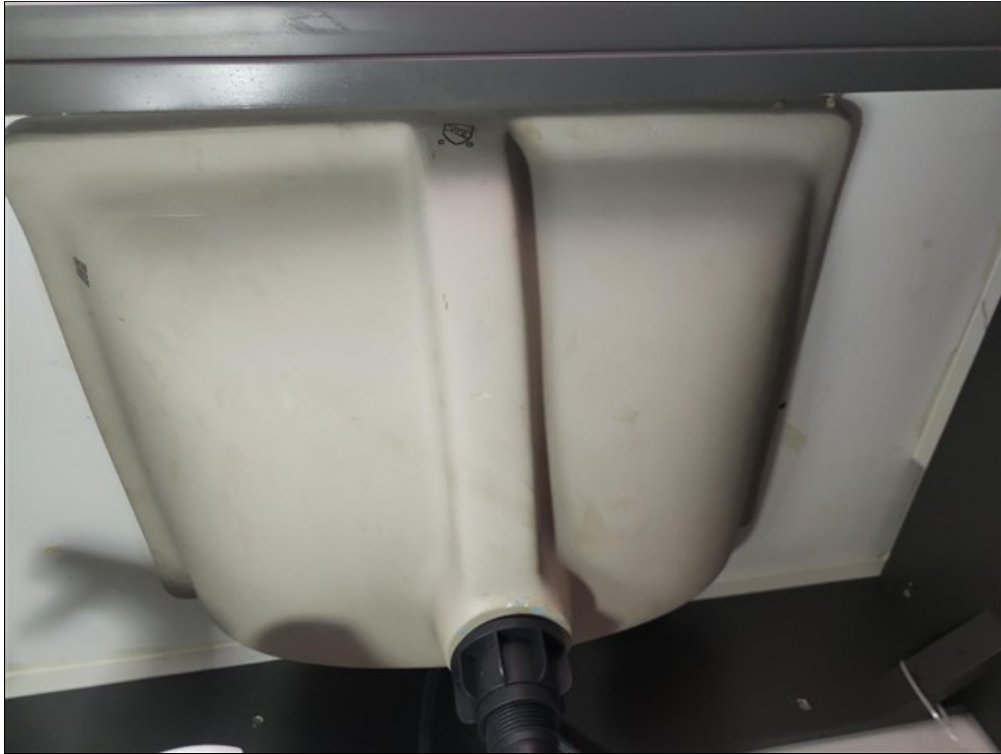
A. No clips/braces installed to secure undermount style sink to underside of countertop

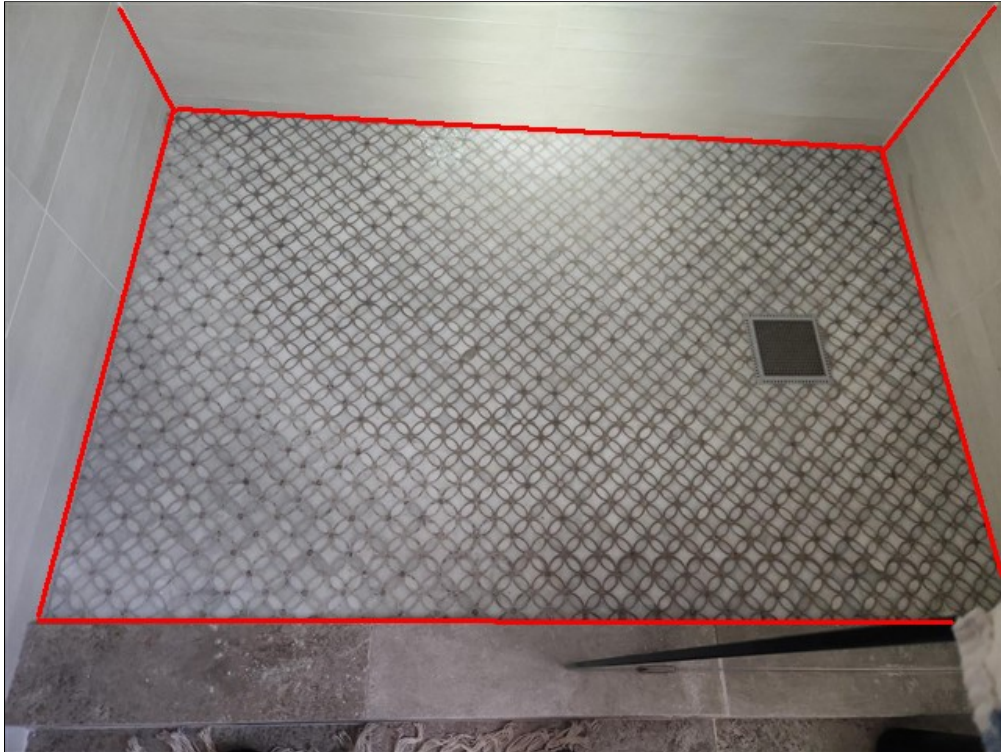
A. Caulking improvements needed in shower enclosure

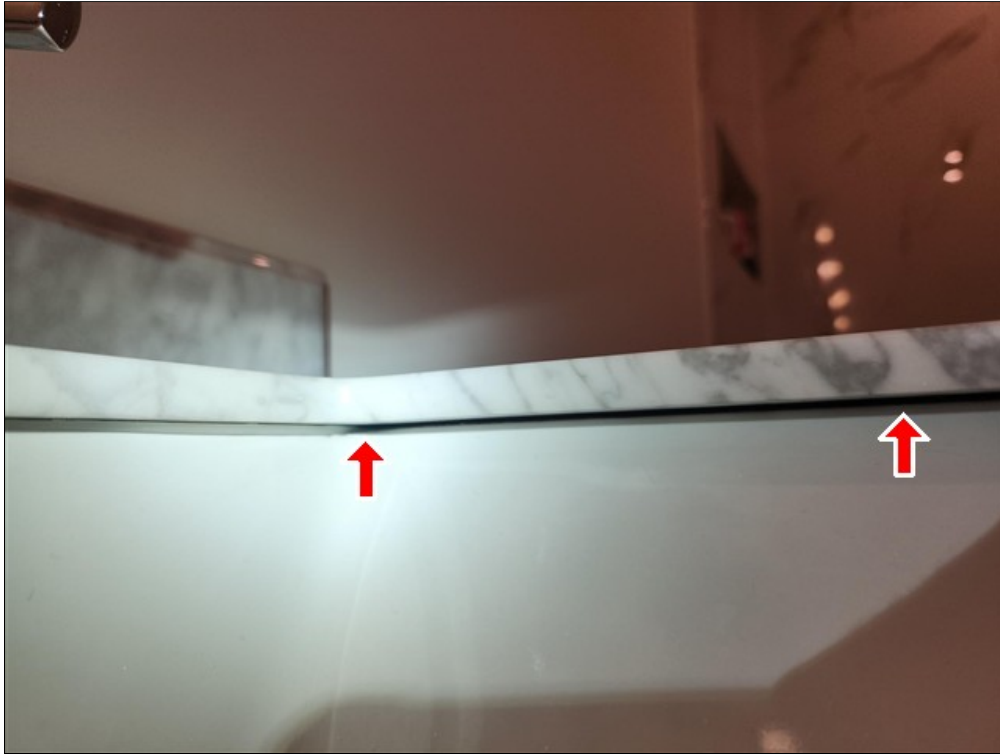
A. Caulking improvements needed at undermount sink to countertop transitions

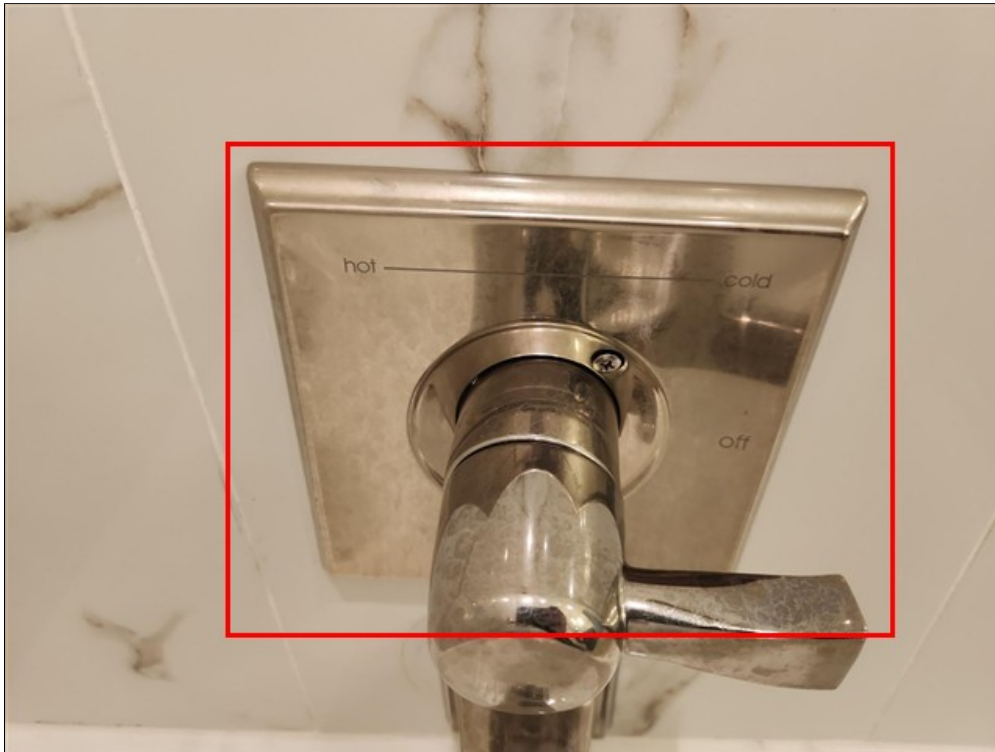
A. Caulking improvements needed around bathtub water valve cover plate
