Inspection Report

Property Address:
7610 Trinity Pines Drive
Montgomery TX 77316

Home Data Inspection Services, PLLC

PROPERTY INSPECTION REPORT FORM

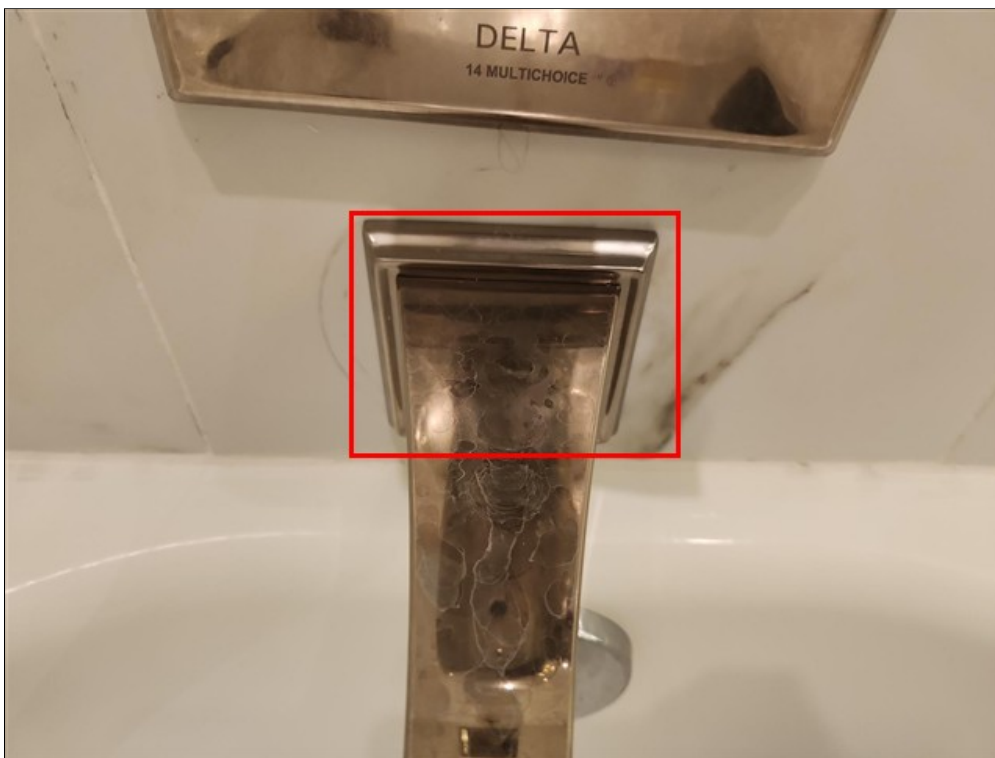
A. Caulking improvements needed around base of bathtub spigot

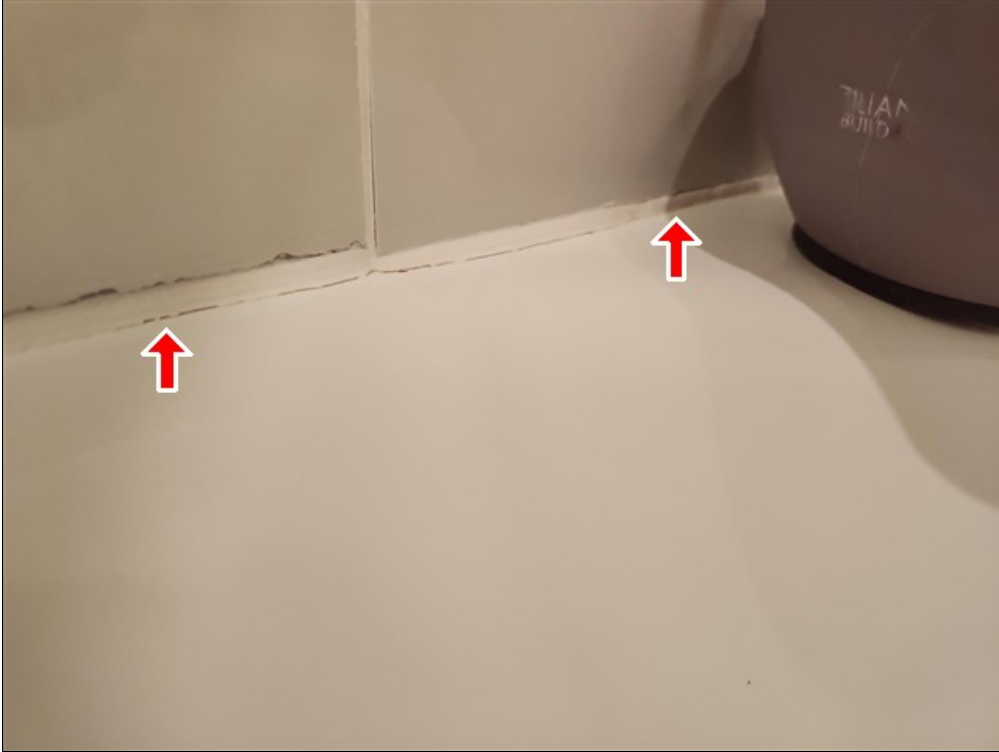
A. Caulking improvements needed at the shower wall to tub transitions

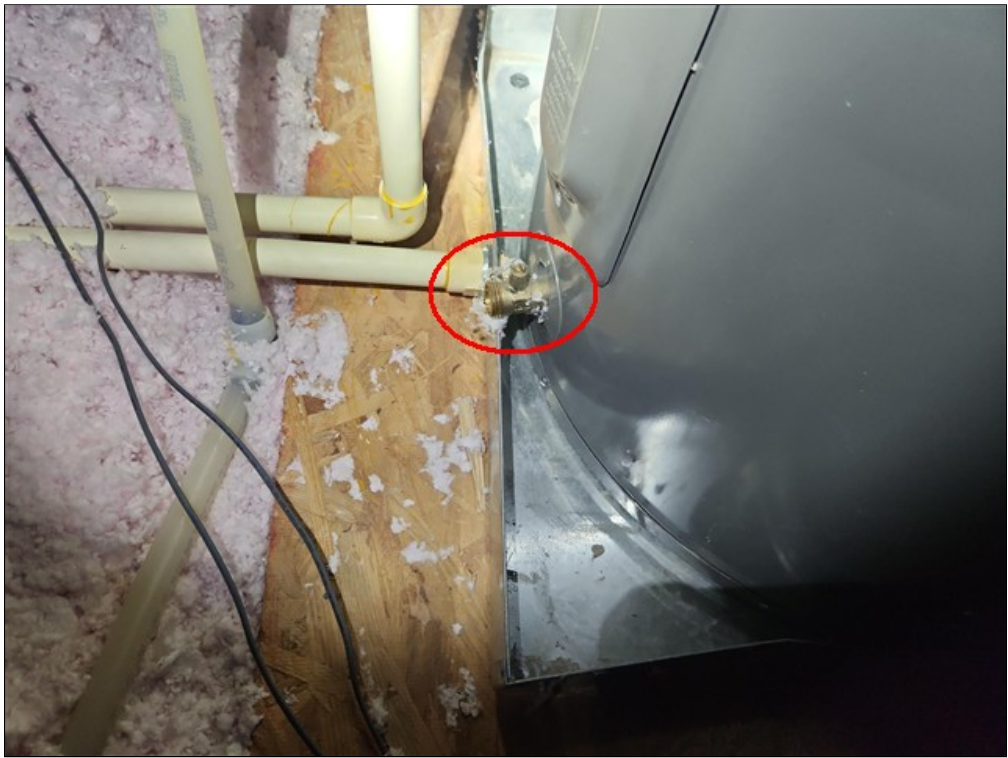
- View of water heater data plate:
- Although the water heater appeared to be functioning as intended, some items in need of repair were observed.
- The drain valve at the water heater extends over the edge of the safety pan. If the valve leaks, water damage to the home could occur.

C. Drain valve extends over safety pan

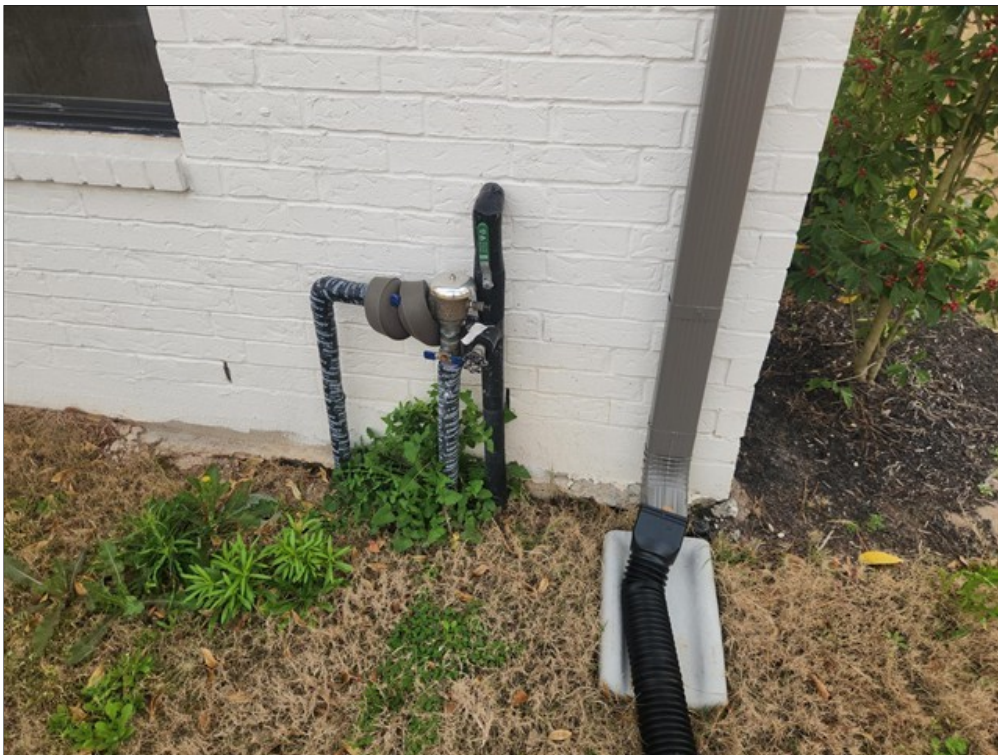
- Irrigation system vacuum breaker assembly should be secured to the side of the home.

A. System vacuum breaker

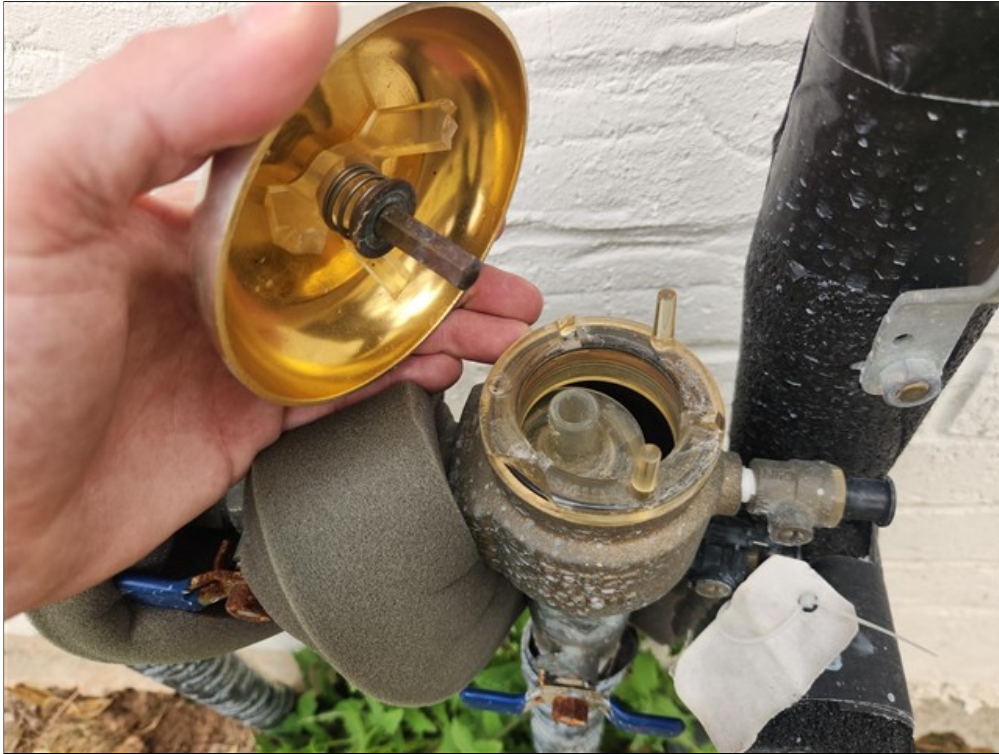
- The vacuum breaker was observed to be broken. This prevented the inspector from being able to test the system.

A. Vacuum breaker broken
